SOUND HOME INSPECTION, LLC

Inspection Report

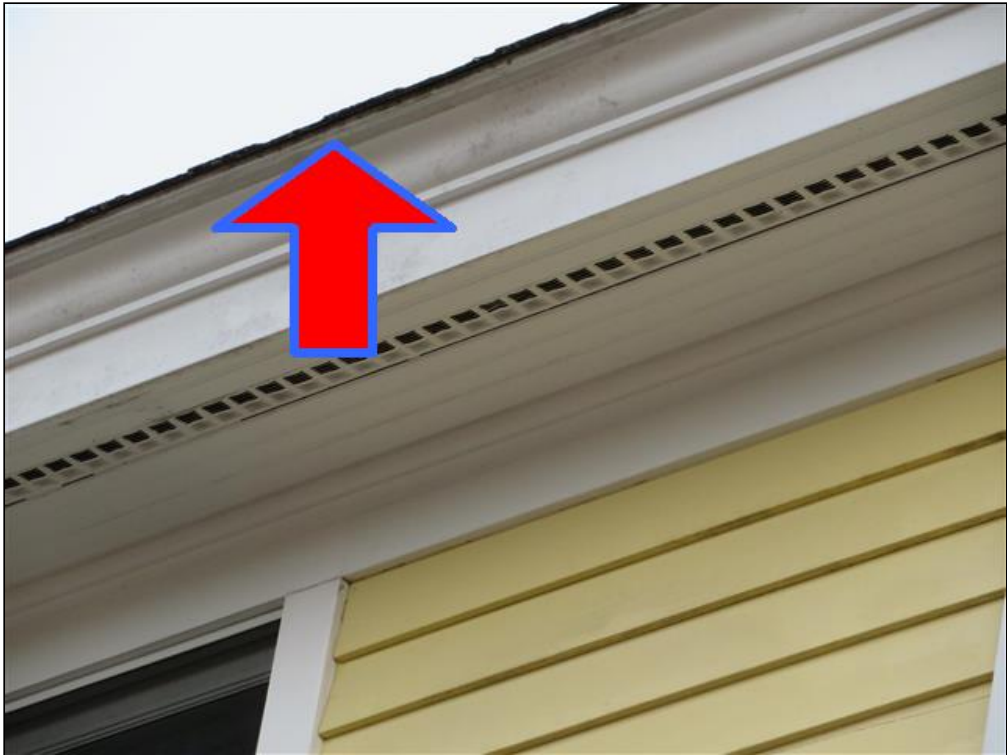
Aluminum seamless gutters and down spouts need to be installed at the front and rear of the house. Contact a gutter contractor.

1.3 Item 1(Picture) Recommend installing gutters.

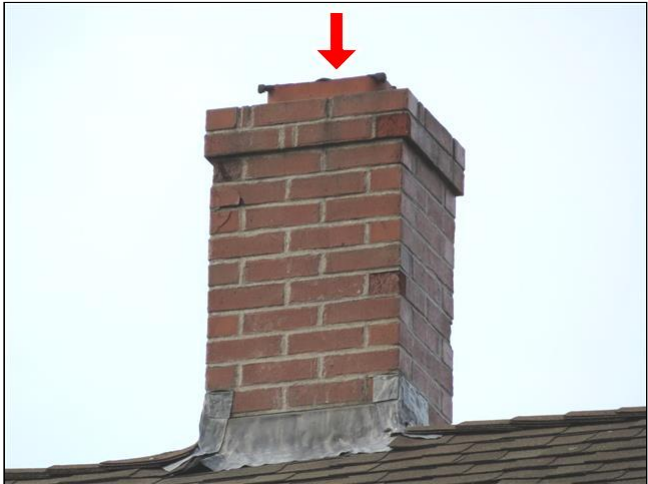
1.10 Item 1(Picture) Stainless steel rain cap recommended

Recommend the installation of a stainless steel rain cap on the chimney for the boiler.

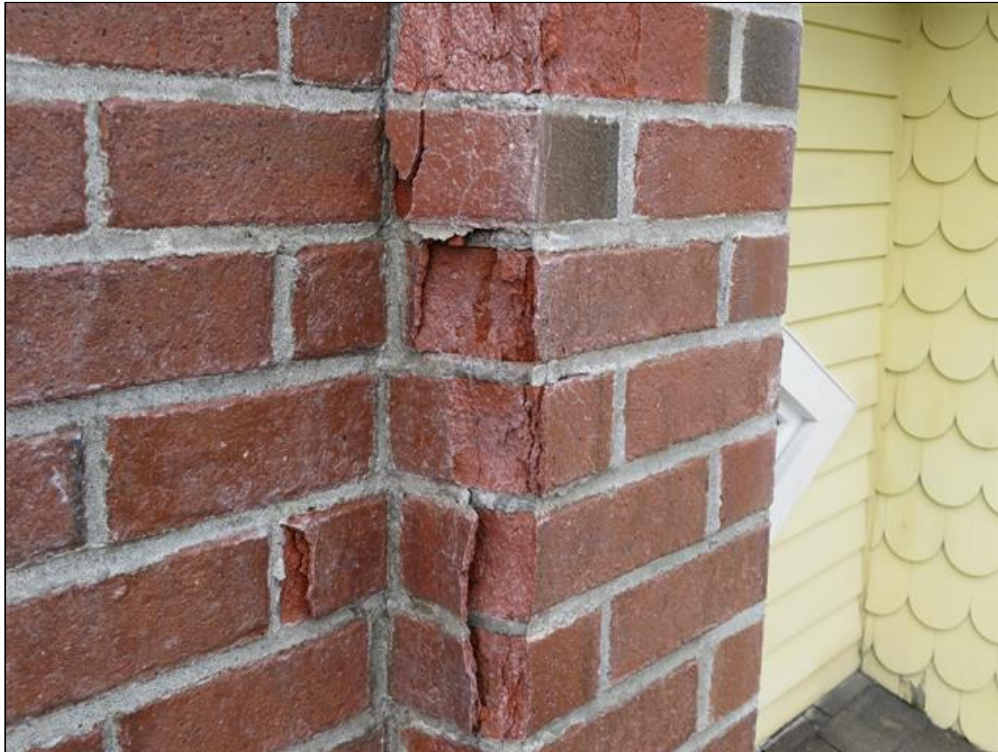
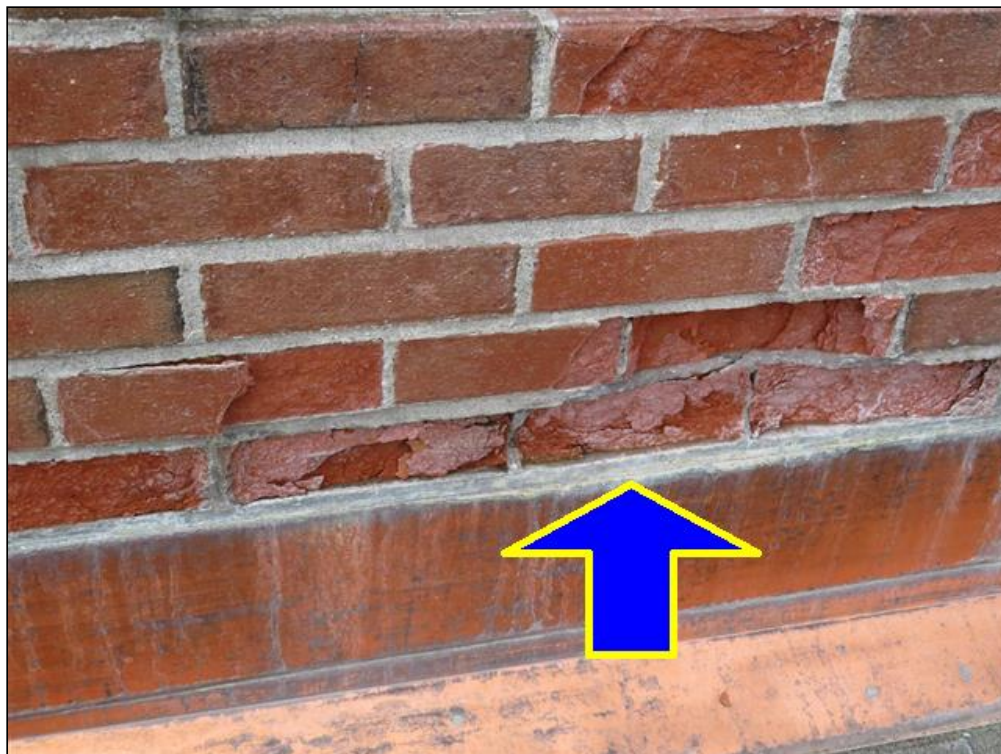
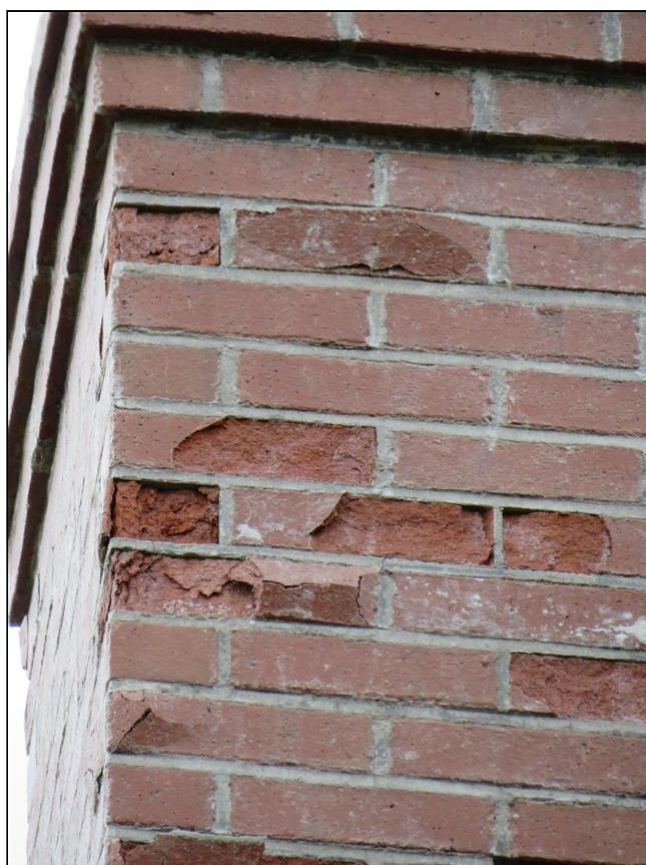
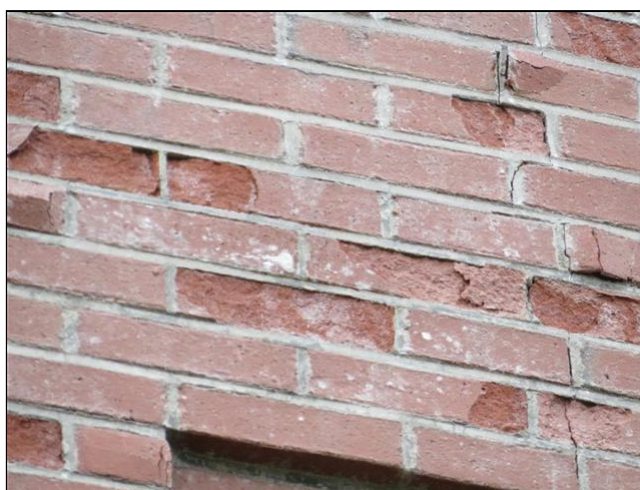
(1) The East chimney exterior chimney has excessive spalling and deteriorated bricks. Spalling is caused by rain penetrating the bricks, freezing, splitting and shattering the bricks. *Anticipate rebuilding the chimney from the shed roof to the crown of the chimney. Contact a mason.*

1.14 Item 1(Picture) Spalling bricks

1.14 Item 2(Picture) Spalling above flashing

1.14 Item 3(Picture) Spalling bricks

1.14 Item 4(Picture) Spalling bricks

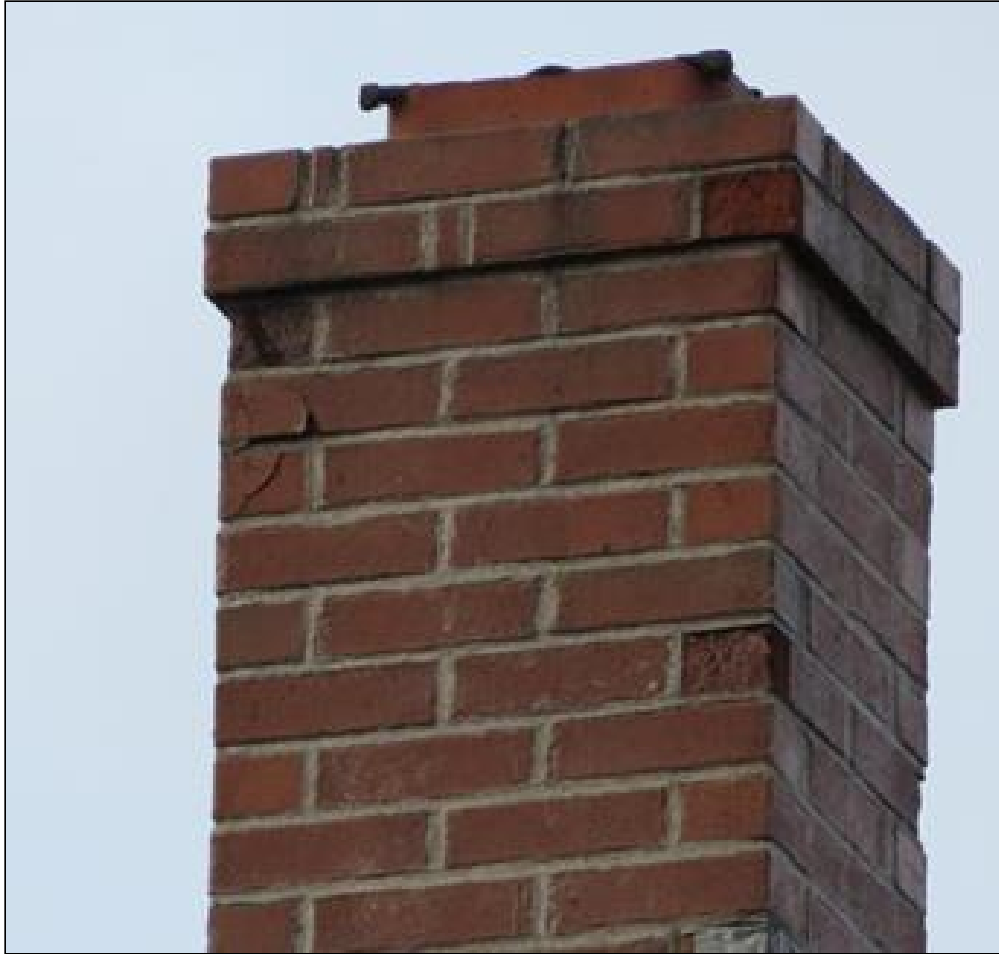
(2) The brick boiler chimney has spalling bricks and needs to be rebuilt.

1.14 Item 5(Picture) Spalling bricks

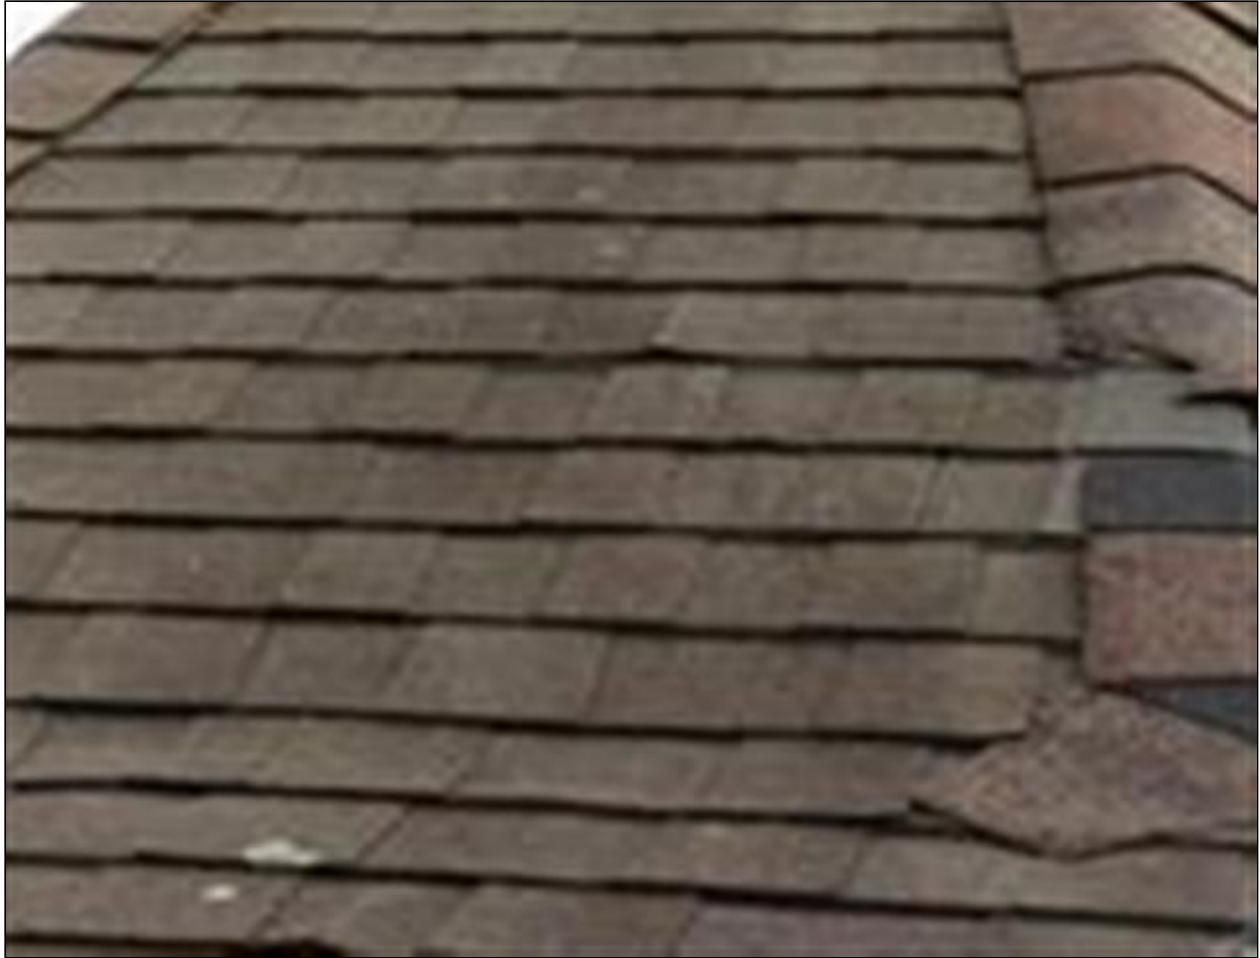
The one layer of architectural roof shingles have reached the end of their functional design life. The roof shingles are so worn, that they need to be stripped, and new roof shingles need to be installed on the main house and the garage/mother-in-law apartment. *Contact a roofing contractor.*

1.21 Item 1(Picture) Contact a roofing contractor

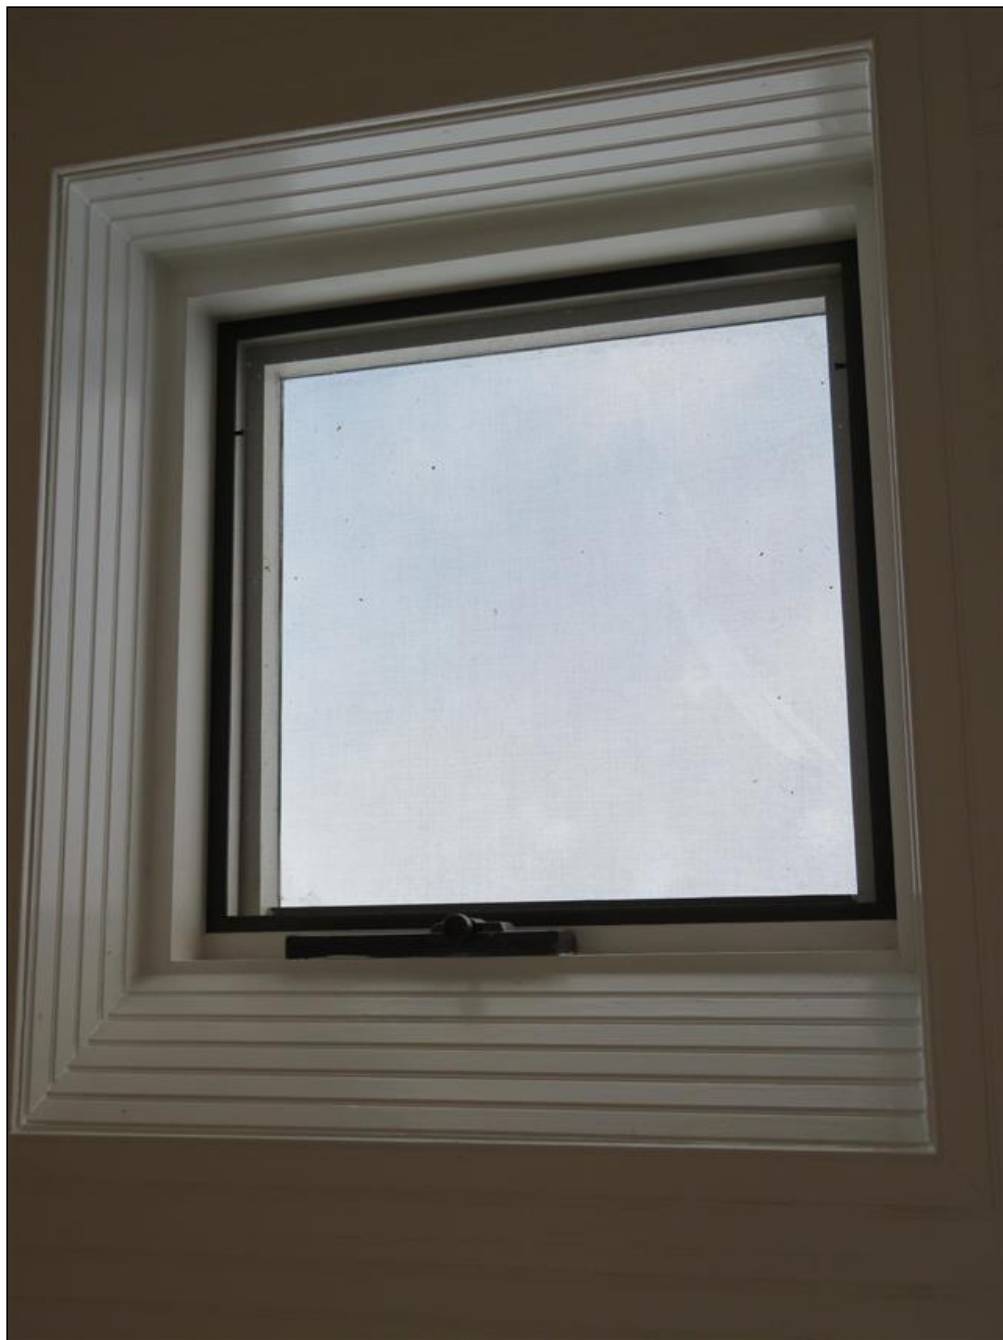
Skylight has a thermal leak.

1.22 Item 1(Picture) Skylight

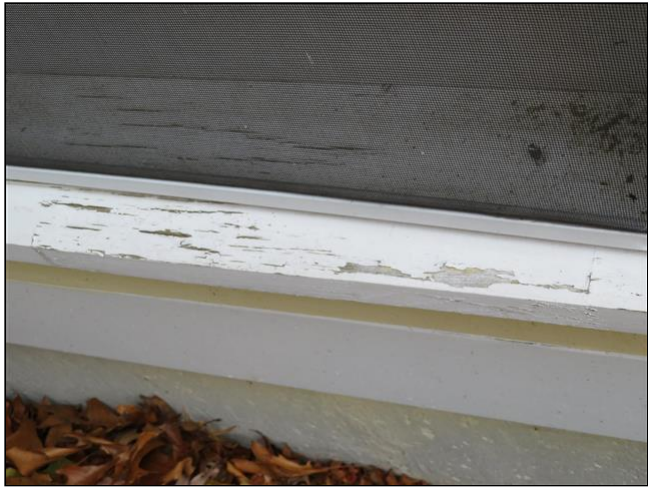
(1) Deferred maintenance was observed on the rear exterior window sills. Numerous windows may need to be replaced. Contact a carpenter. *Scrape, sand, prime and paint window sills. This will help to protect the wood from the elements.*

2.2 Item 1(Picture) Scrape, sand, prime and paint window sills.

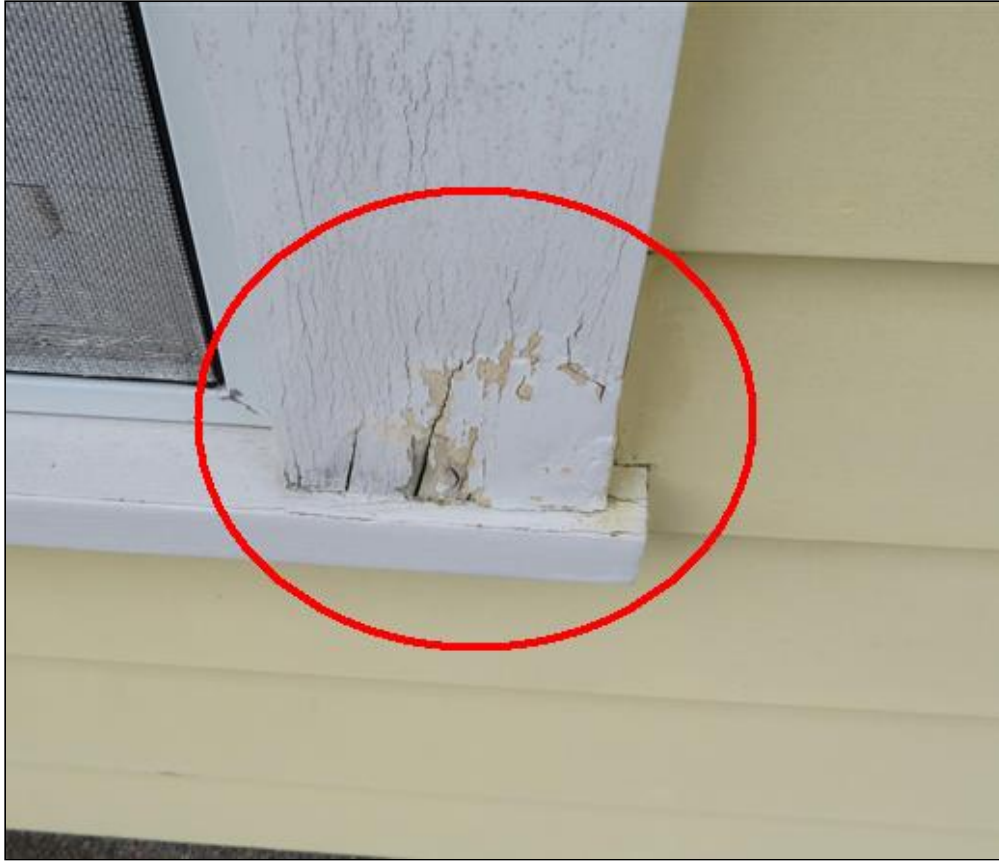
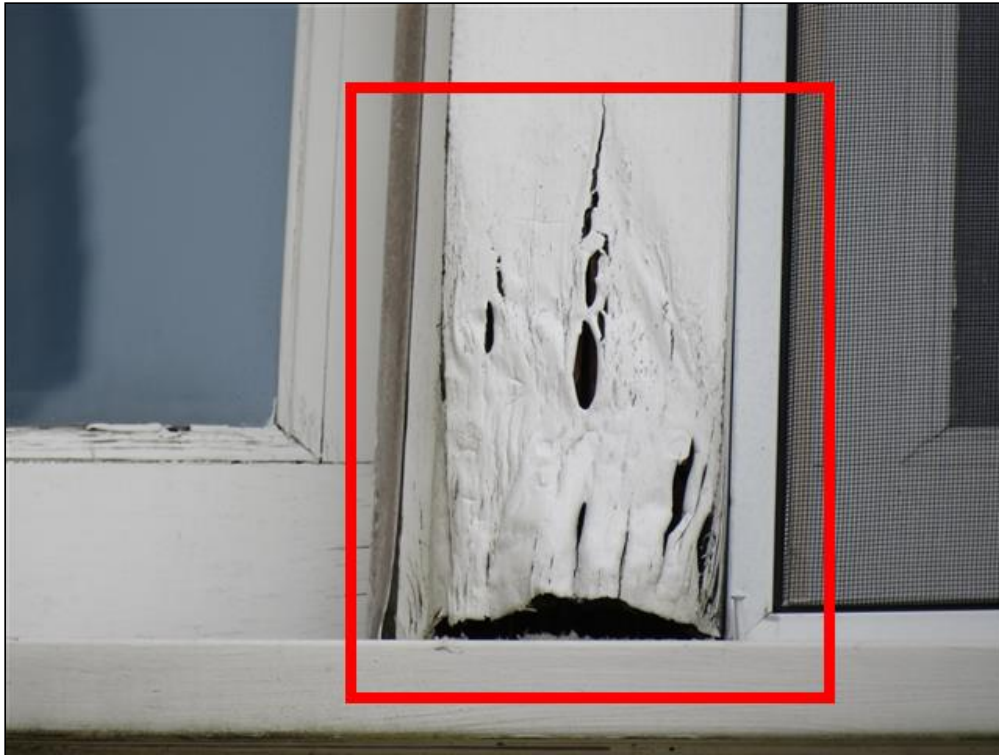
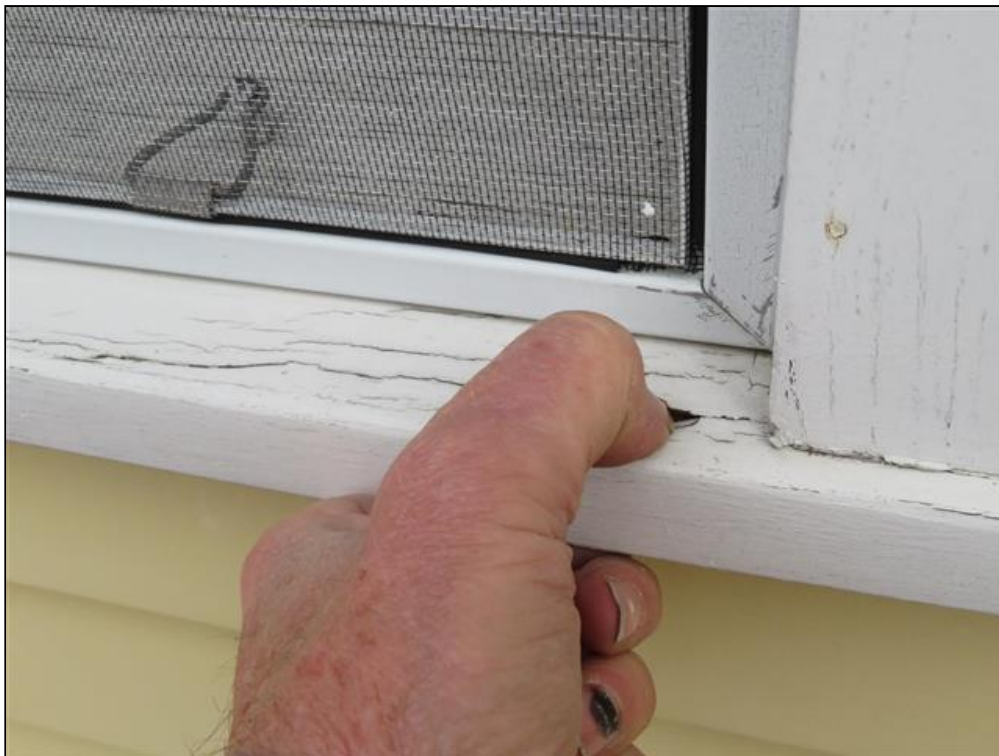
(2) Excessive dry rot on the bottom of the vertical window trim.

2.2 Item 5(Picture) Dry rot

2.2 Item 6(Picture) Dry rot

2.2 Item 7(Picture) Window sill

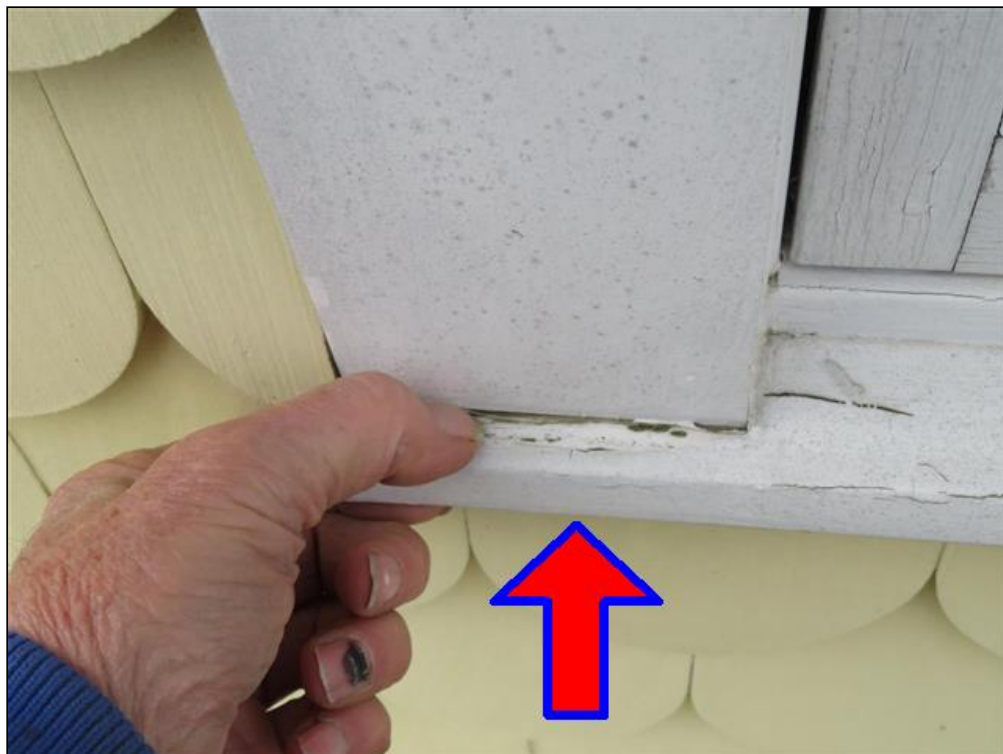
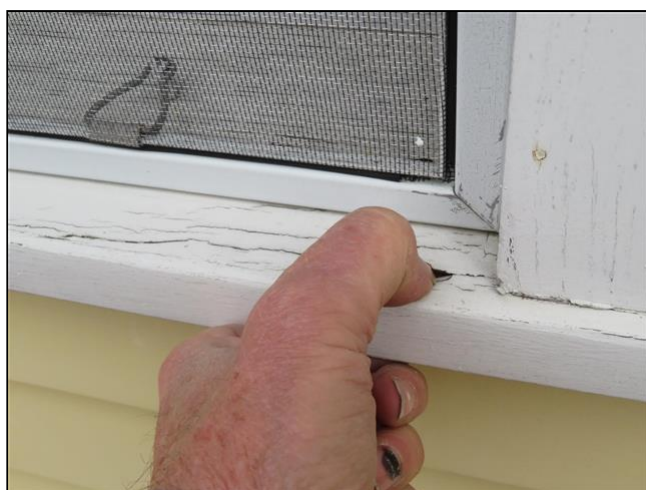
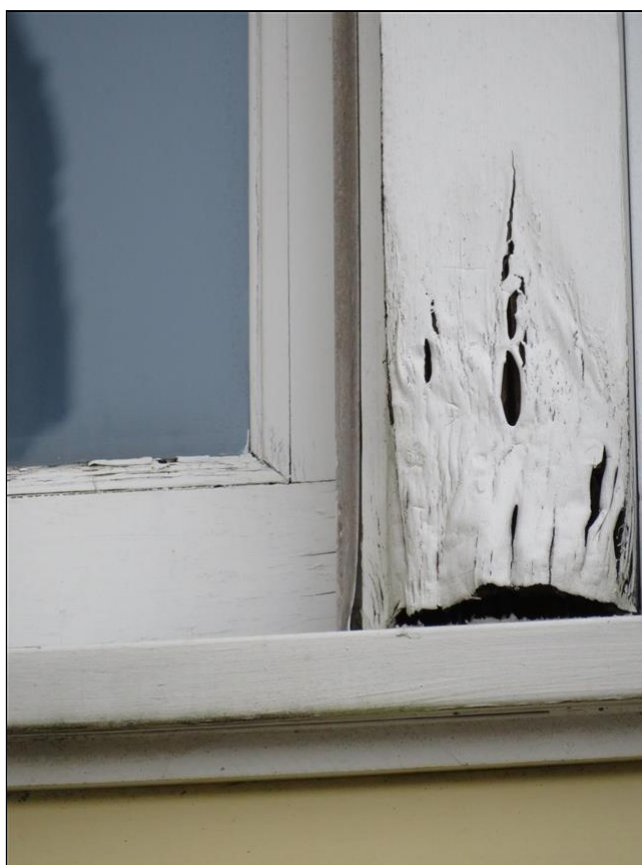
(3) Excessive dry rot on the exterior sills.

2.2 Item 8(Picture) Dry rot

2.2 Item 9(Picture) Dry rot

2.2 Item 10(Picture) Dry rot

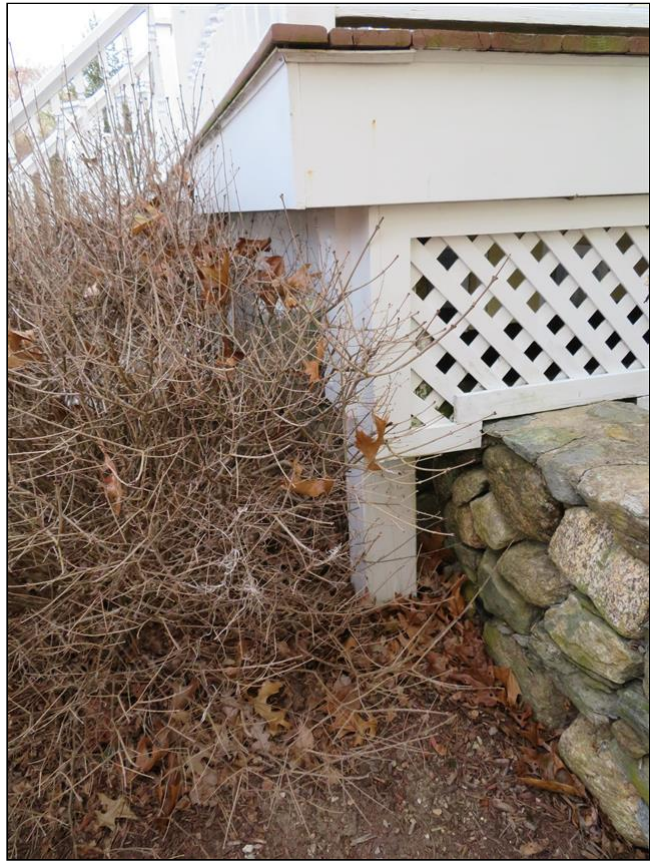
Vegetation too close to house. The recommended distance between vegetation and side of house is eighteen inches to two feet.

2.4 Item 1(Picture) Vegetation too close to house

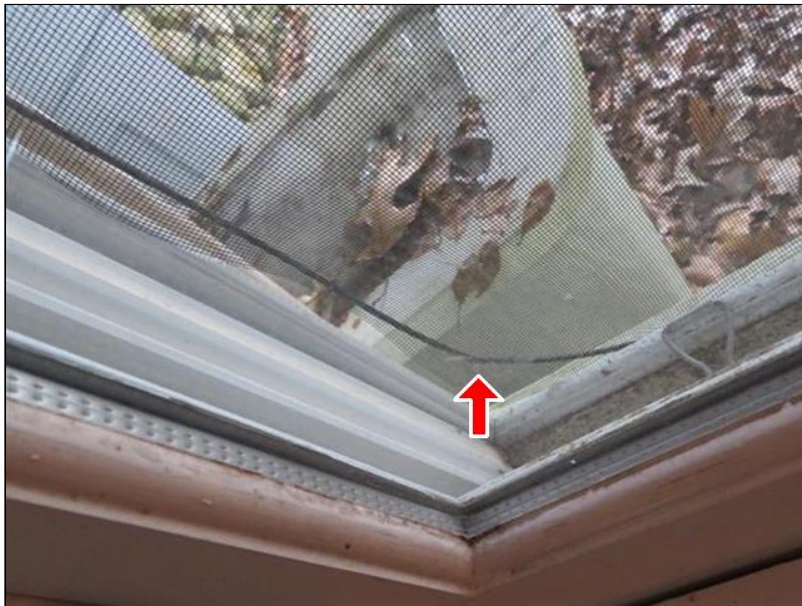
One of the window screens in the lower level bedroom is torn. *Repair window screen.*

2.22 Item 1(Picture) Torn screen

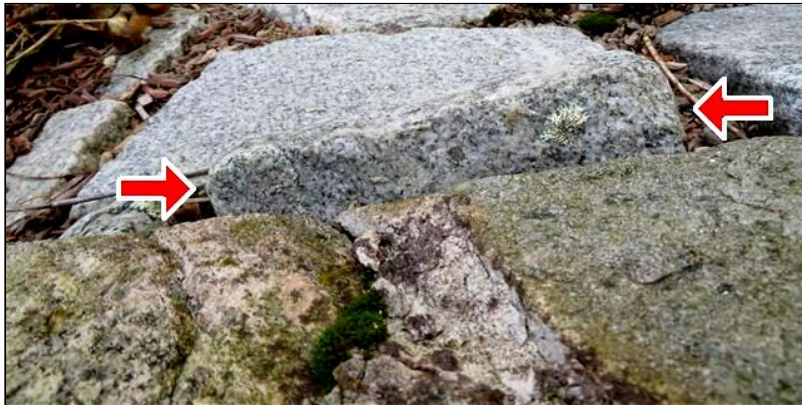
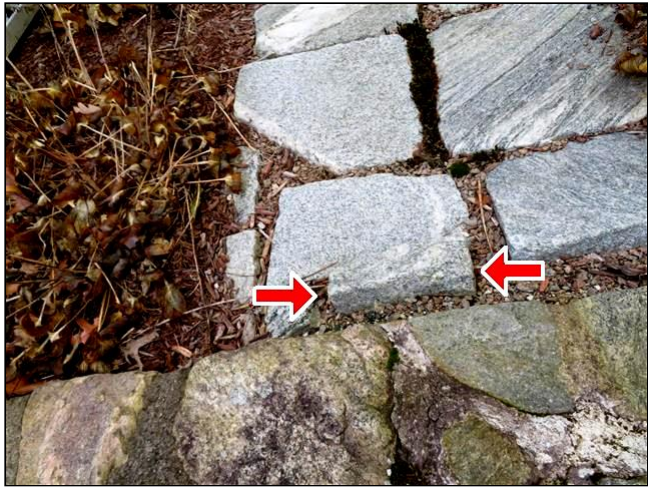
One of the stones on the stone sidewalk, which is located between the house and the garage is ***NOT*** the same height as the other stones. *The stone is raised above the adjacent stones, causing a tripping hazard. Contact a mason.*

2.34 Item 1(Picture) Tripping hazard

2.34 Item 2(Picture) Contact a mason

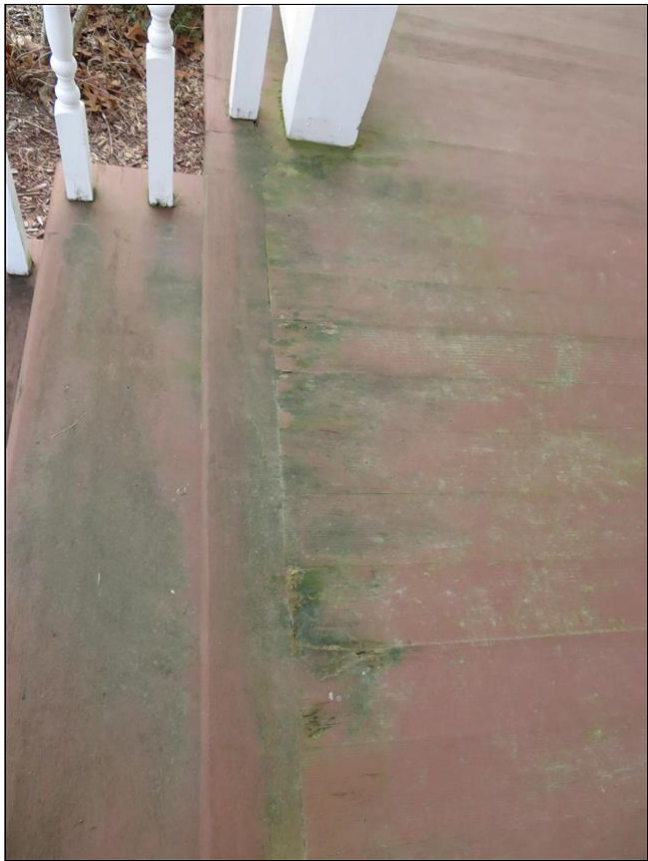
Algae has accumulated on the right front porch steps. This condition could be a slipping hazard. Remove algae.

2.35 Item 1(Picture) Remove algae

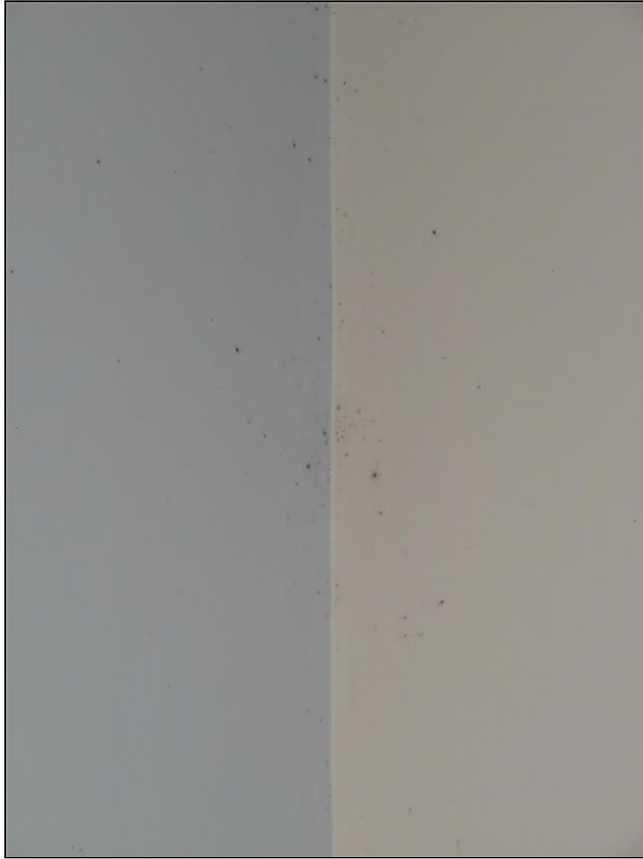
(1) Mold-like substance was observed on the lower level bathroom walls. *Contact an air quality company.*

4.0 Item 1(Picture) Contact an air quality company

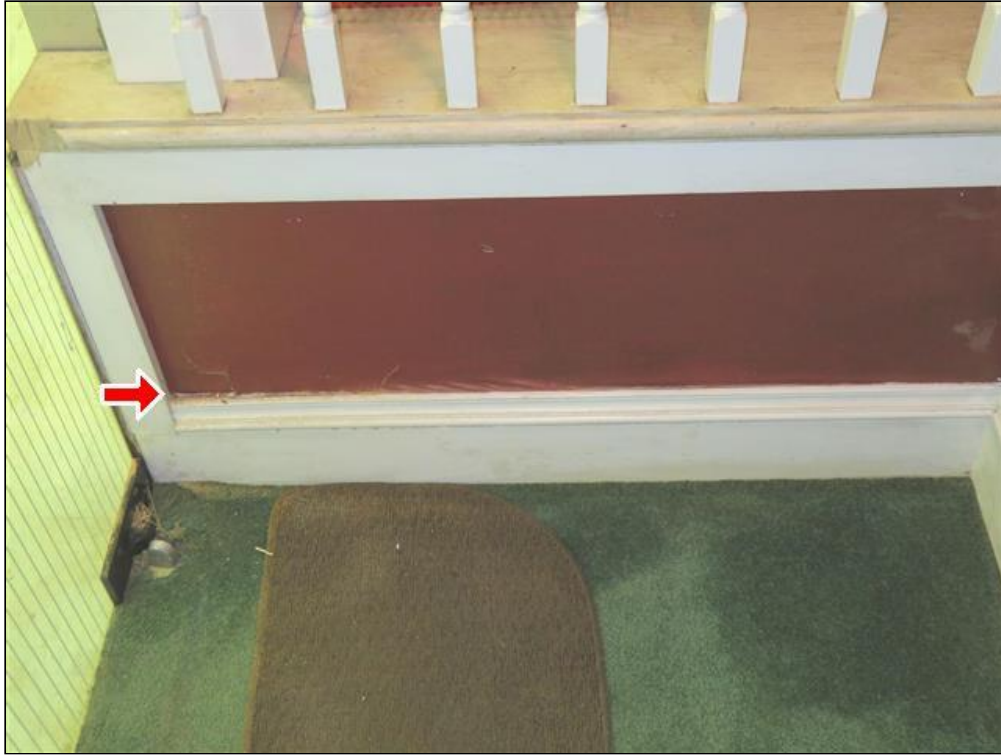
(2) The drywall and wood molding at the exterior of the squash court glass door appears to be water damaged and in appears to be in need of repair. *Contact a carpenter.*

4.0 Item 8(Picture) Contact a carpenter

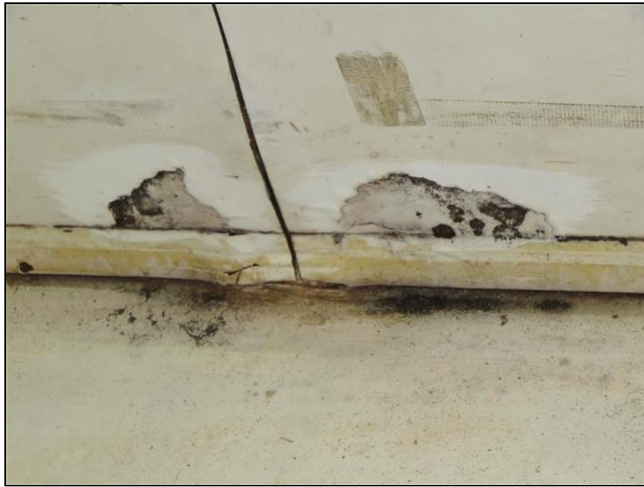
(3) Mold-like substance and water damage was observed on the lower level squash court walls.
Contact a carpenter and an air quality company.

4.0 Item 11(Picture) Contact a carpenter and an air quality company

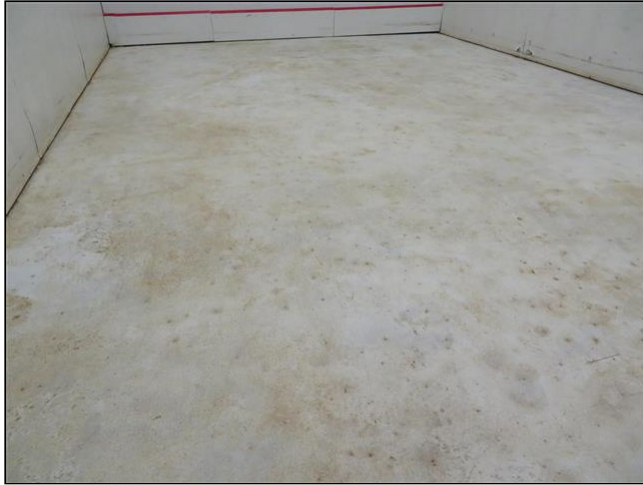
The lower level squash court floor, walls and ceiling shows signs of mold-like material. *This may be a potential health hazard. Contact an air quality company for further evaluation.*

4.1 Item 1(Picture) Contact an air quality company

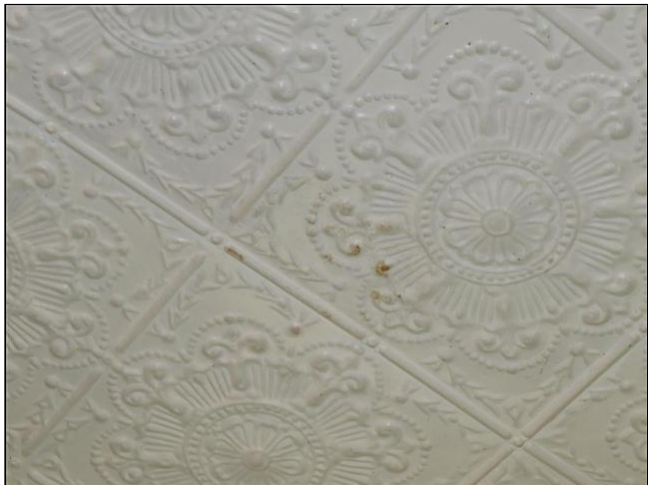
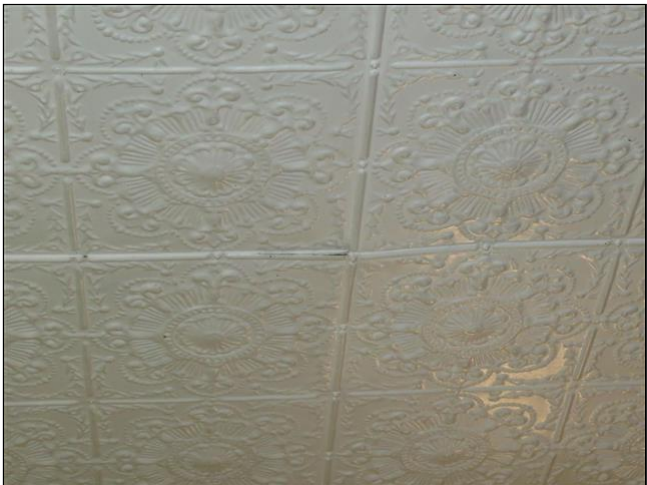
(1) Stains were observed on the kitchen metal ceiling.

4.2 Item 1(Picture) Stains were observed on the kitchen metal ceiling

4.2 Item 2(Picture) Stains were observed on the kitchen metal ceiling

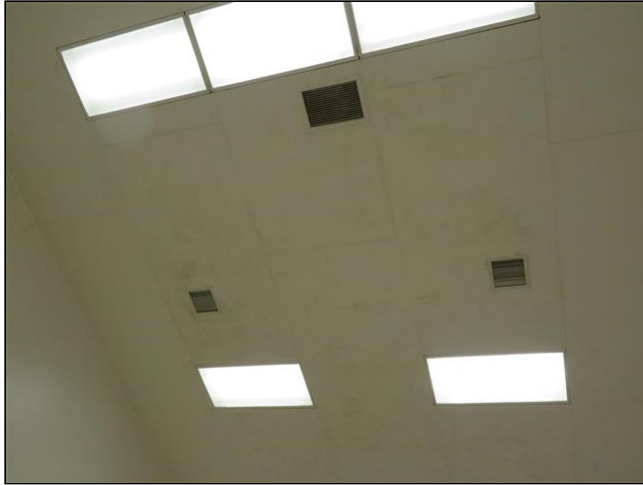
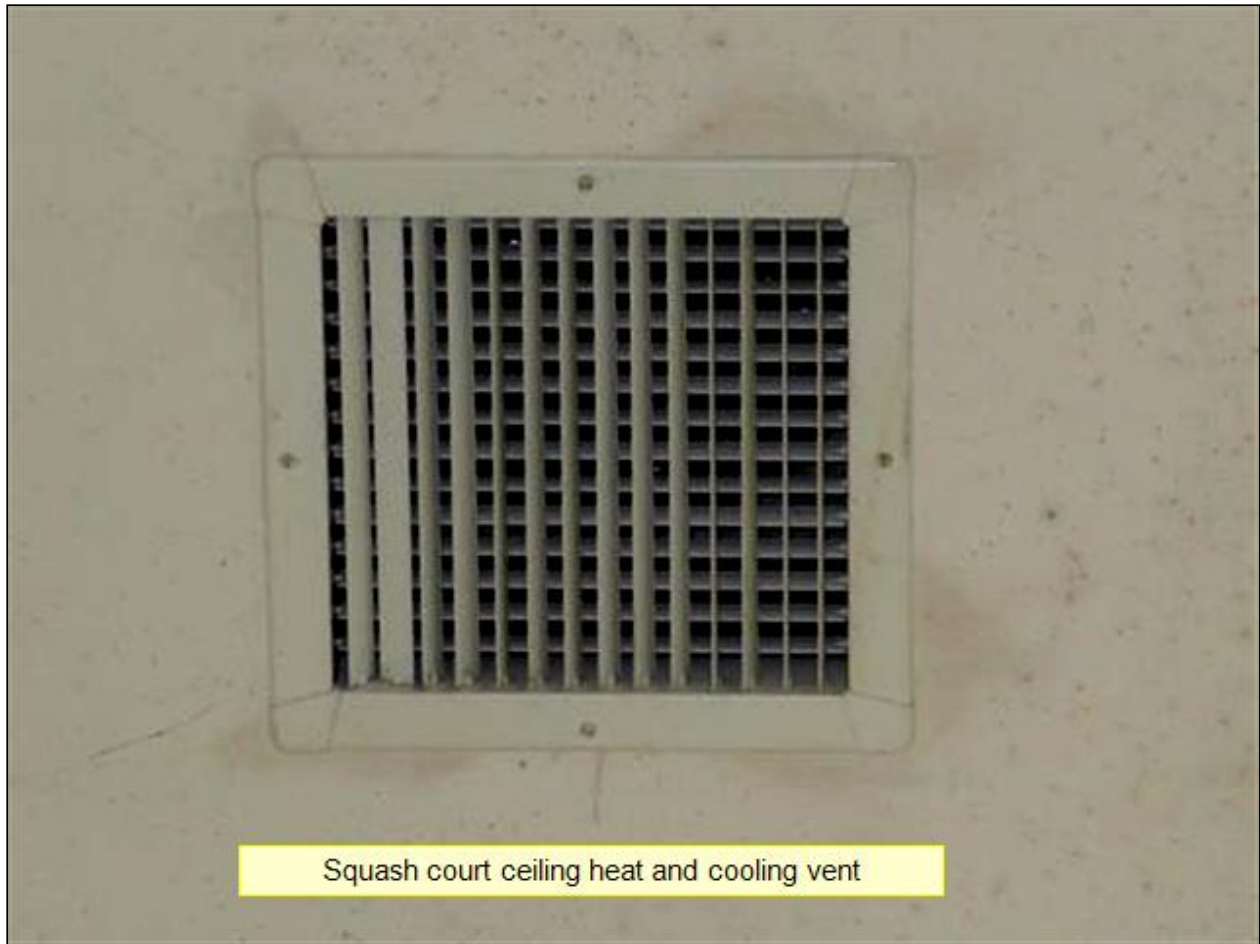
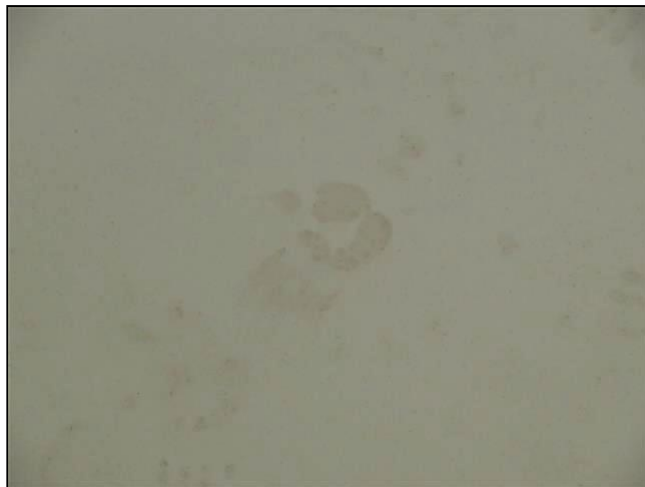
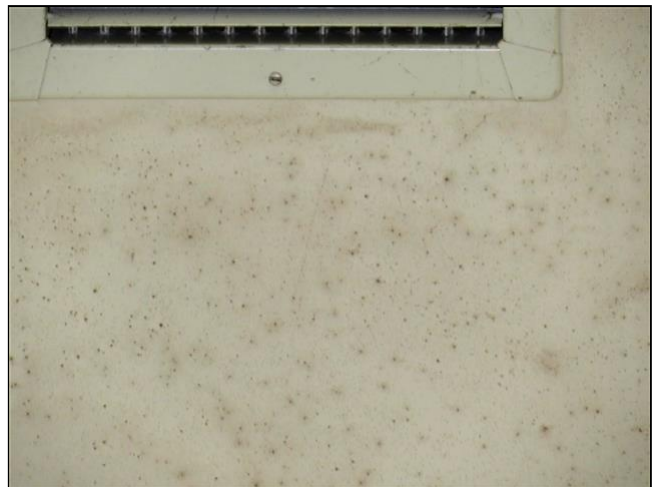
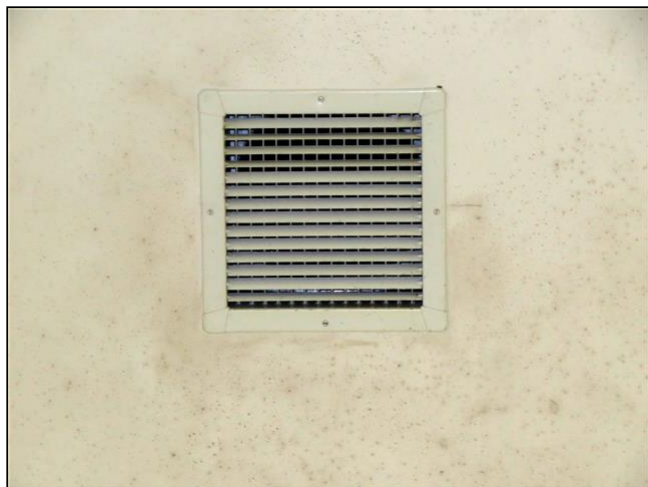
(2) Stains were observed on the squash court ceiling. The cause of the stains may be due to moisture. *Contact an air quality company for further evaluation.*

4.2 Item 3(Picture) Stains on squash court ceiling

4.2 Item 4(Picture) Stains on squash court ceiling

4.2 Item 5(Picture) Stains on squash court ceiling

4.2 Item 6(Picture) Stains on squash court ceiling

4.2 Item 7(Picture) Stains on squash court ceiling

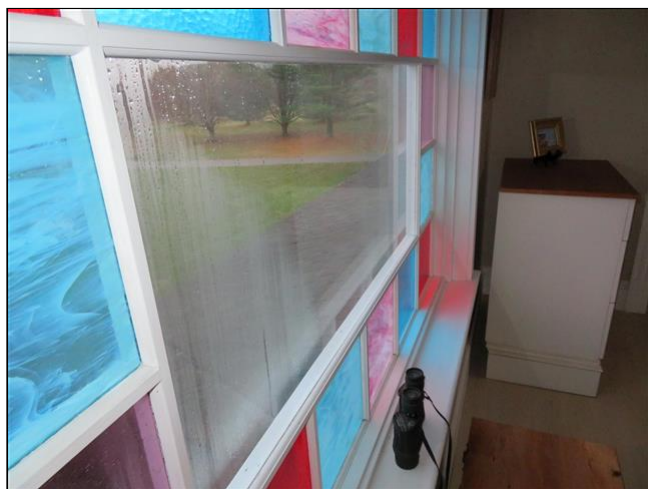
(1) Stained glass and fixed window on second floor have thermal leaks. *This is for information purposes only.*

4.6 Item 1(Picture) Thermal leak

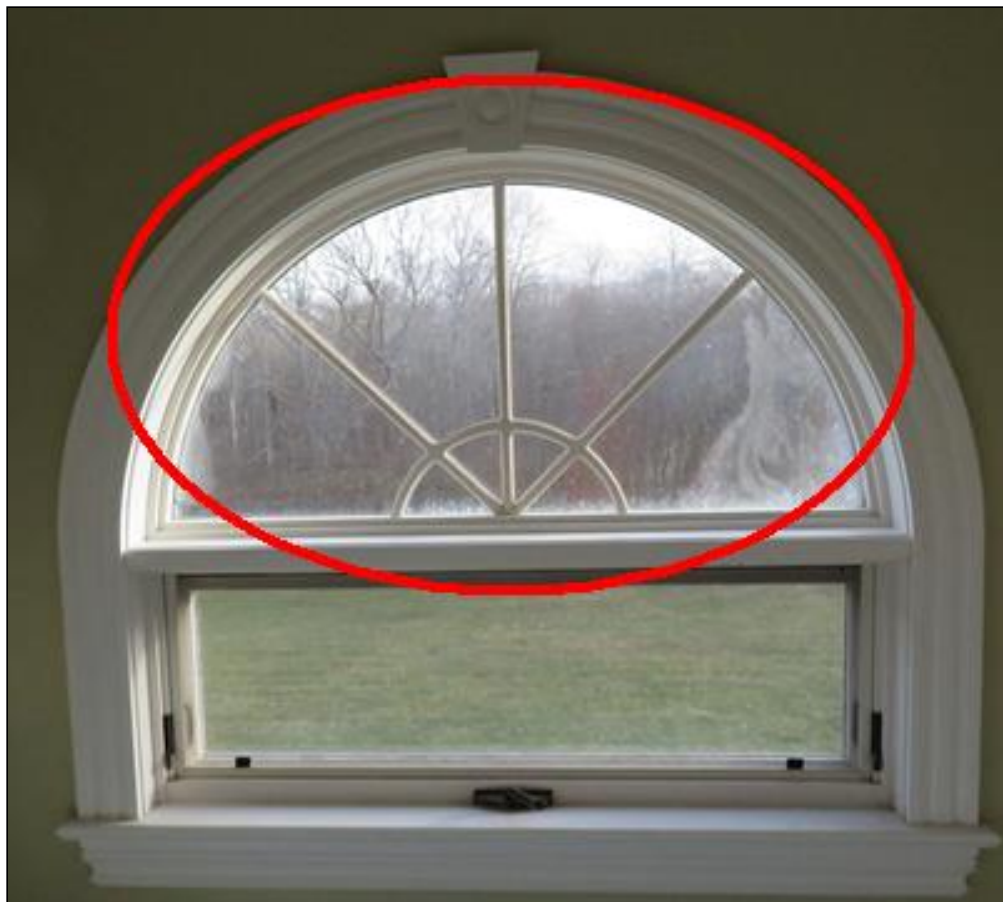
(2) Thermal leaks.

4.6 Item 2(Picture) Thermal leak

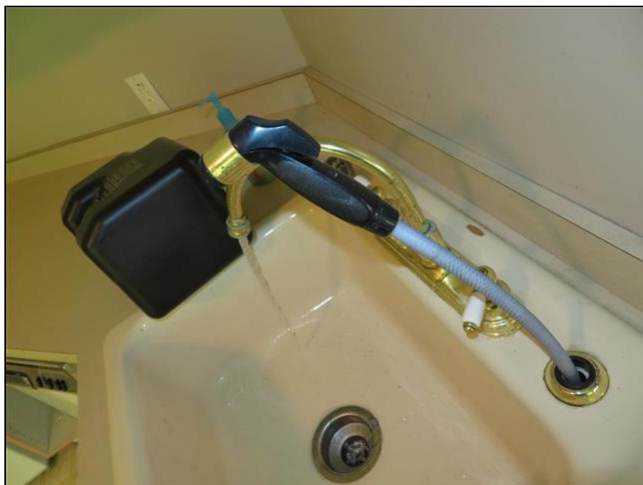
Lower level kitchen sprayer was ***NOT*** operational.

4.21 Item 1(Picture) Lower level kitchen sprayer was NOT operational

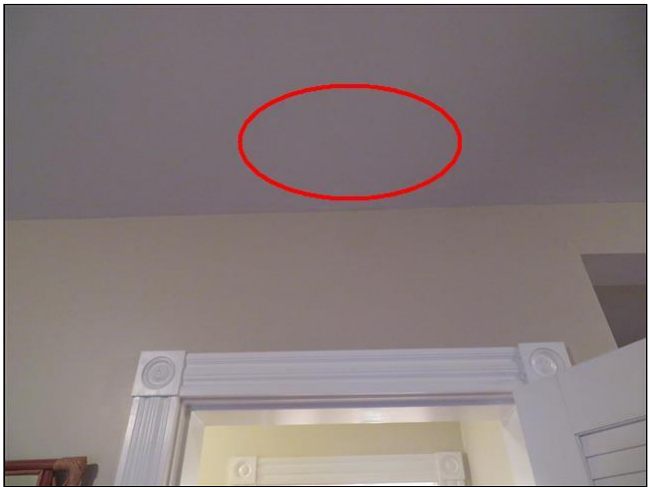
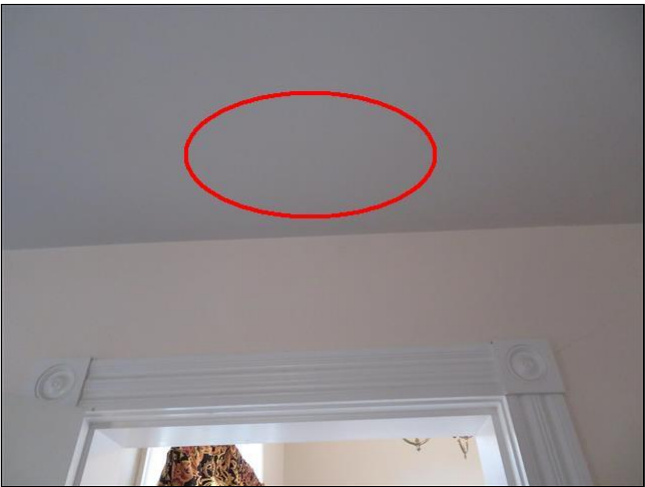
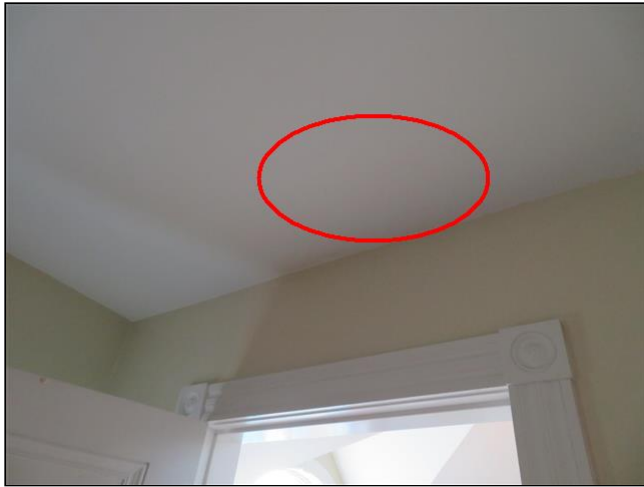
(1) Smoke alarms are missing in bedrooms. The smoke detector needs to be at least 4 inches from ceiling/wall junction and no further than 12 inches away in bedrooms. *Install smoke alarms in bedrooms.*

7.8 Item 1(Picture) Missing smoke alarms in bedrooms

7.8 Item 2(Picture) Missing smoke alarms in bedrooms

7.8 Item 3(Picture) Missing smoke alarms in bedrooms

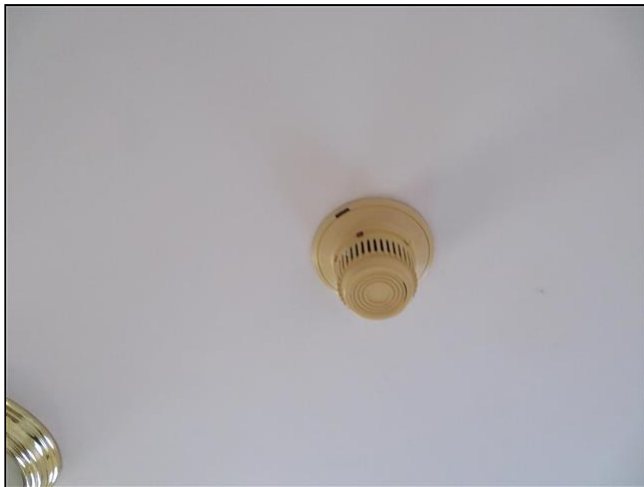
(2) Smoke alarms are yellowed, which is a sign that they are outdated. The functional design life of smoke alarms is approximately ten (10) years. *Replace smoke alarms.*

7.8 Item 4(Picture) Yellowed smoke alarm

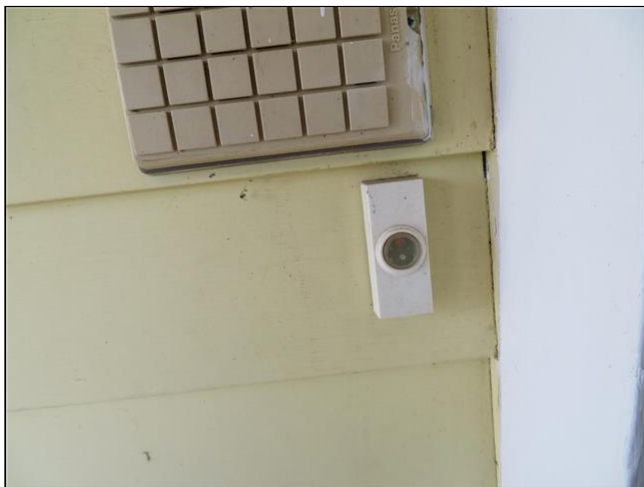
The side door door bell is **NOT** operational.

7.30 Item 1(Picture) Side door door bell is NOT operational
