SOUND HOME INSPECTION, LLC

Inspection Report

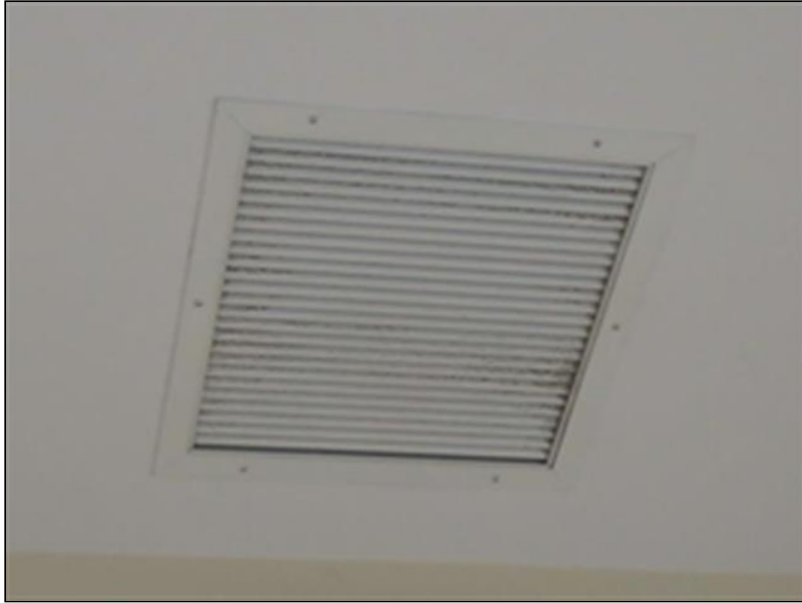
The heat registers need to be cleaned. *Clean heat registers.*

8.3 Item 1(Picture) Contact a duct cleaning company

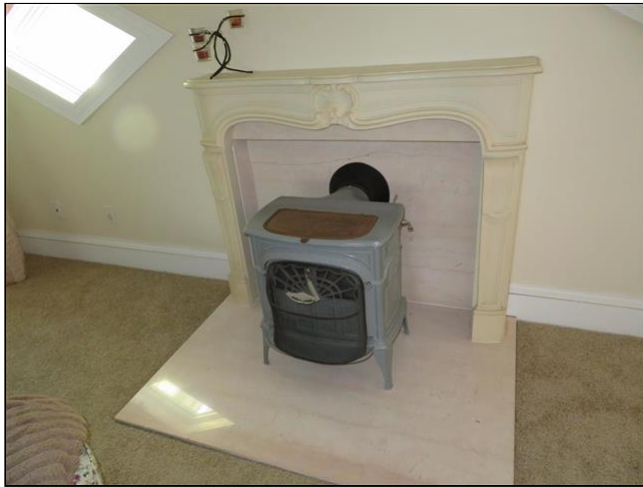
The wood stoves were ***NOT*** inspected. *Contact the local fire marshall for the current guidelines for wood stove installation.*

8.6 Item 1(Picture) Master bedroom wood stove

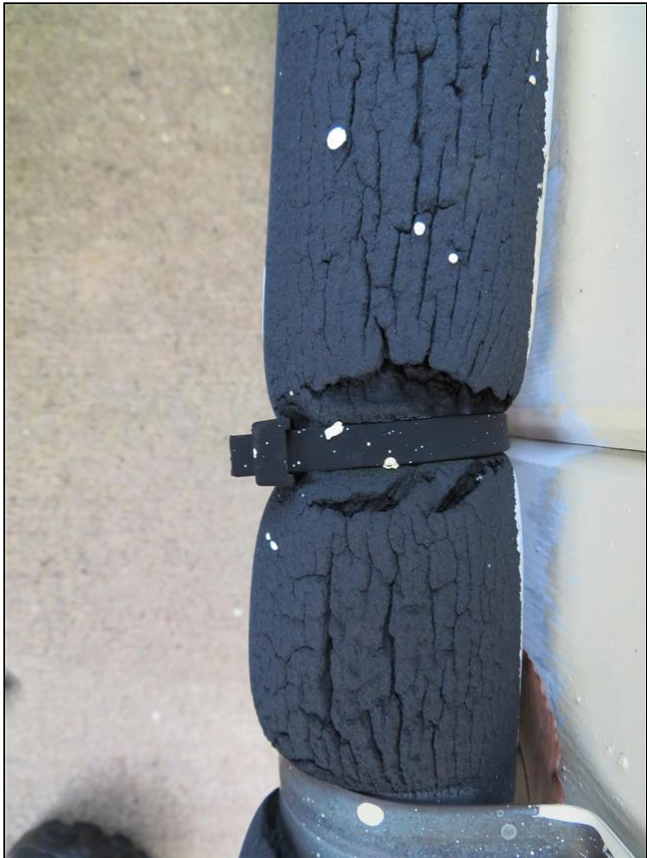
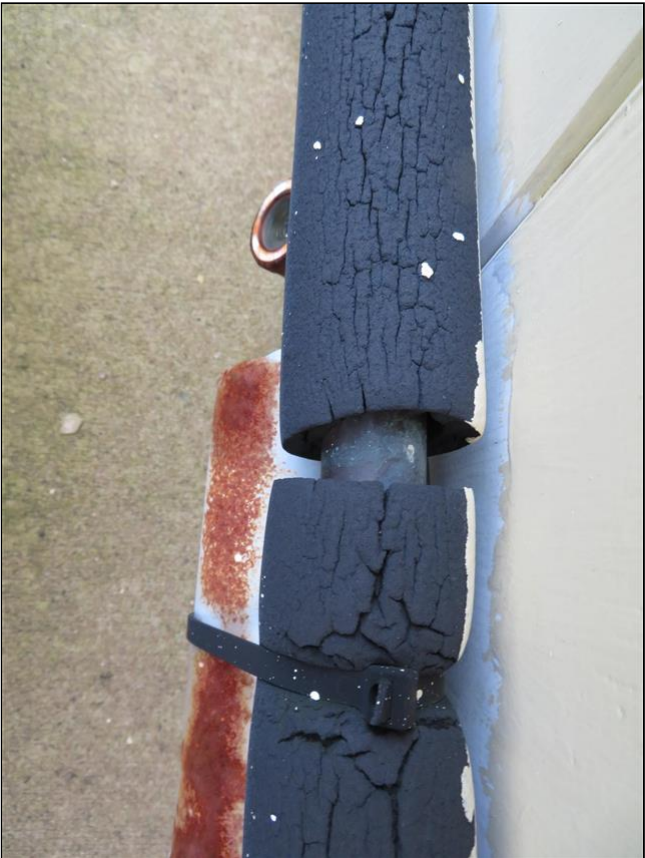
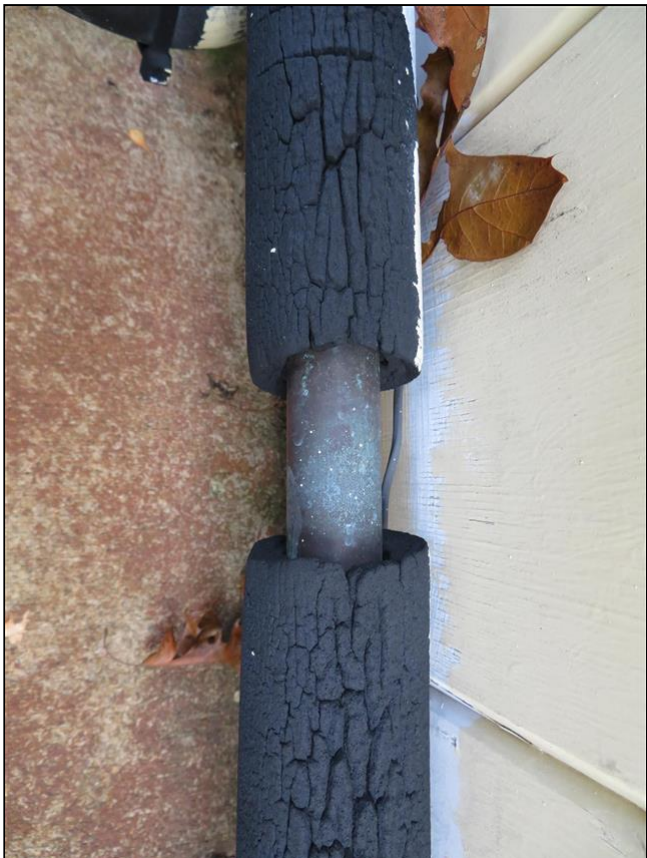
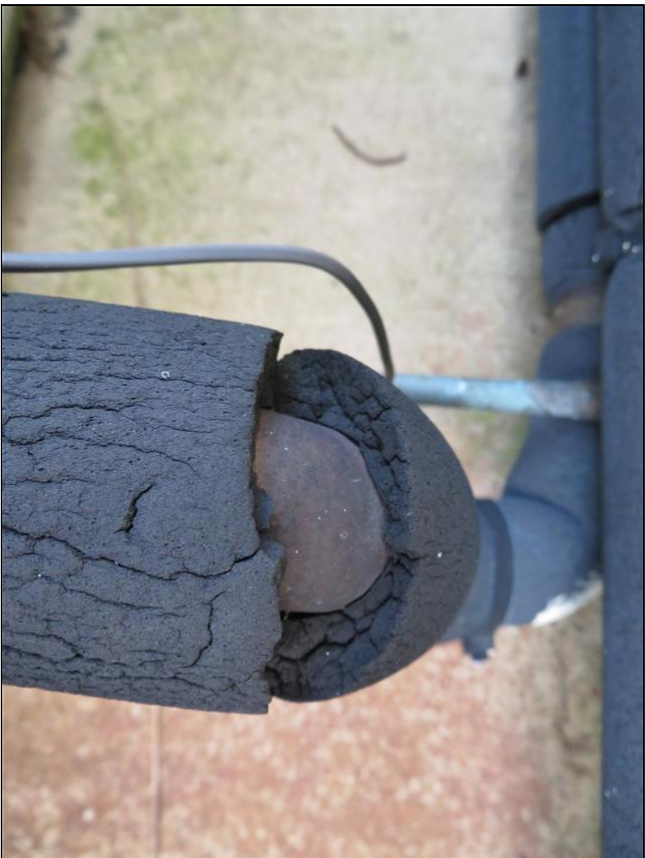
(2) The suction and return line foam sleeves are deteriorated. Missing foam on suction line can cause energy loss and condensation. *I recommend service or repair as needed.*

8.8 Item 6(Picture) Replace foam sleeves

8.8 Item 7(Picture) Replace foam sleeves

8.8 Item 8(Picture) Replace foam sleeves

8.8 Item 9(Picture) Replace foam sleeves

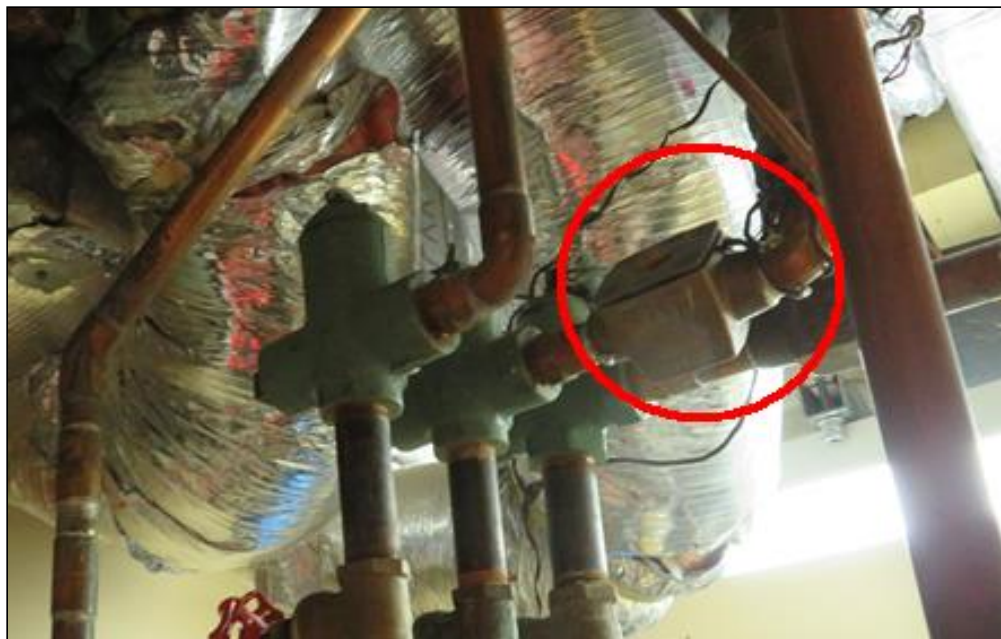
One (1) of the heating zones does NOT have a zone valve (Gold power head) installed on the boiler manifold.

8.10 Item 1(Picture) Missing zone valve

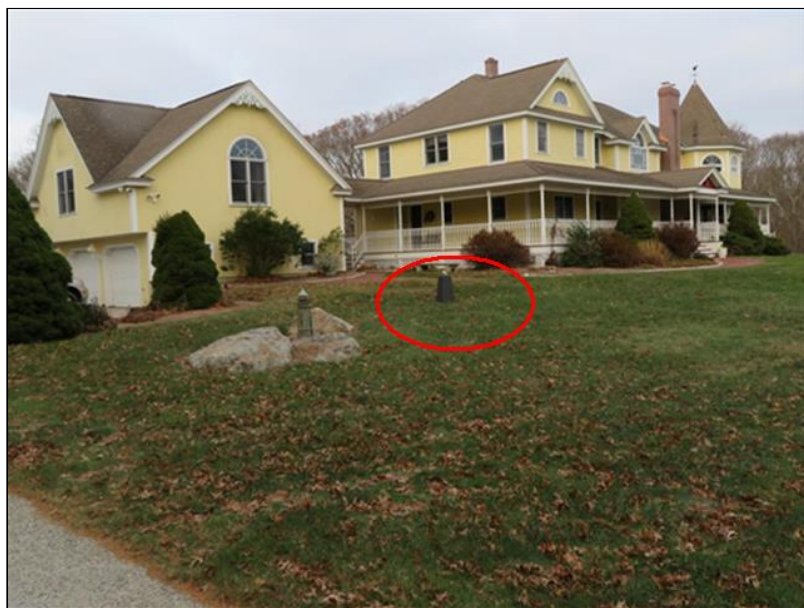
The property has a buried oil tank. The capacity and condition of the tank cannot be determined. *Sound Home Inspection, LLC did not inspect, test nor render any opinion on the age nor condition of tank. Recommend further evaluation and/or testing by an oil company.*

8.14 Item 1(Picture) Buried oil tank

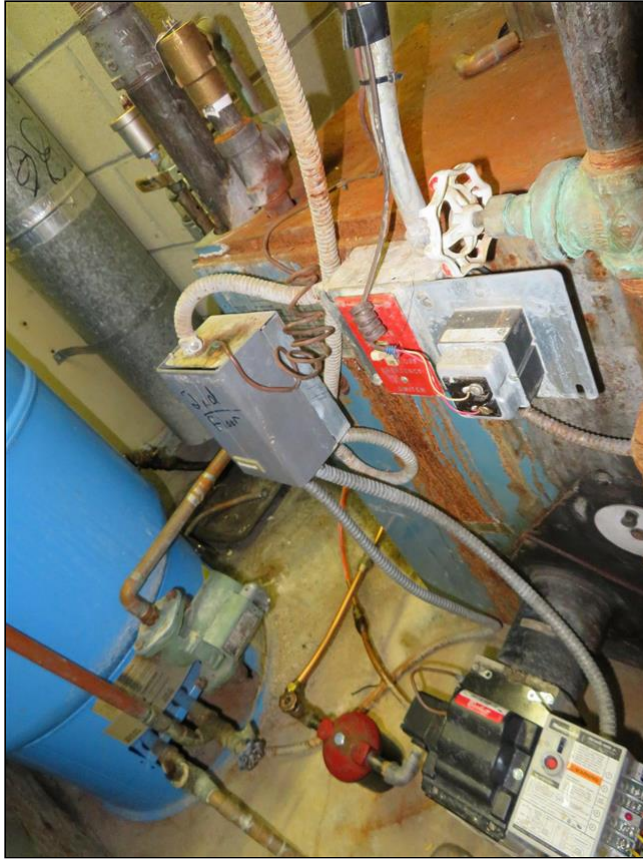
(1) The oil-fired boiler does ***NOT*** have an annual service tag. EXCESSIVE RUST ON THE BOILER JACKET. Service prior to closing Contact an oil company.

8.21 Item 1(Picture) Service prior to closing
Contact an oil company

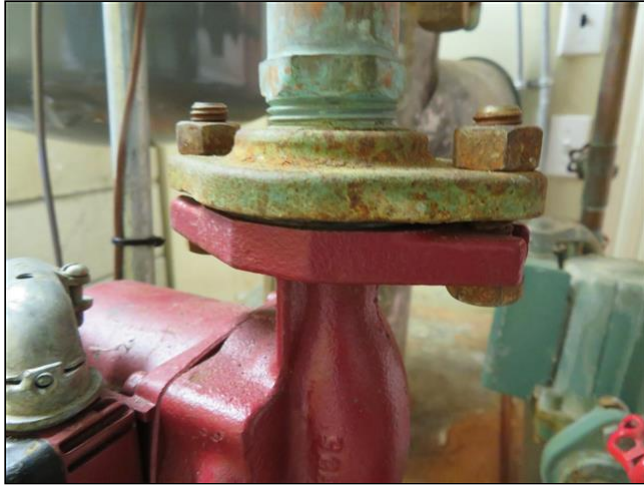
(2) Boiler in basement has evidence of rust and deferred maintenance. *Contact a oil company.*

8.21 Item 2(Picture) Contact a oil company

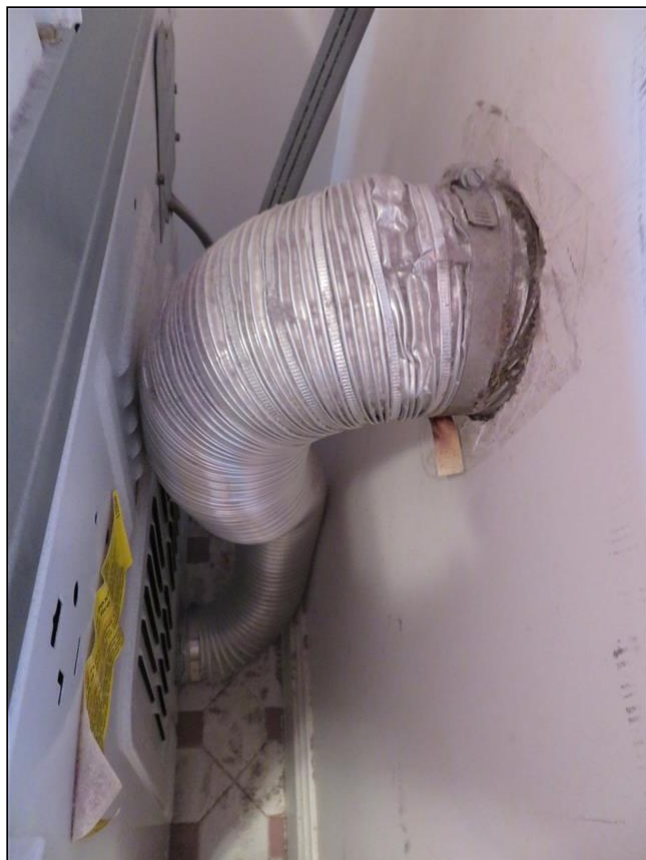
(1) Lint can accumulate in an exhaust duct, reducing the dryer's ability to expel heated water vapor, which then accumulates as heat energy within the machine. As the dryer overheats, mechanical failures can trigger sparks, which can cause lint trapped in the dryer vent to burst into flames. This condition can cause the whole house to burst into flames. Fires generally originate within the dryer, but spread by escaping through the ventilation duct, incinerating trapped lint, and following its path into the building wall. **MAJOR SAFETY ISSUE!!!**

9.3 Item 1(Picture) Dryer vent

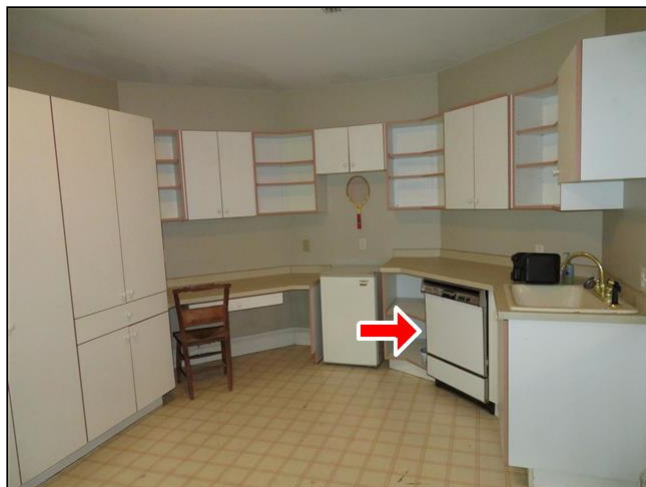
The main dishwasher was operational. *The lower level dishwasher was **NOT** operational.*

10.0 Item 1(Picture) Lower level dishwasher is not operational

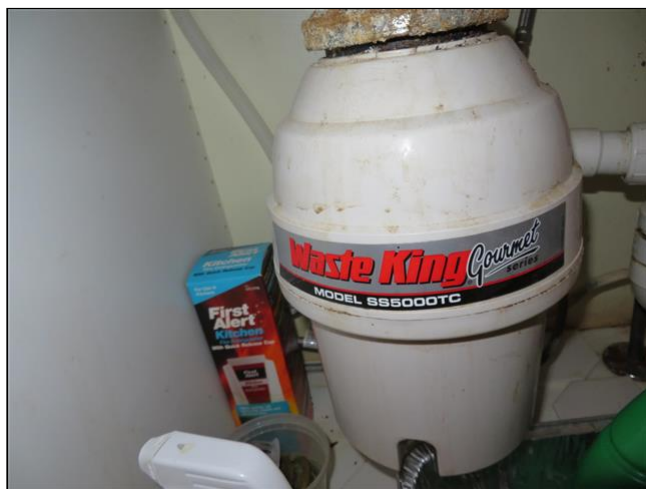
It is not advisable to have a garbage disposal in a house that is connected to a septic system. The septic system is designed to be the recipient of human waste and waste water that does not contain table scraps, coffee grinds, grease food, etc. *Kitchen items down the garbage disposal put stress on the septic system, and reduce the functional life of the septic system.*

10.3 Item 1(Picture) Waste King brand garbage disposal

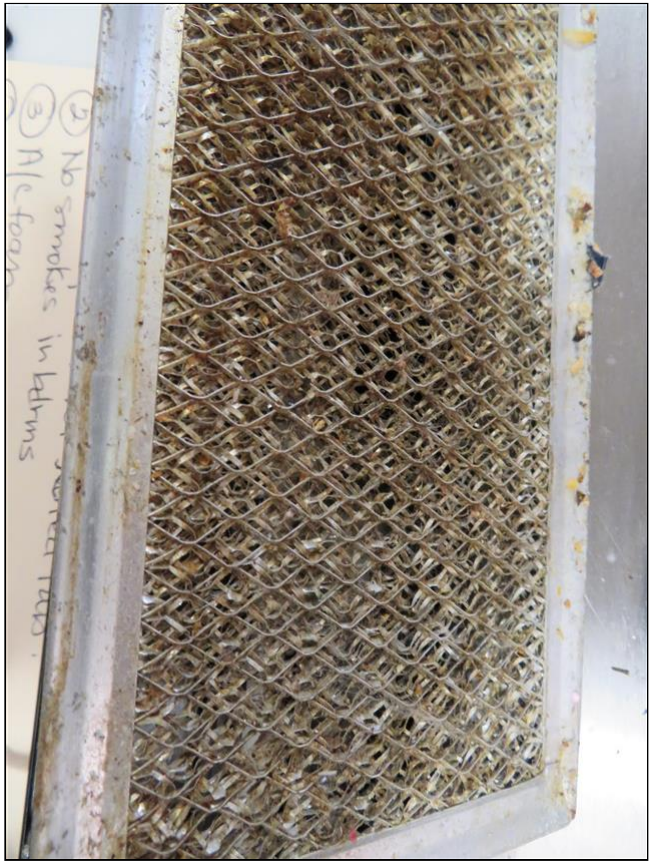
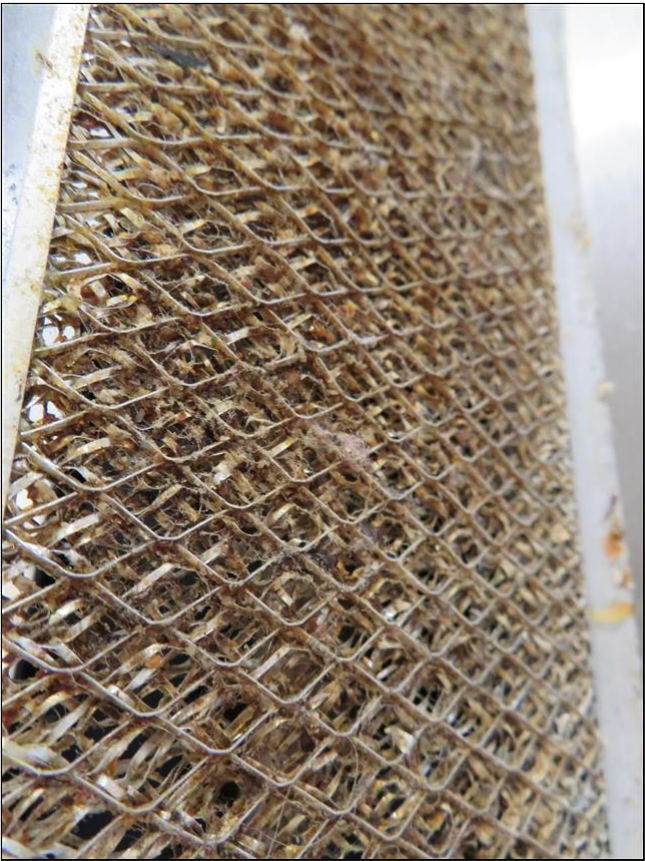
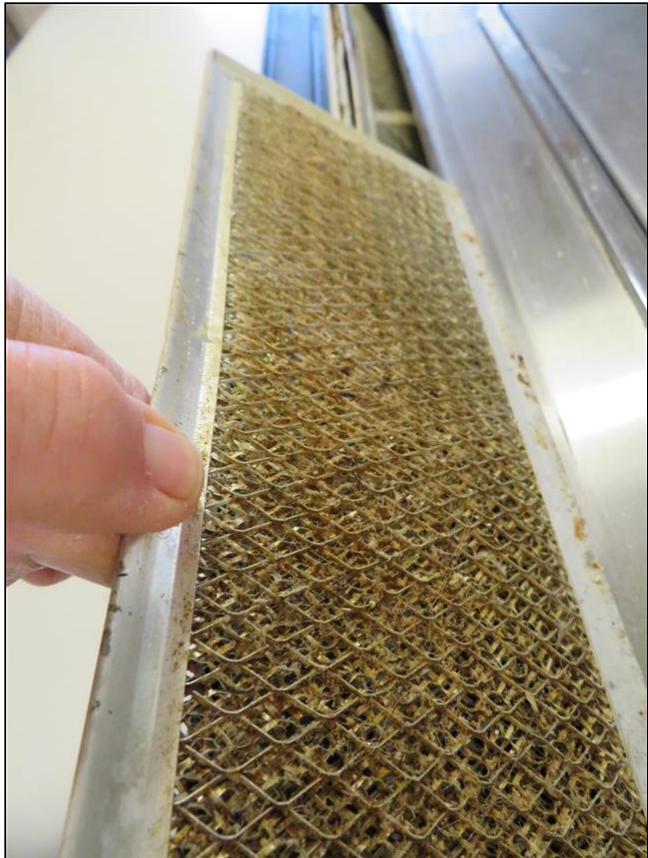
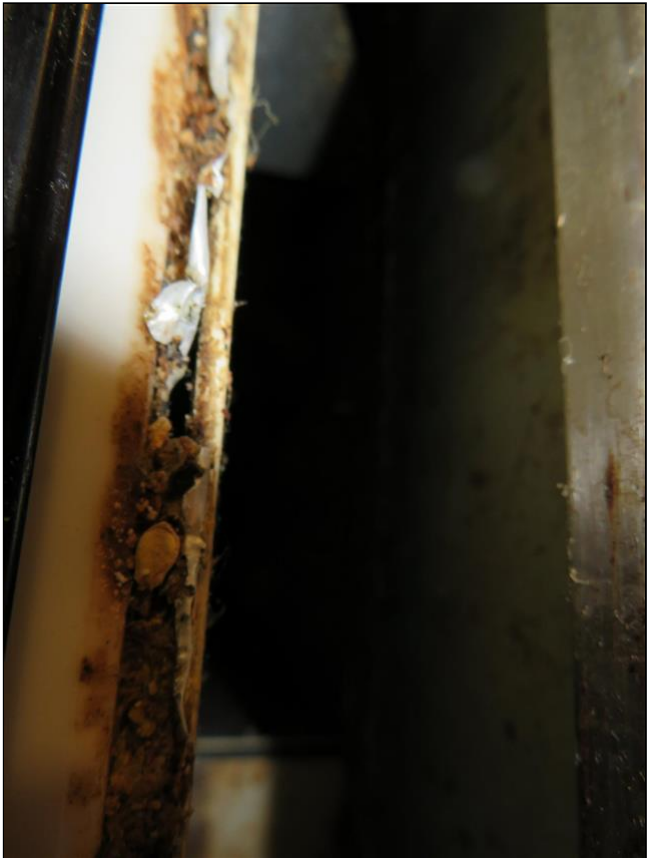
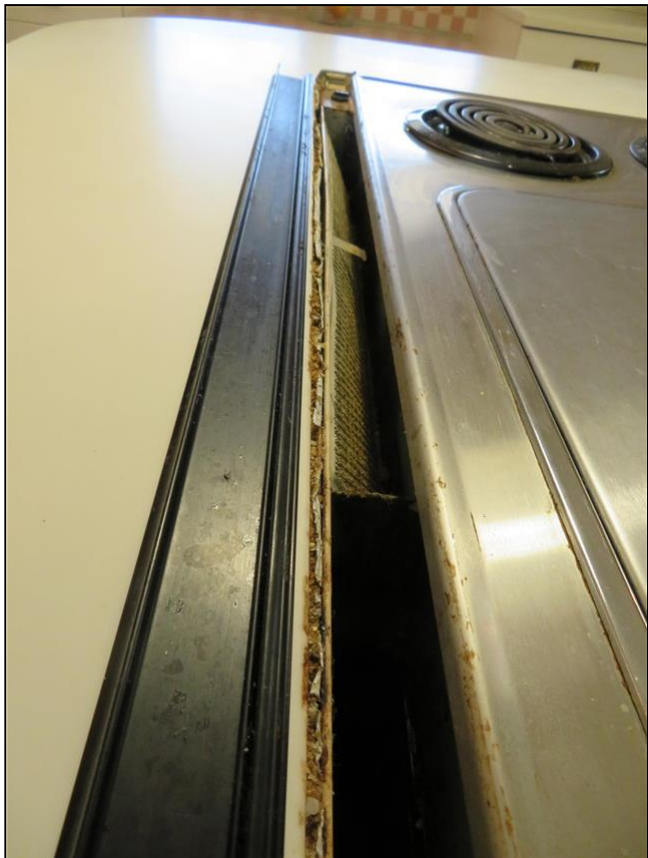
The stove down draft filters need to be cleaned and/or replaced.

10.8 Item 1(Picture) Clean or replace filters

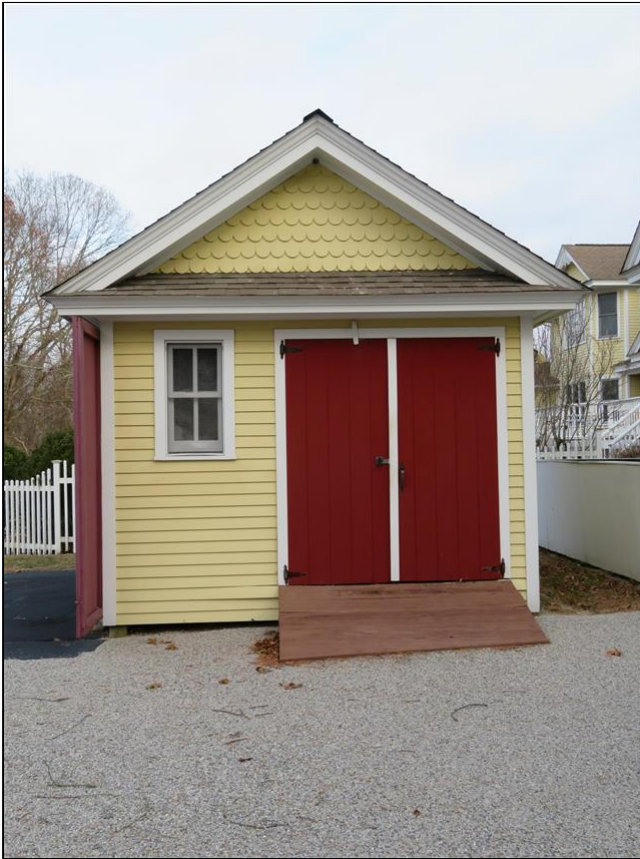
Personal items were observed in the shed. *Remove personal items prior to closing.*

12.12.A Item 1(Picture) Remove personal items

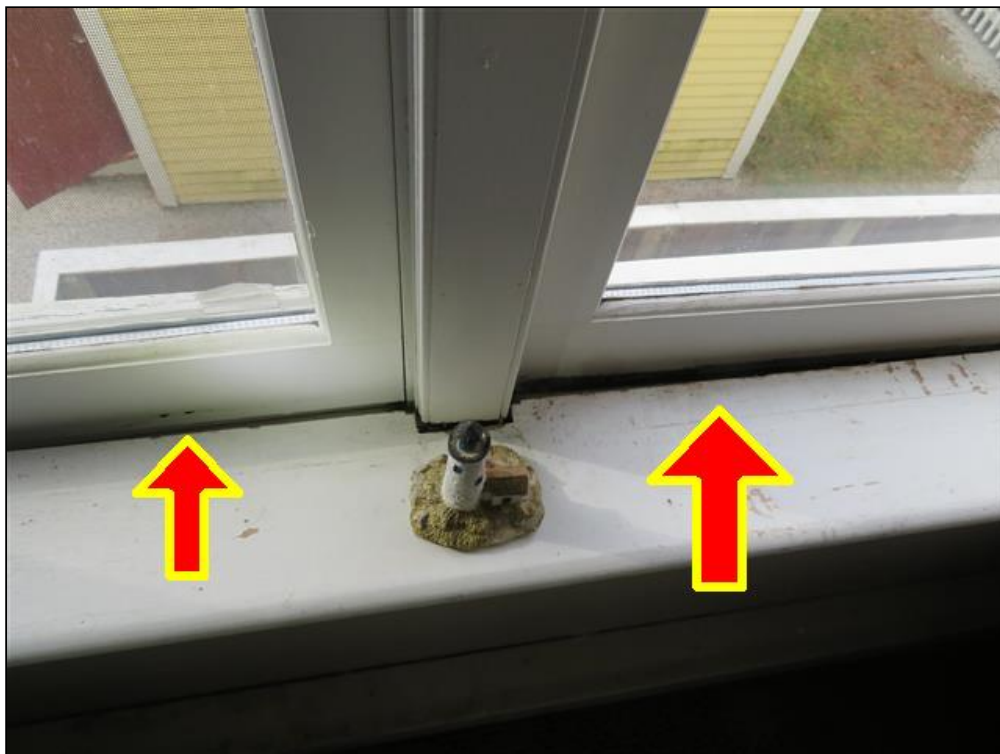
The in-law apartment round top window shows signs of downward thrust because the bottom sash is not tangent on the window sill. *Contact a carpenter.*

12.2.B Item 1(Picture) Contact a carpenter

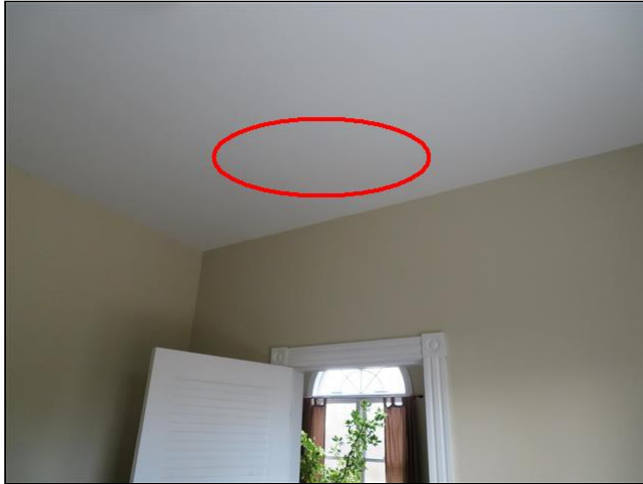
(1) Smoke alarm is missing in bedroom. *Install smoke alarm.*

12.8.B Item 1(Picture) Install smoke alarm
