SOUND HOME INSPECTION, LLC

Inspection Report

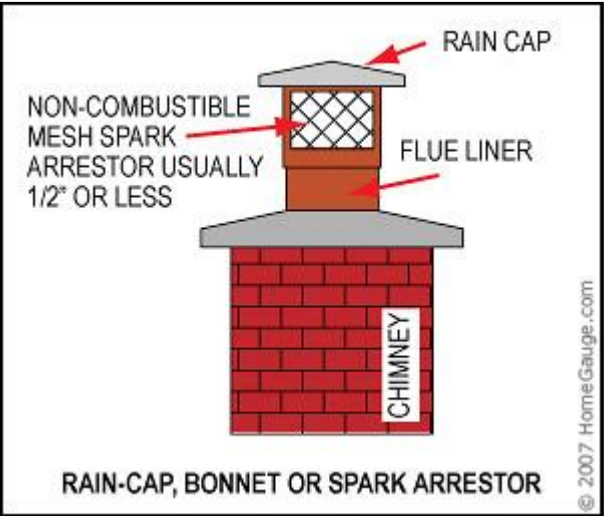
1.10 Item 2(Picture) Drawing of rain cap on chimney

1.10 Recommend the installation of a stainless steel rain cap on the chimney for the boiler.

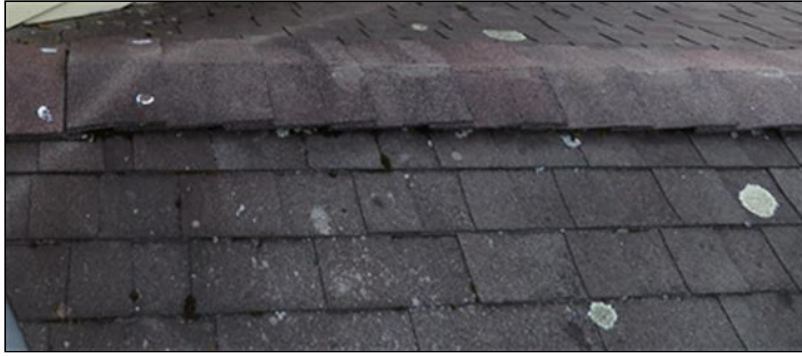
One layer of architectural roof shingles.

1.13 Item 1(Picture) One layer of architectural roof shingles

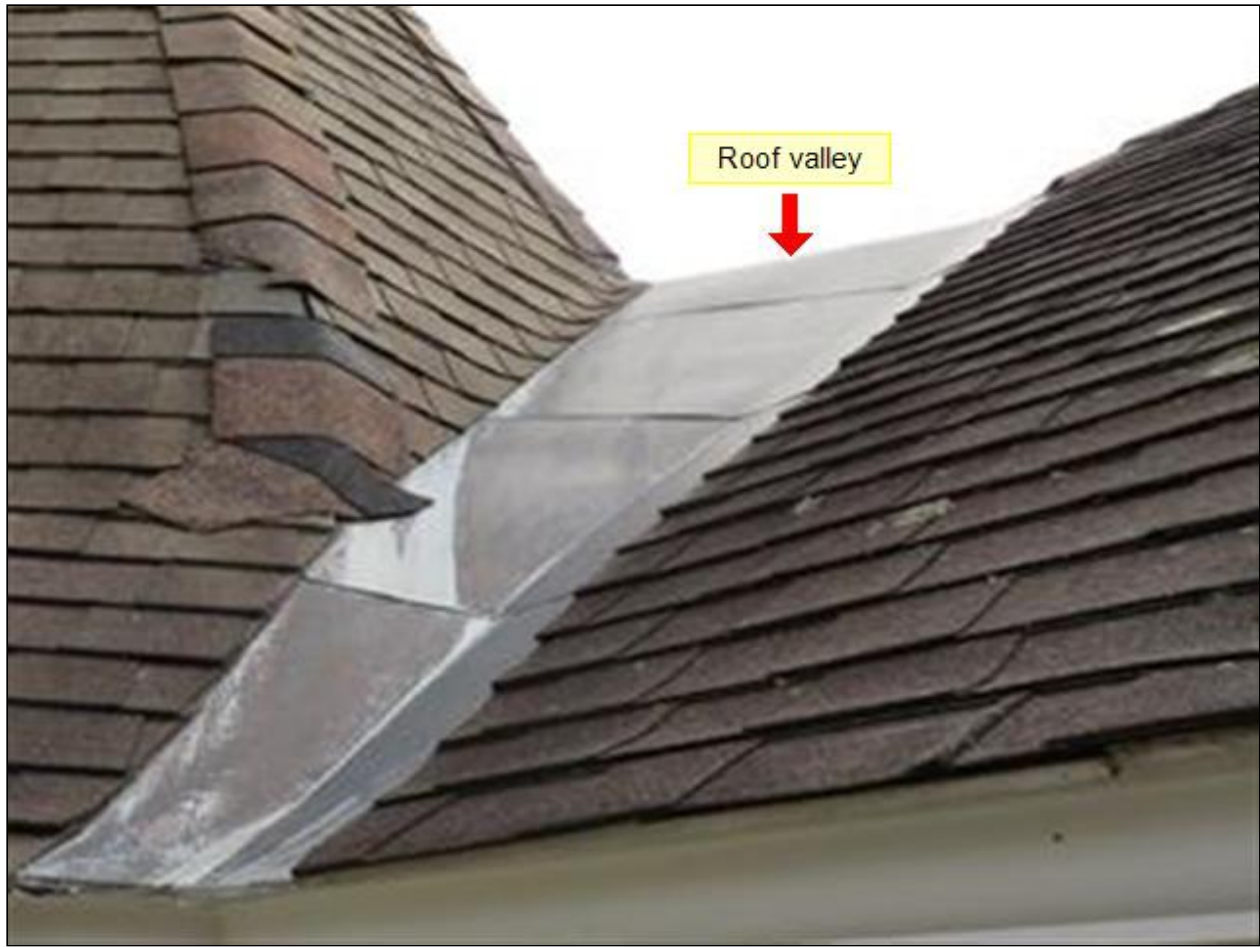
All roof valleys are copper. *This is for information purposes only.*

1.20 Item 1(Picture) Copper valley

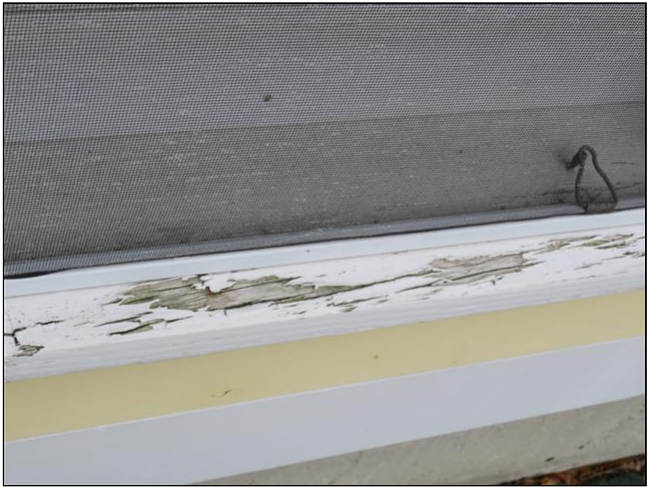
**2.2** (1) Deferred maintenance was observed on the rear exterior window sills. Numerous windows may need to be replaced. Contact a carpenter. *Scrape, sand, prime and paint window sills. This will help to protect the wood from the elements.*

2.2 Item 2(Picture) Scrape, sand, prime and paint window sills

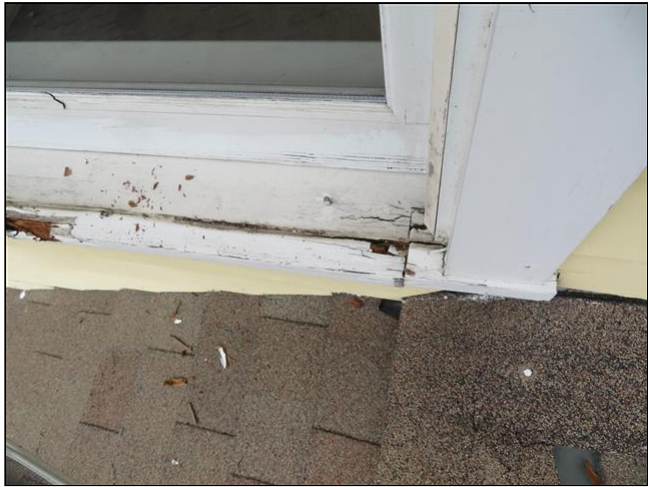
2.2 Item 3(Picture) Scrape, sand, prime and paint window sills.

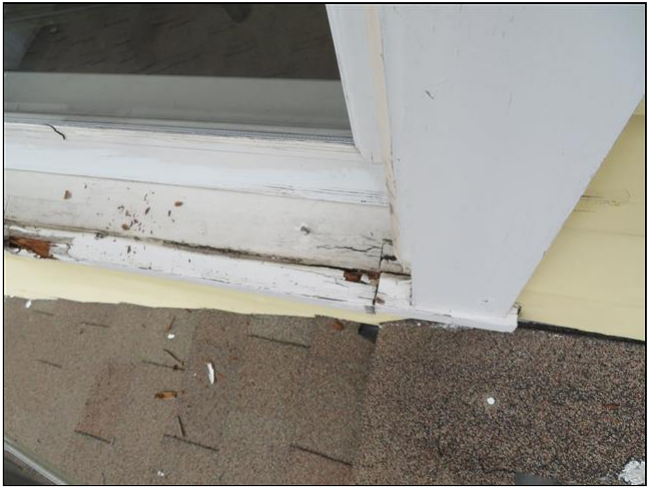
2.2 Item 4(Picture) Scrape, sand, prime and paint window sills.

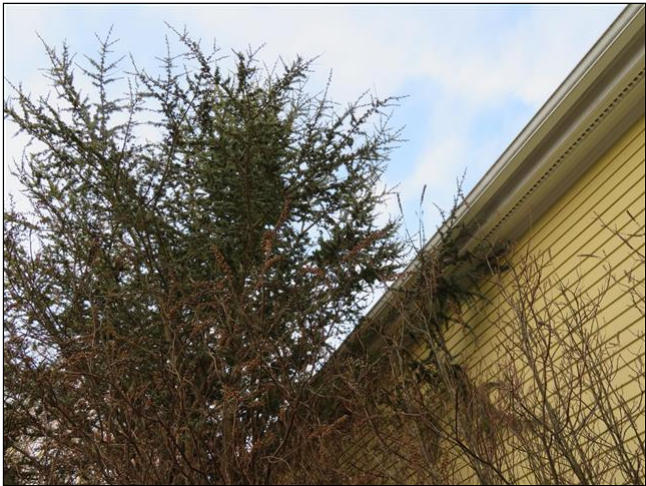
**2.4** Vegetation too close to house. The recommended distance between vegetation and side of house is eighteen inches to two feet.

2.4 Item 2(Picture) Vegetation too close to house

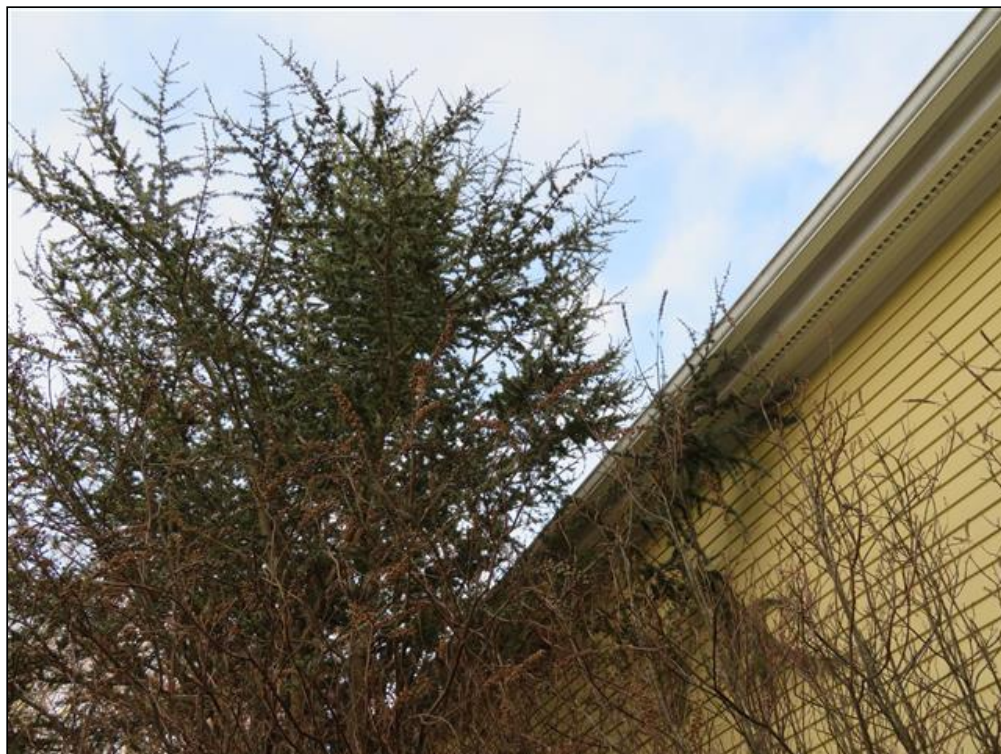
2.4 Item 3(Picture) Remove shrubberty

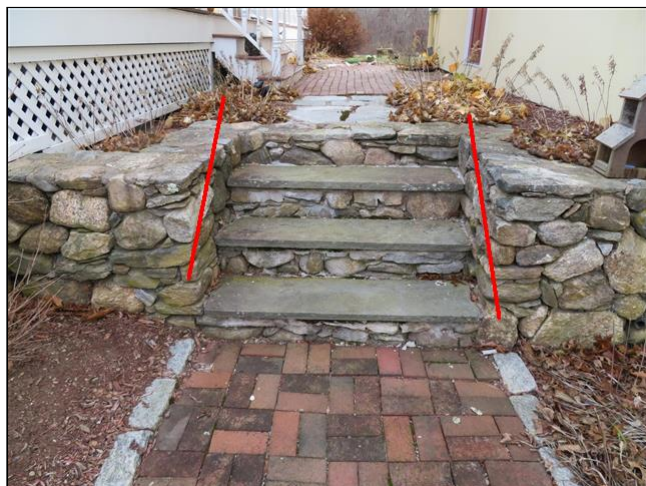
(1) A handrail needs to be installed for the side stone steps.

2.13 Item 1(Picture) Handrail needed

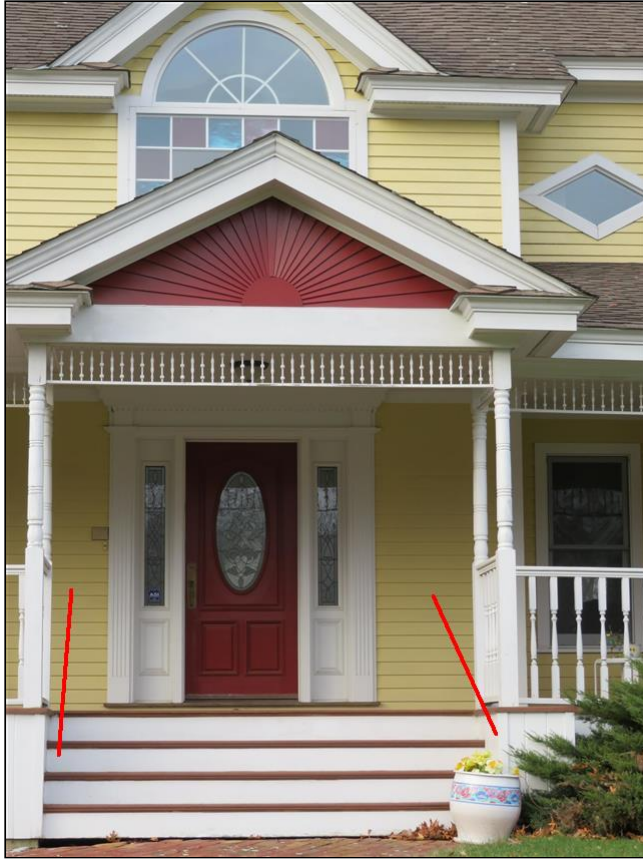
(2) A handrail needs to be installed for the front porch steps.

2.13 Item 2(Picture) Handrail is need at front porch steps

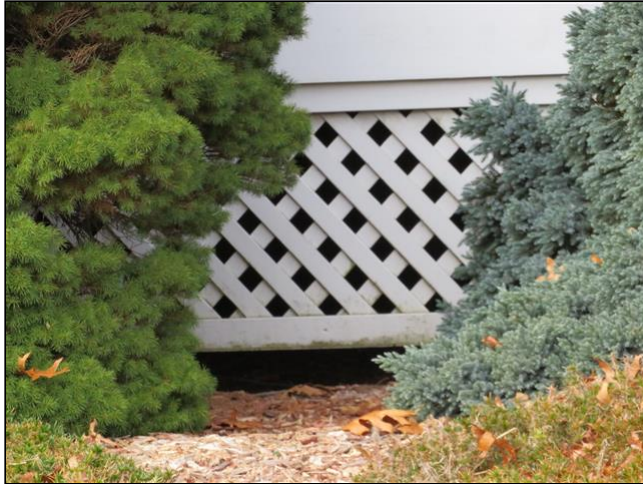
Due to lattice work, the underside of the front porch was inaccessible. We did ***NOT*** inspect the underside of the front porch.

2.33 Item 1(Picture) We did NOT inspect the underside of the front porch

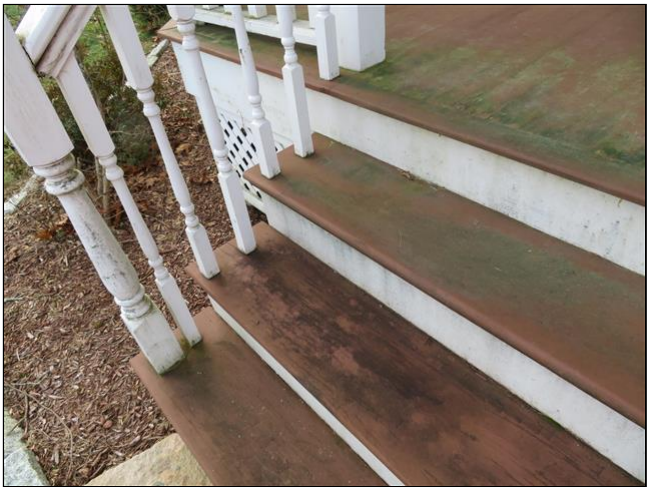
**2.35** Algae has accumulated on the right front porch steps. This condition could be a slipping hazard. *Remove algae.*

2.35 Item 2(Picture) Remove algae

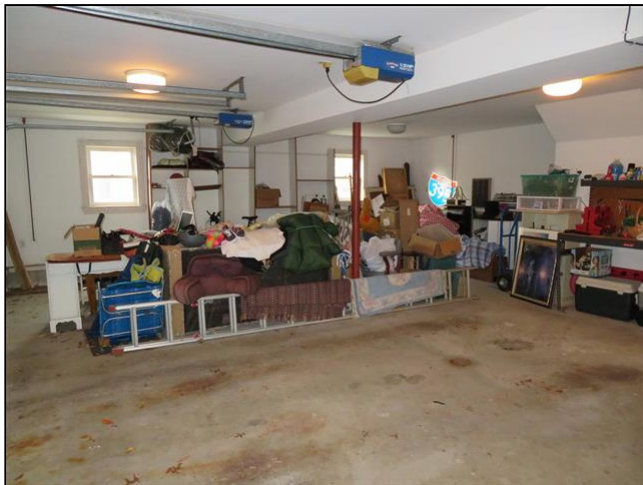
Remove personal items from garage prior to closing.

3.18 Item 1(Picture) Remove personal items from garage prior to closing

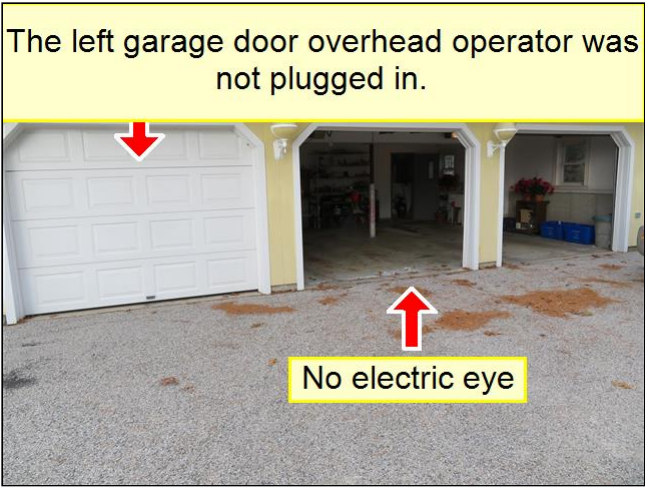
(1) The middle garage door does **NOT** have an electric eye.

3.19 Item 1(Picture) Left door not plugged in. No electric eye on middle door

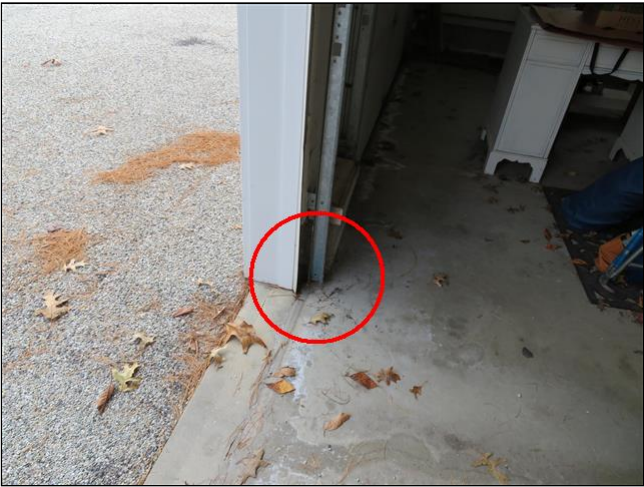
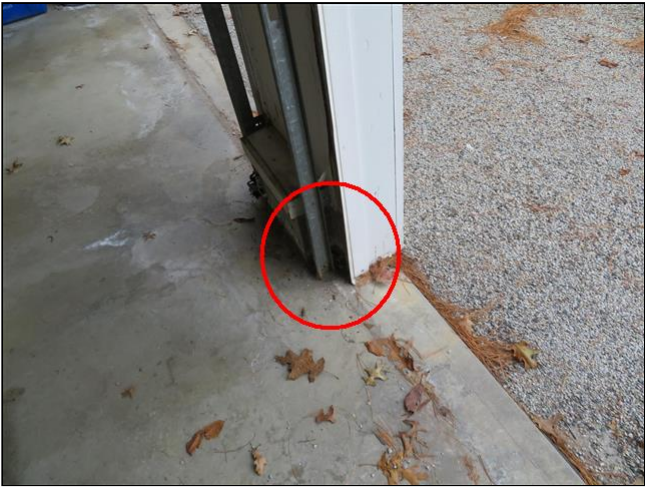
3.19 Item 2(Picture) No electric eye for middle door

3.19 Item 3(Picture) No electric eye for middle door

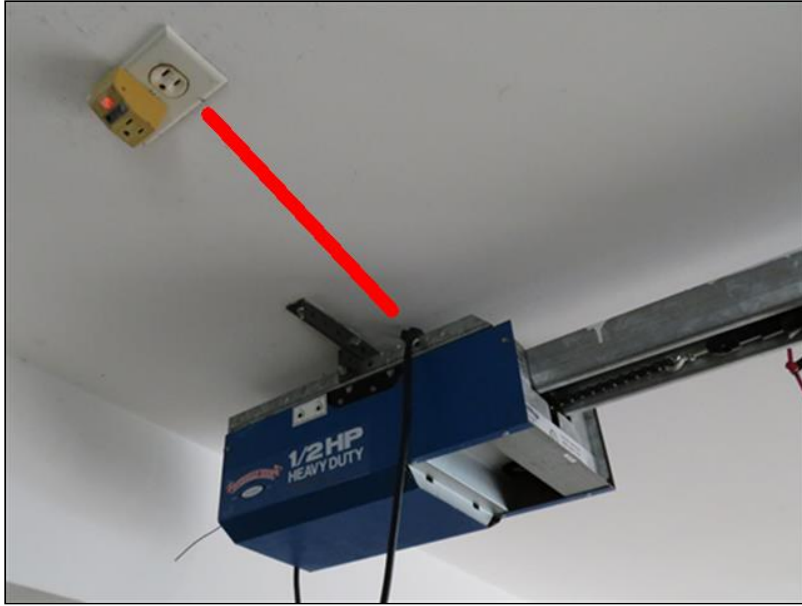
(2) The left garage door overhead motor was ***NOT*** plugged into the ceiling receptacle.

3.19 Item 4(Picture) Left garage door operator was not plugged into the receptacle.

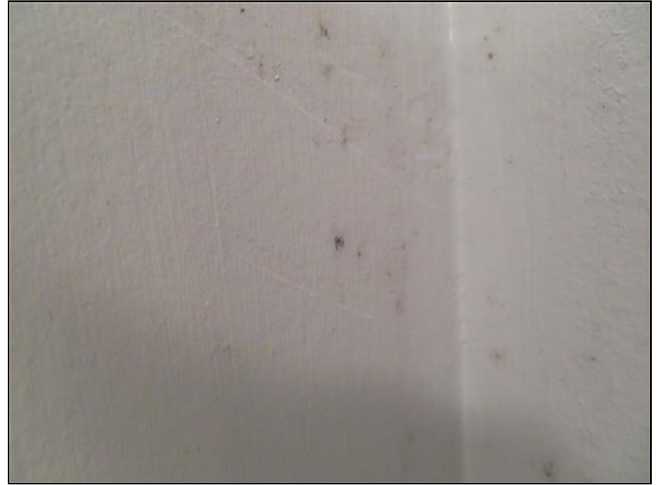
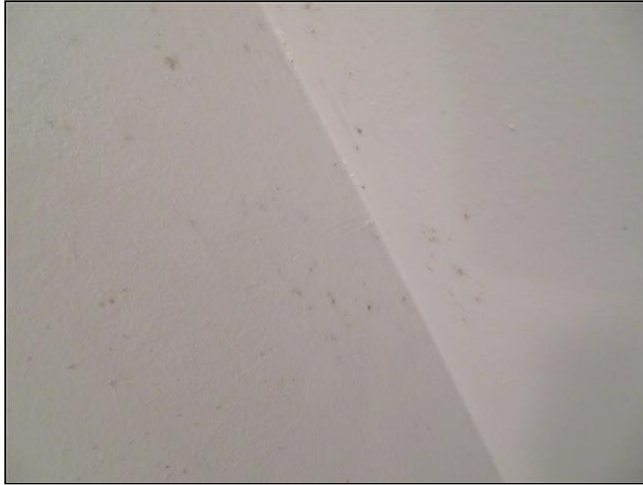
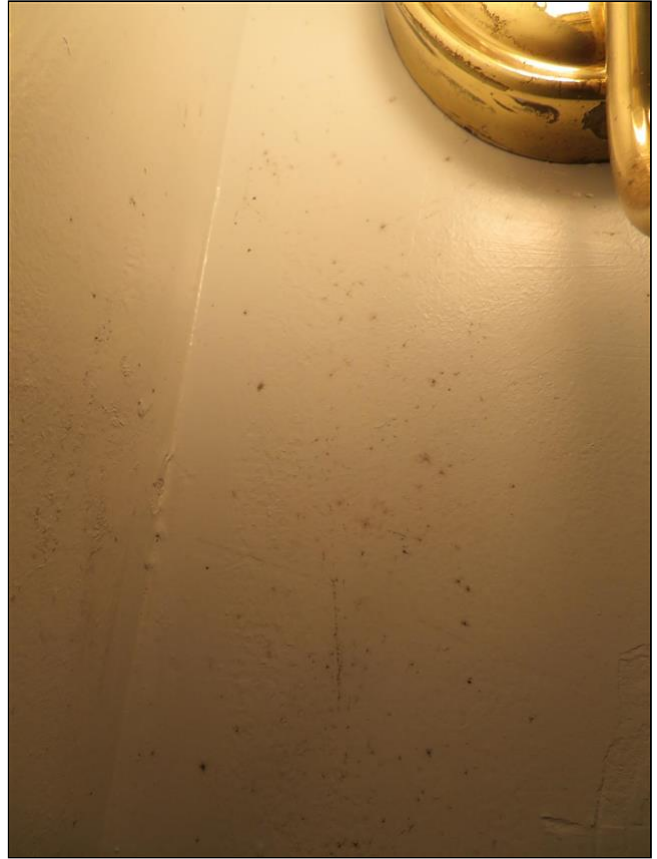
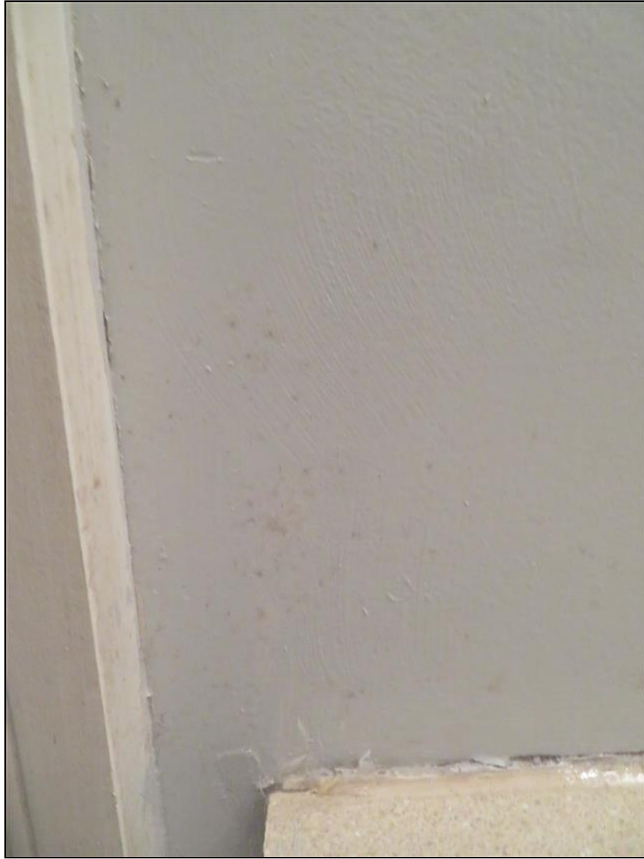
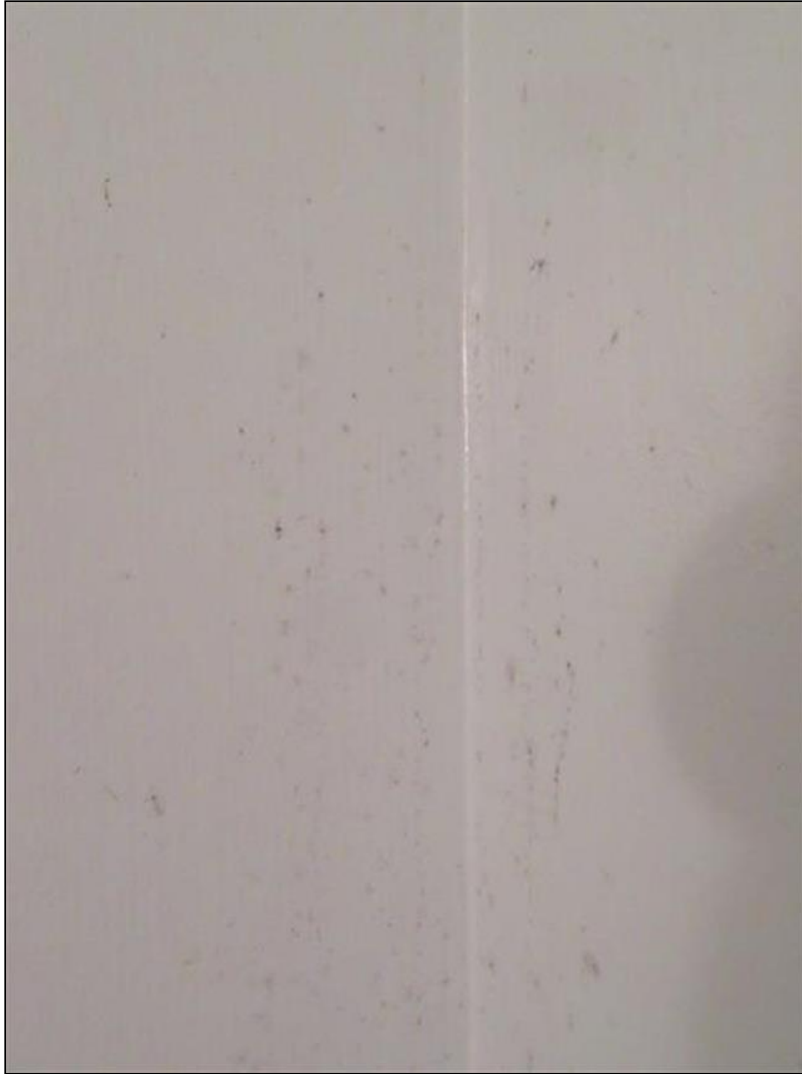
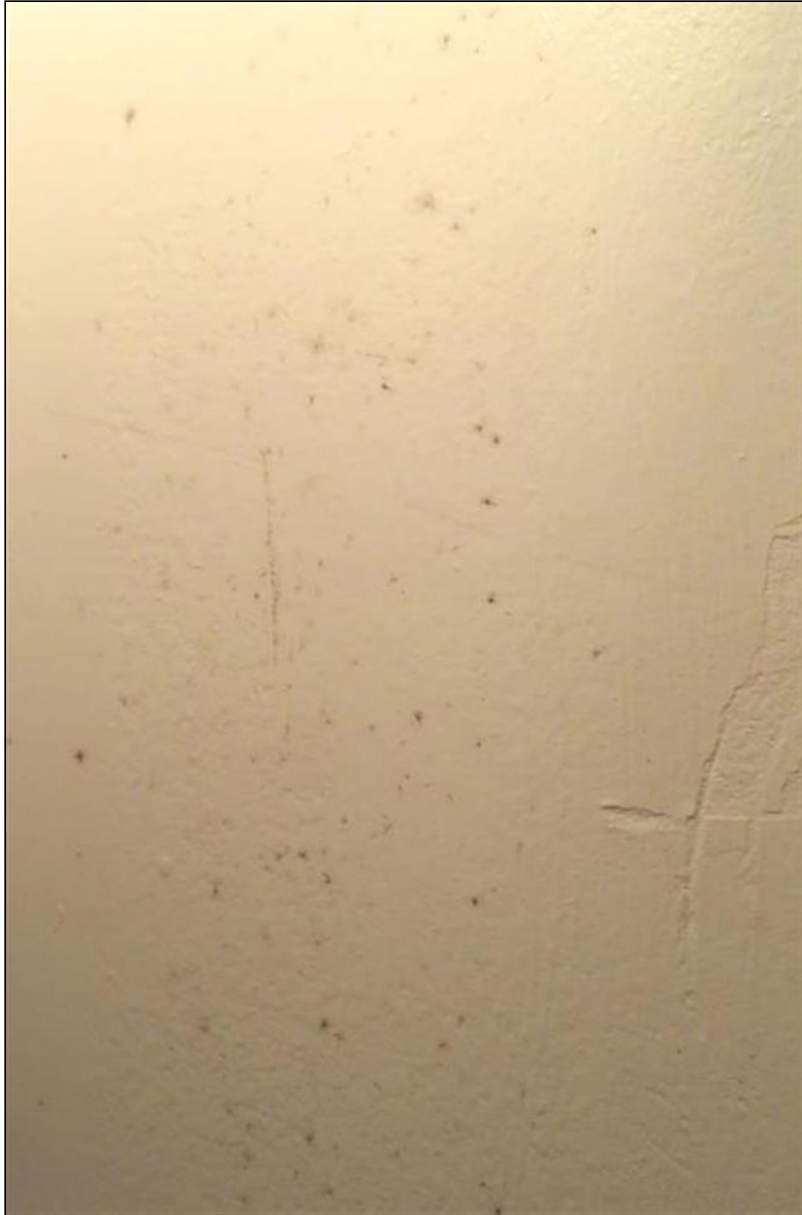
4.0 (1) Mold-like substance was observed on the lower level bathroom walls. *Contact an air quality company.*

4.0 Item 2(Picture) Contact an air quality company

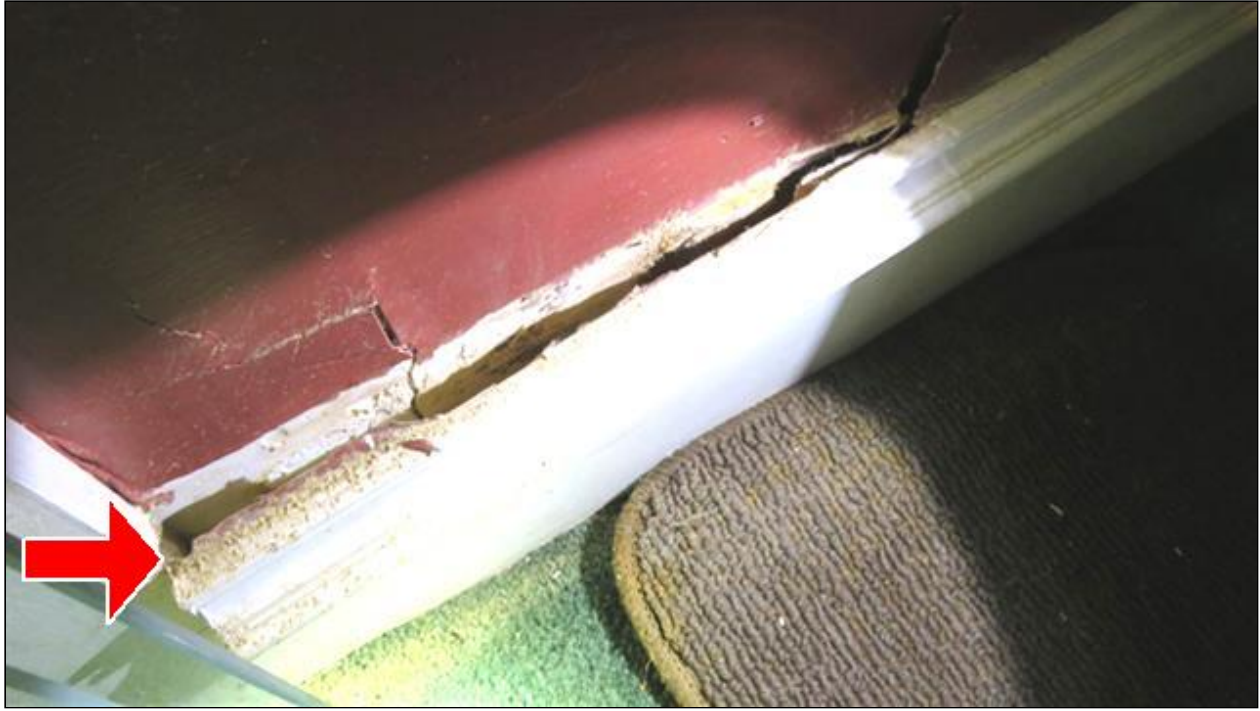
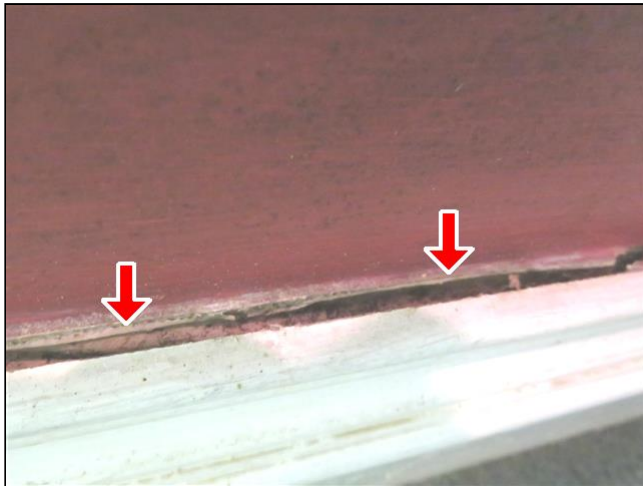
(2) The drywall and wood molding at the exterior of the squash court glass door appears to be water damaged and in appears to be in need of repair. *Contact a carpenter.*

4.0 Item 9(Picture) Contact a carpenter

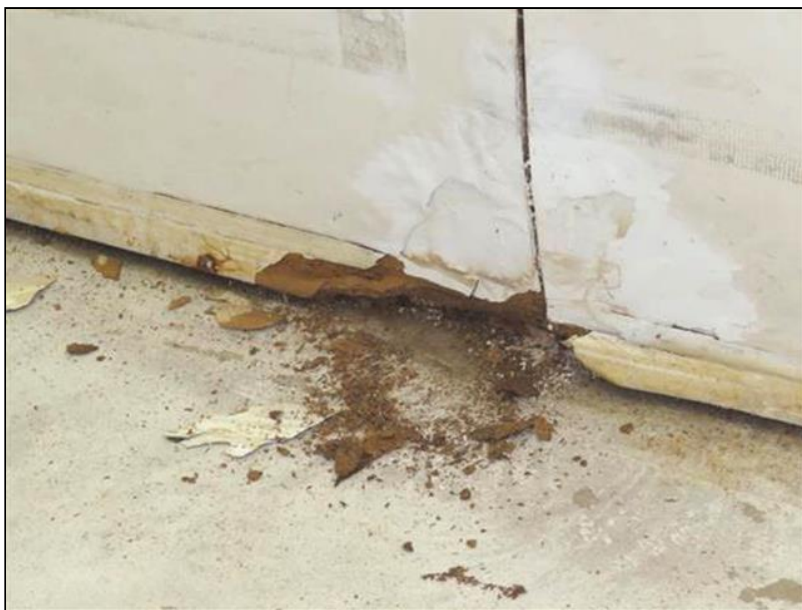
(3) Mold-like substance and water damage was observed on the lower level squash court walls. *Contact a carpenter and an air quality company.*

4.0 Item 12(Picture) Contact a carpenter and an air quality company

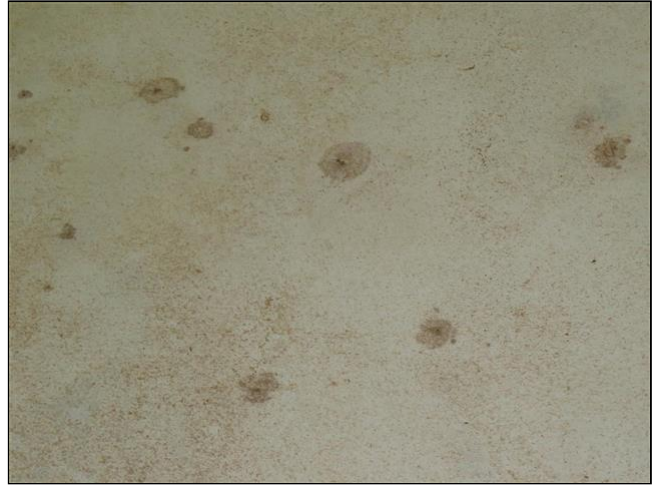
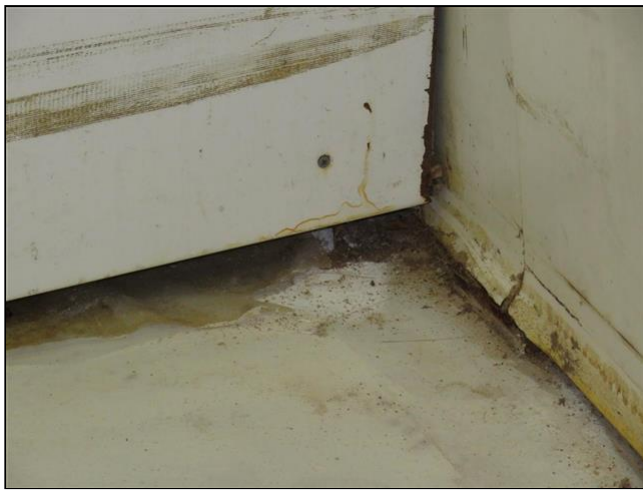
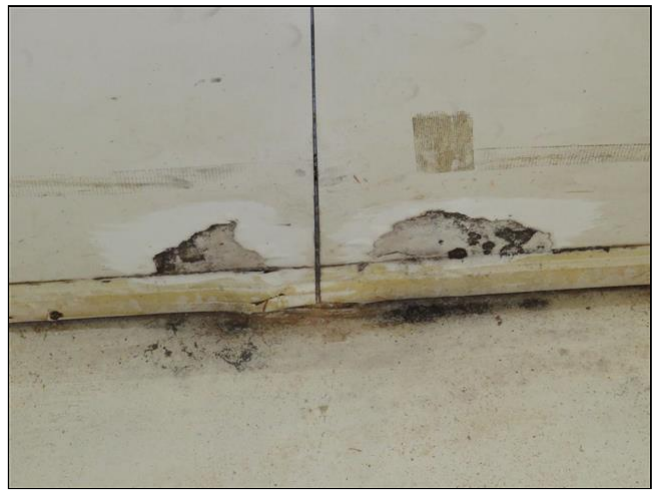
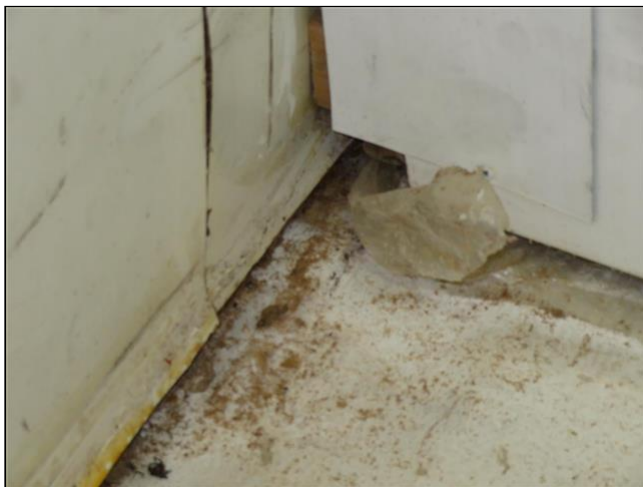
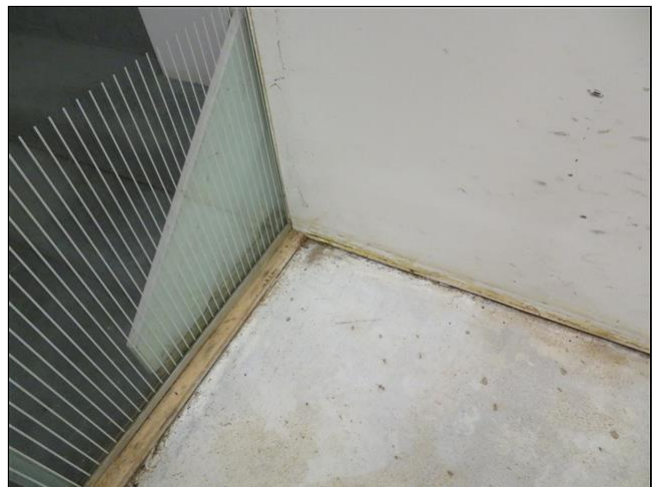
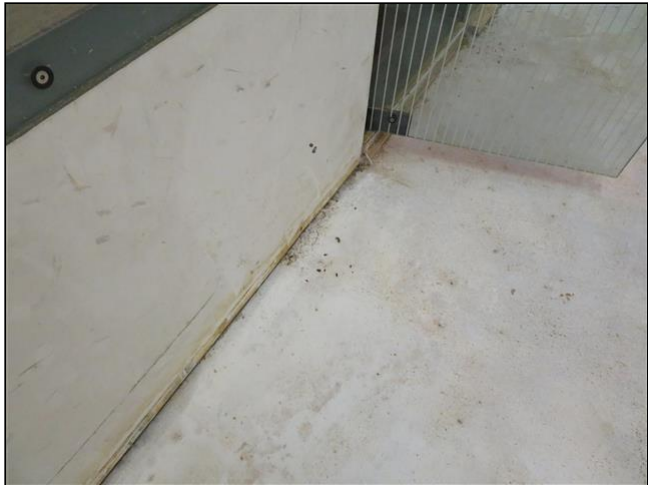
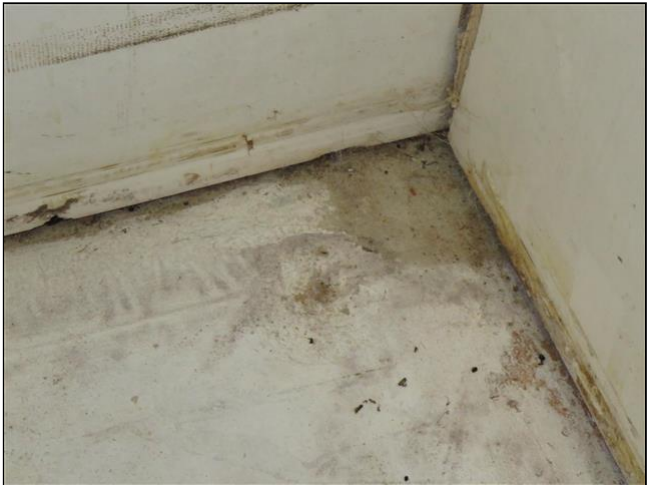
4.1 The lower level squash court floor, walls and ceiling shows signs of mold-like material. *This may be a potential health hazard. Contact an air quality company for further evaluation.*

4.1 Item 2(Picture) Contact an air quality company

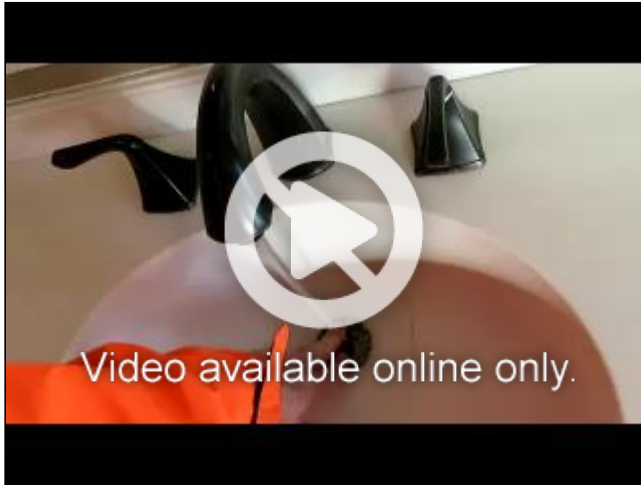
The right sink stopper in the master bathroom does **NOT** hold water.

6.9 Item 1(Video) Right sink stopper in the master bathroom does NOT hold water

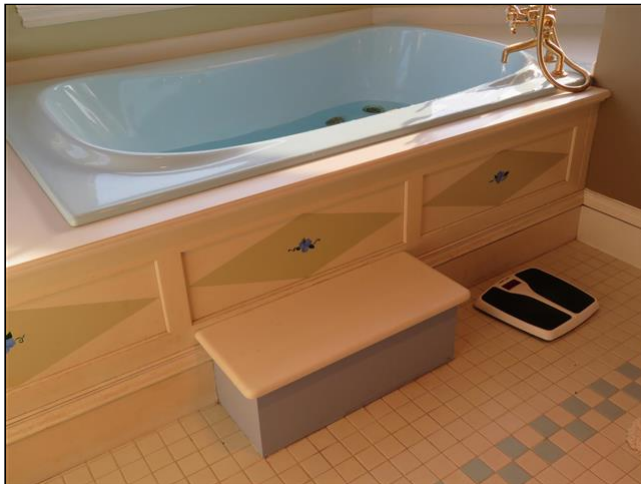
(1) The jetted tub does **NOT** have an access panel.

6.20 Item 1(Picture) Jetted tub does NOT have an access panel

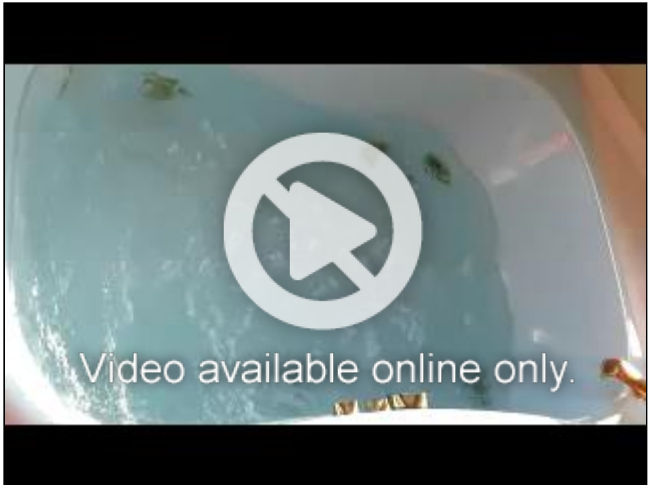
(2) The jetted tub was operational at the time of the inspection.

6.20 Item 2(Video) Jetted tub was operational

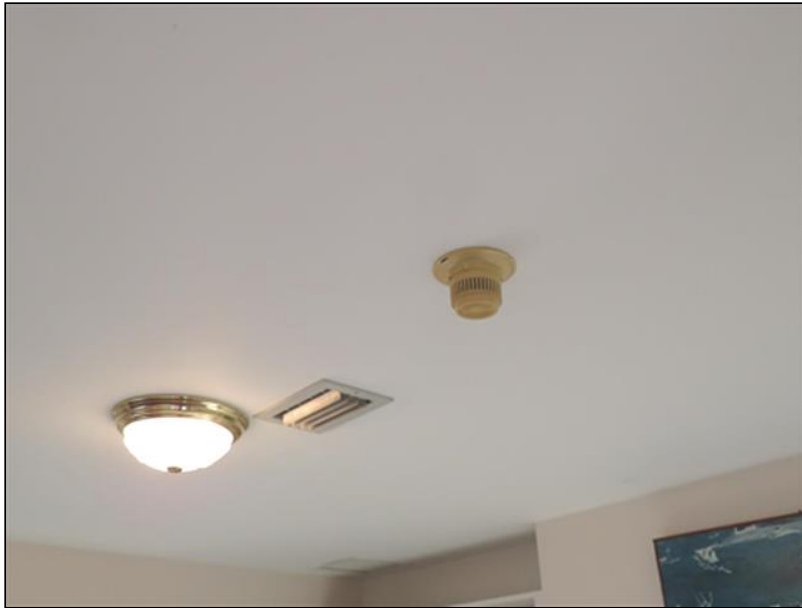
(2) Smoke alarms are yellowed, which is a sign that they are outdated. The functional design life of smoke alarms is approximately ten (10) years. *Replace smoke alarms.*

7.8 Item 5(Picture) Yellowed smoke alarm

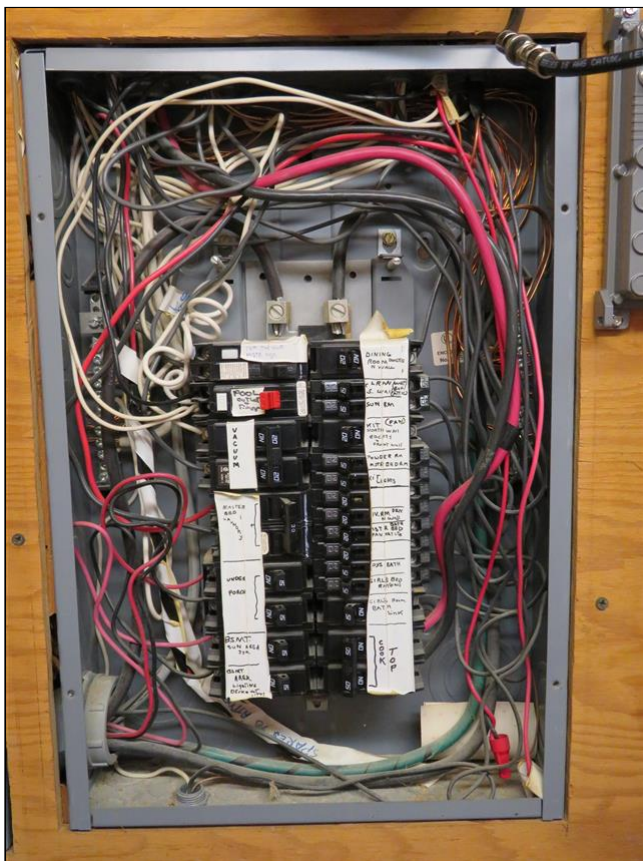
(1) One of the two sub panels is located in the basement next to the main panel.

7.12 Item 1(Picture) Sub panel

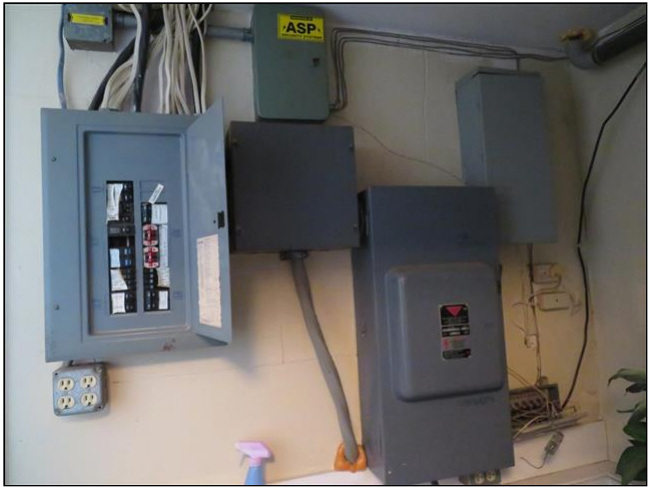
(2) The second sub panel is located in the garage, at the base of the apartment stairway.

7.12 Item 2(Picture) Sub panel in garage

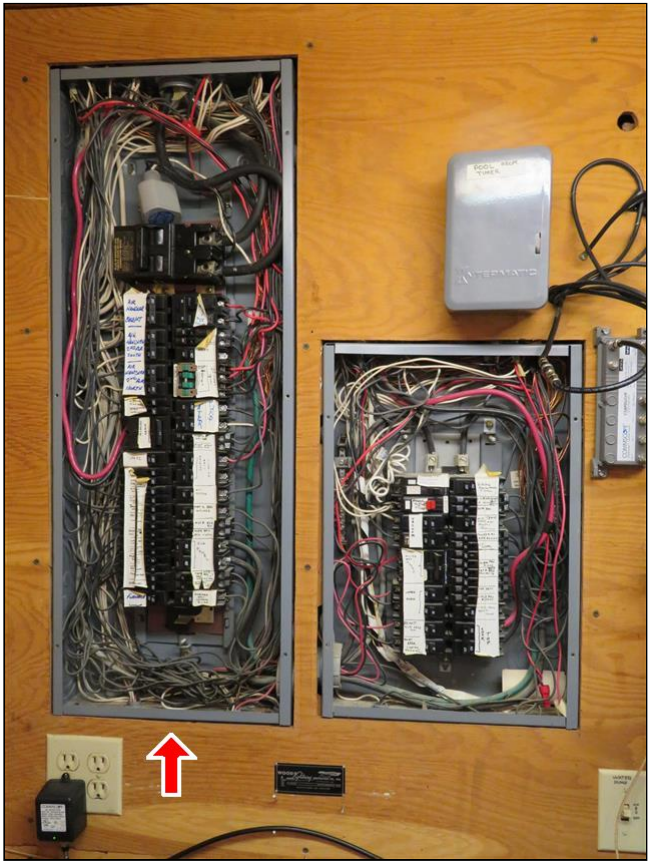
The main panel with the cover removed. *This is for information purposes only.*

7.22 Item 1(Picture) Main panel and sub panel with the covers removed

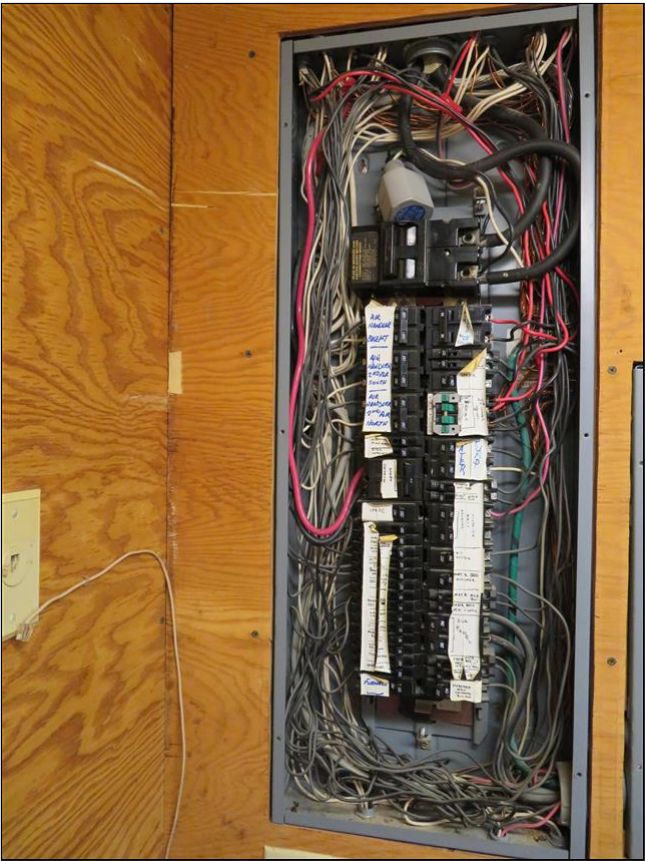
7.22 Item 2(Picture) Main panel with the cover removed

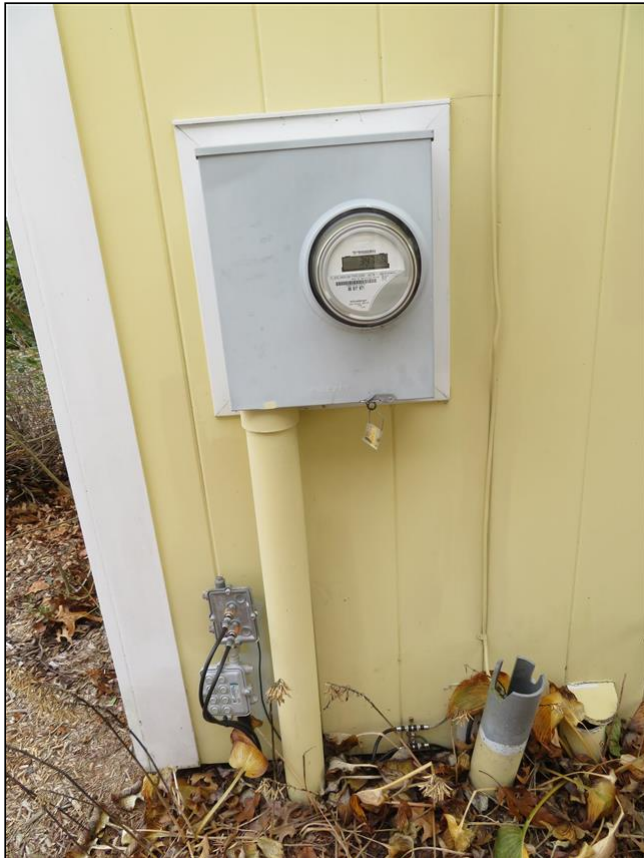
One (1) electric meter, the electrical consumption for the main house and the garage apartment will be reflected on one (1) billing statement. *This is for information purposes only.*

7.27 Item 1(Picture) One electric meter for both living quarters

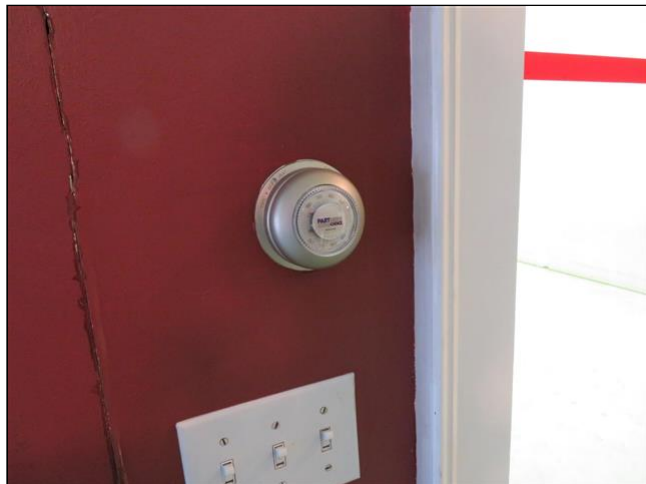
8.1 Item 1(Picture) Thermostat on lower level

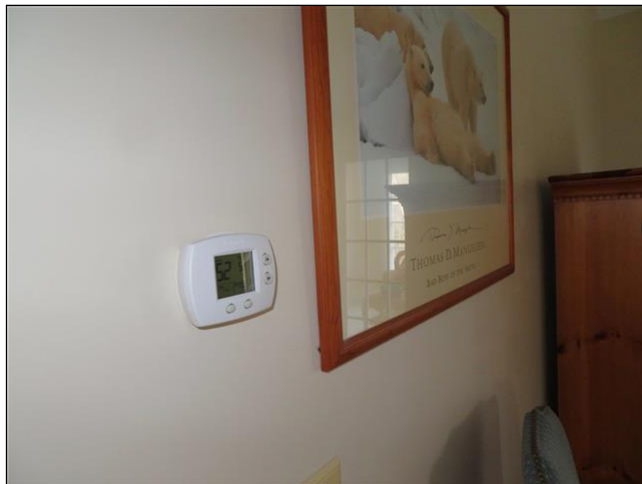
8.1 Item 2(Picture) Thermostat on second floor

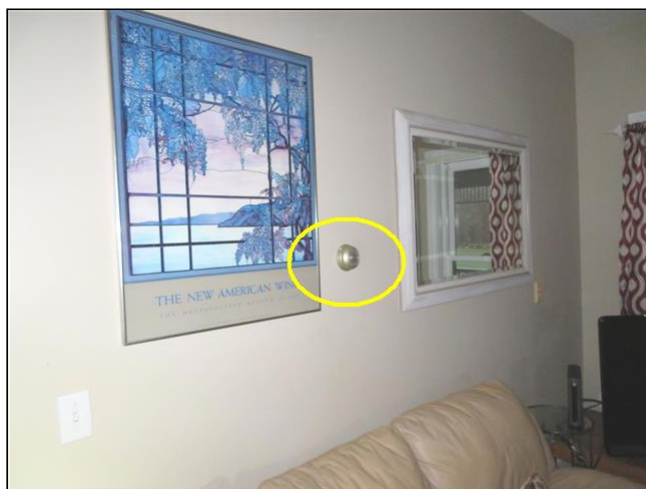
8.1 Item 3(Picture) Thermostat on main level, in living room

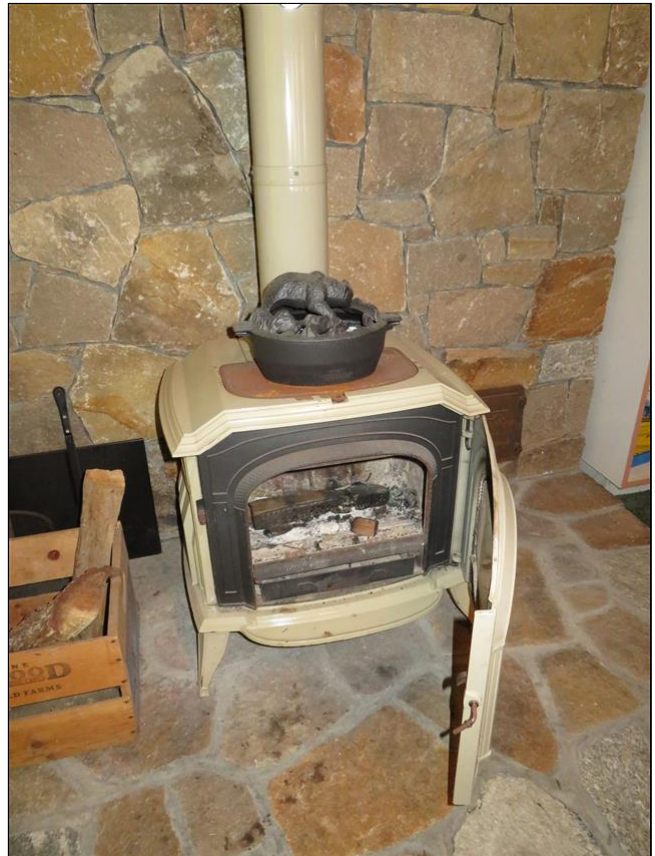
8.6 Item 2(Picture) Lower level wood stove

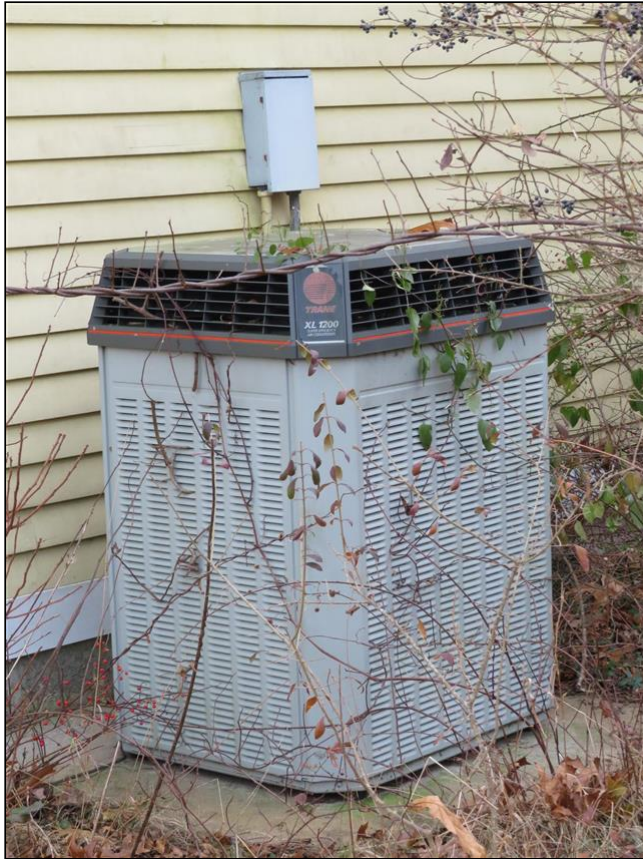
(1) The A/C was **NOT** tested for proper operation due to the outside air temperature is 65 degrees or less. Contact an HVAC company for testing when the exterior temperature is above 65 degrees. *We did not inspect these units.*

8.8 Item 1(Picture) 1988 Trane air condenser

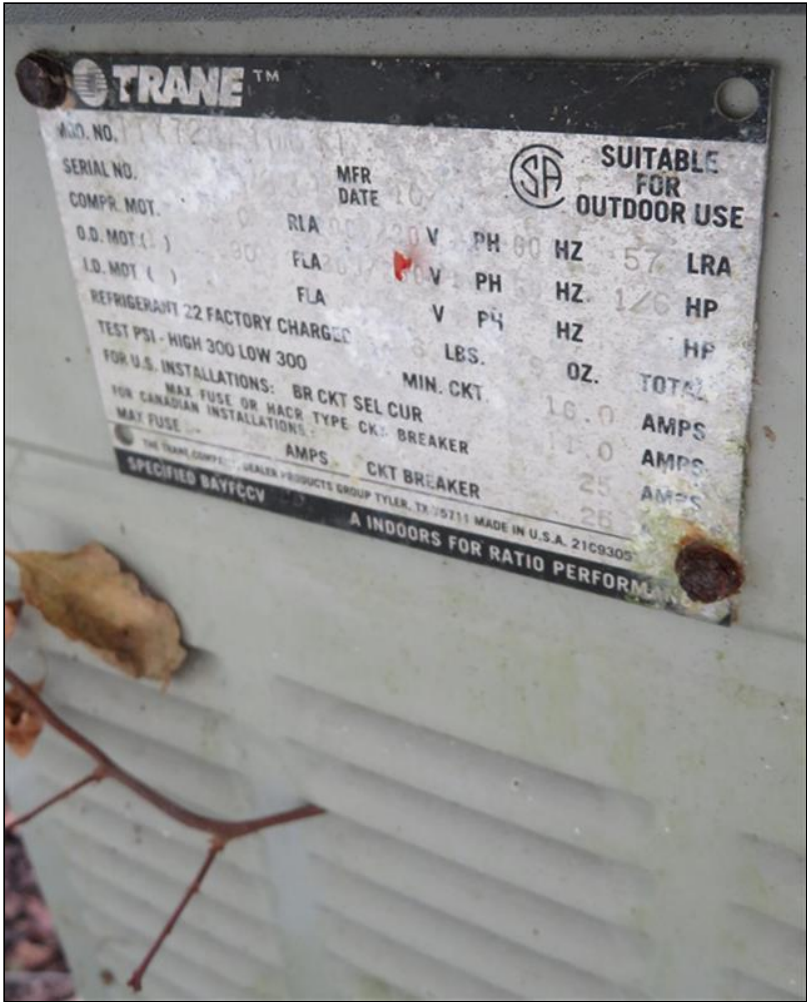
8.8 Item 2(Picture) Label serial number and manufacture date are illegible

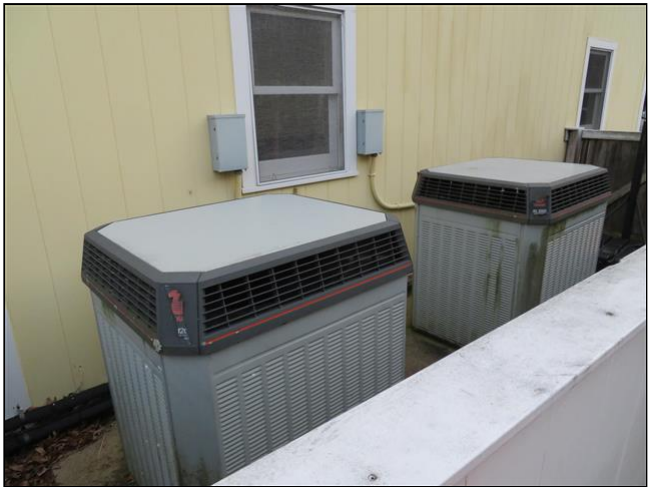
8.8 Item 3(Picture) Two air condensers on side of garage
