SOUND HOME INSPECTION, LLC

Inspection Report

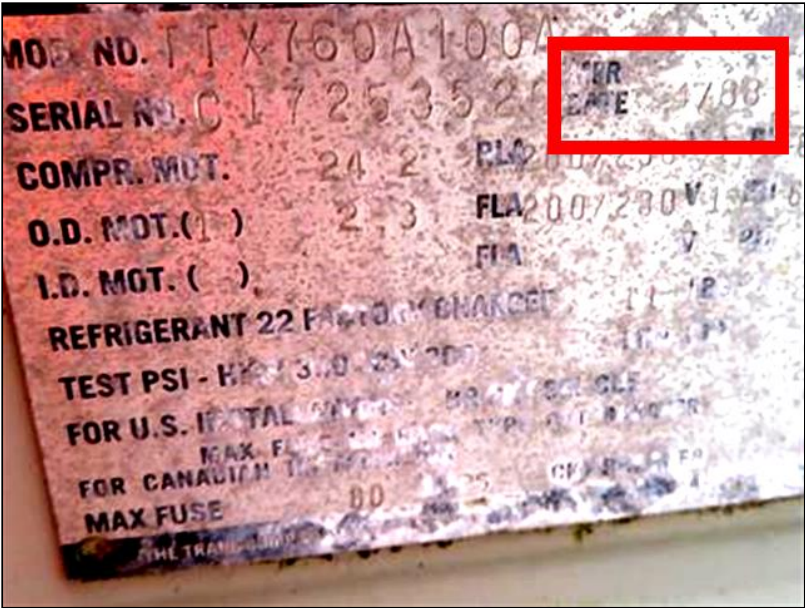
8.8 Item 4(Picture) 1988 Trane air condenser label

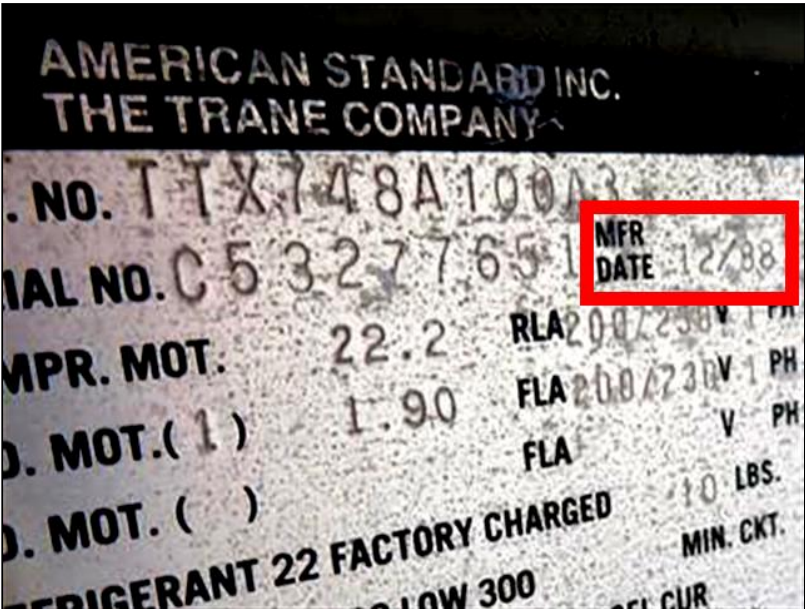
8.8 Item 5(Picture) 1988 Trane air condenser label

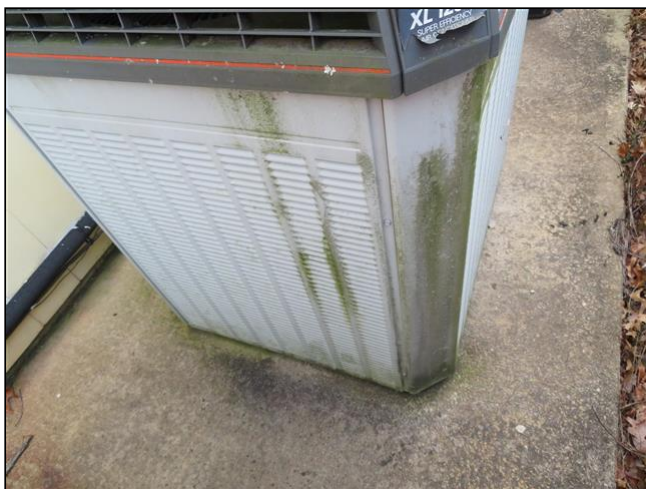
(3) The three (3) condenser has an accumulation of algae. *Clean algae off of the air condenser.*

8.8 Item 10(Picture) Clean algae off of the air condenser

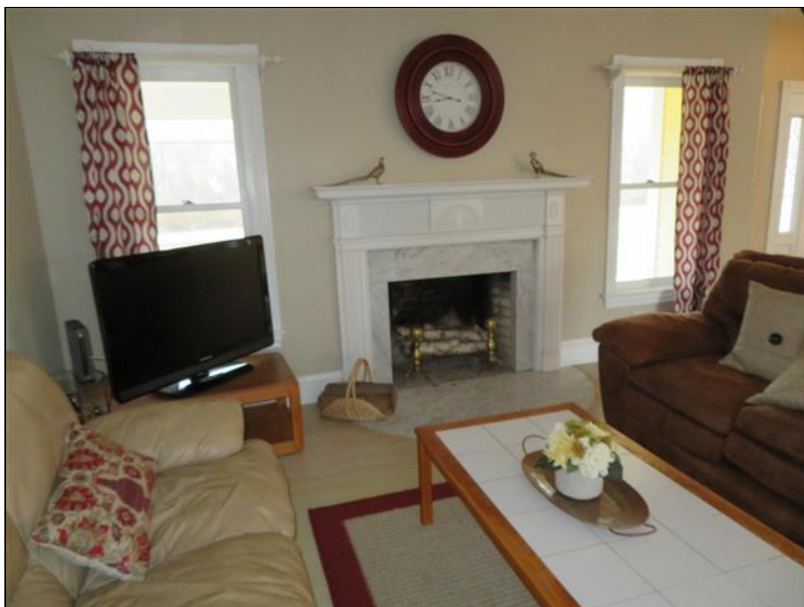
Conventional fireplace.

8.9 Item 1(Picture) Conventional fireplace

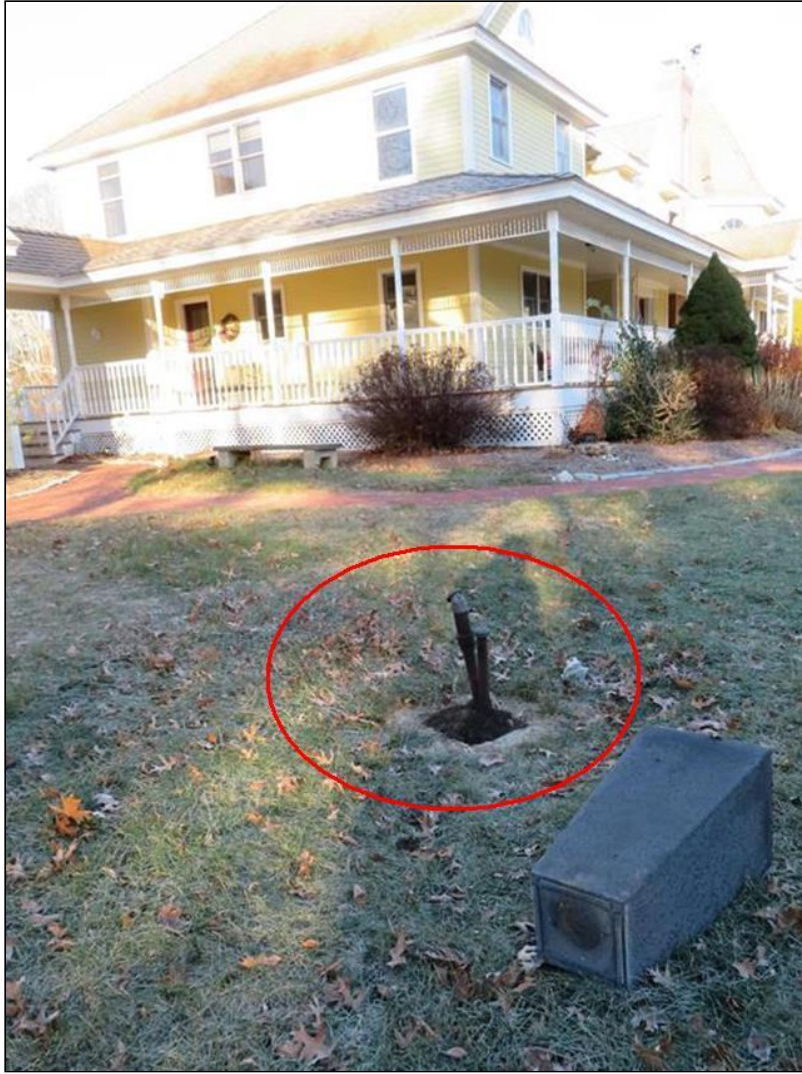
The property has a buried oil tank. The capacity and condition of the tank cannot be determined. *Sound Home Inspection, LLC did not inspect, test nor render any opinion on the age nor condition of tank. Recommend further evaluation and/or testing by an oil company.*

8.14 Item 2(Picture) Buried oil tank

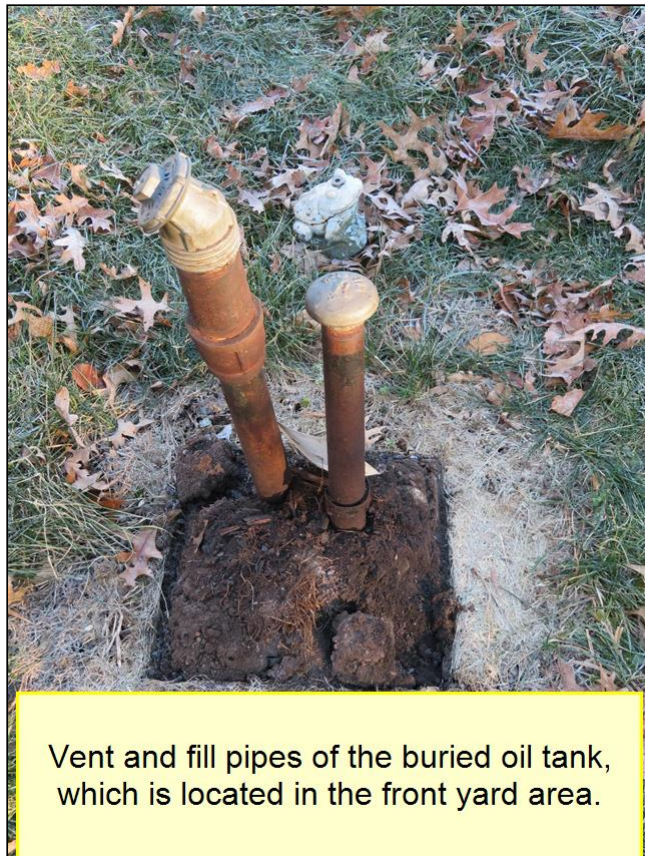
8.14 Item 3(Picture) Buried oil tank

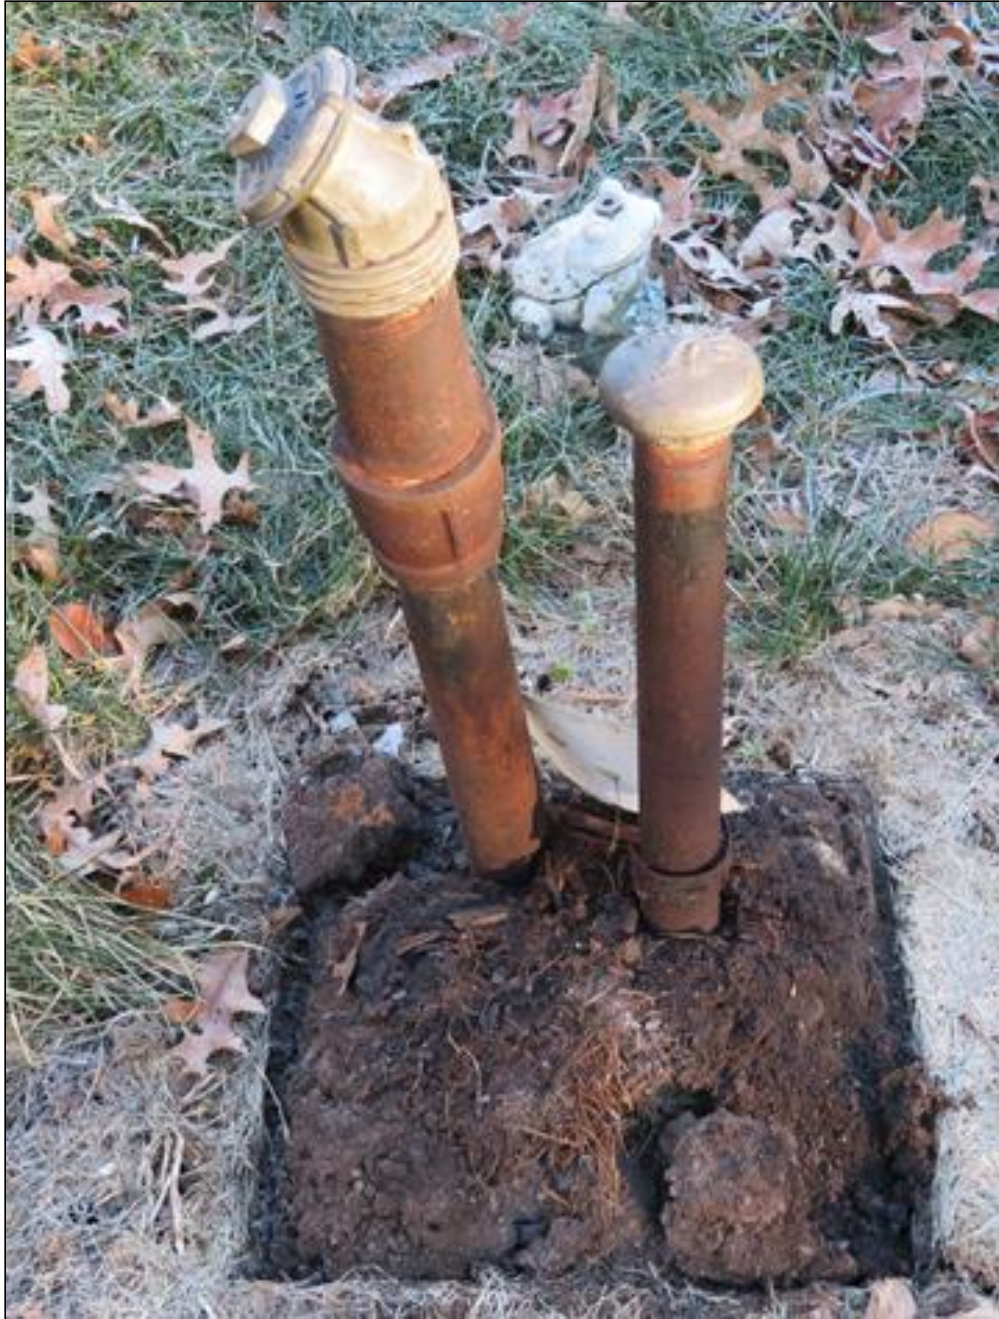
8.14 Item 4(Picture) Fill and vent pipes

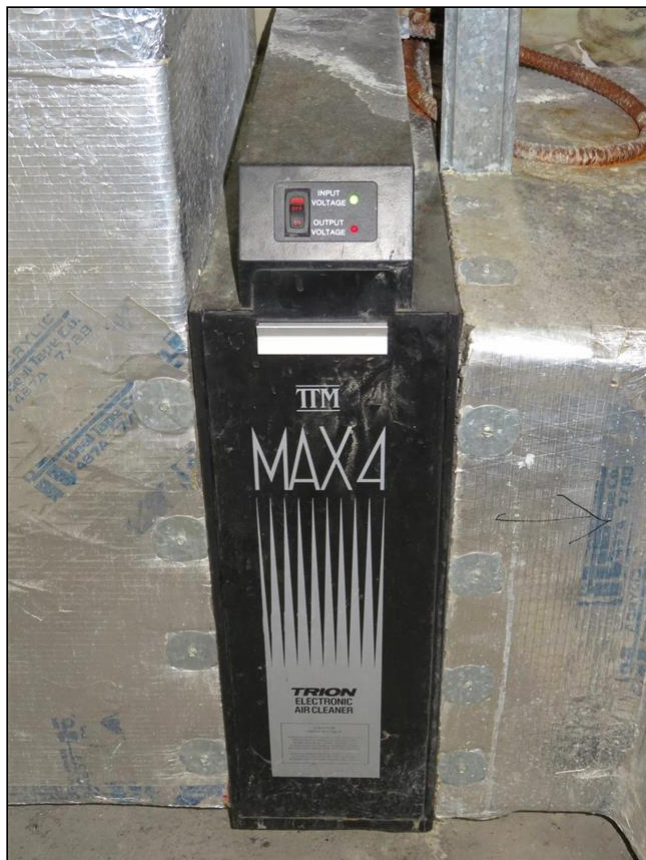
Electronic air filter.

8.15 Item 1(Picture) Electronic air filter

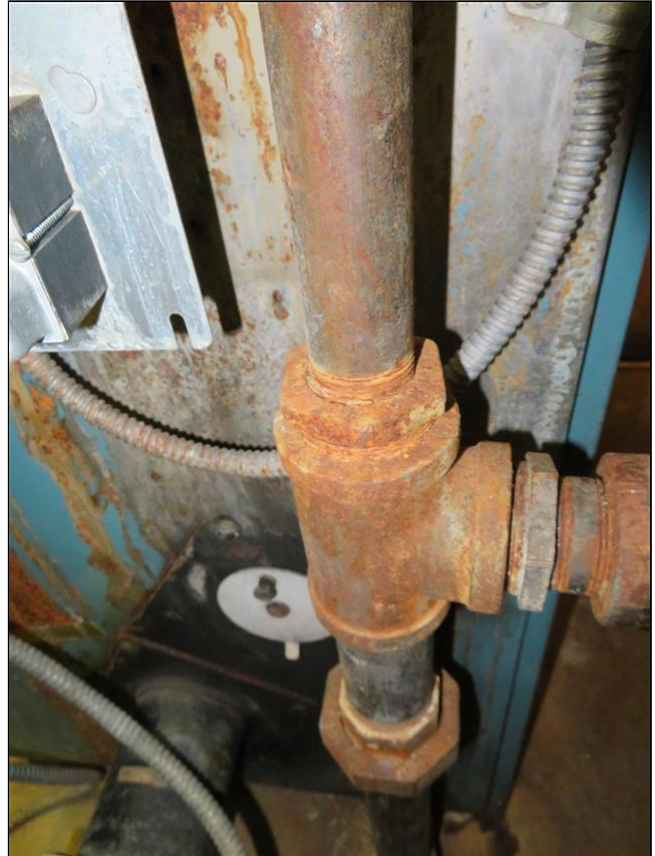
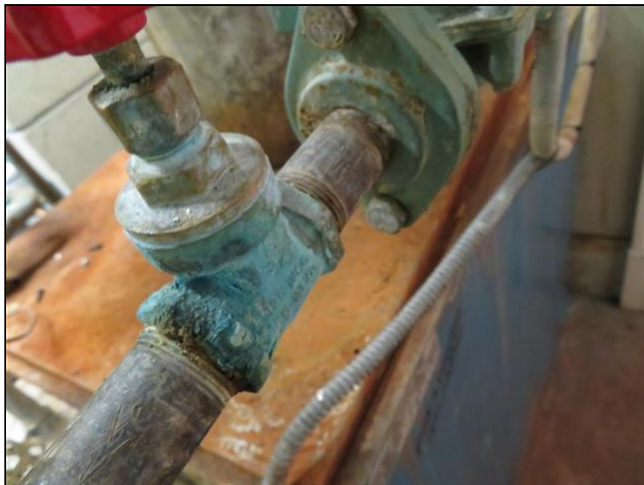
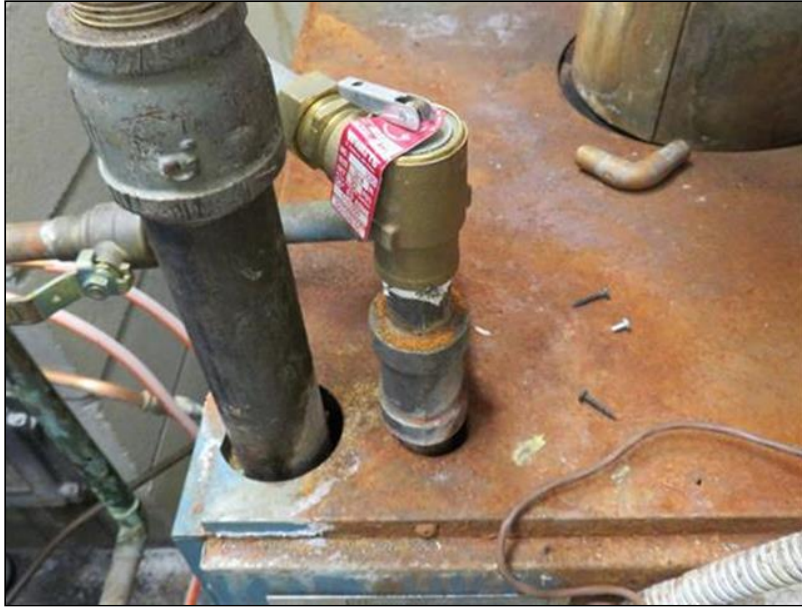
(2) Boiler in basement has evidence of rust and deferred maintenance. *Contact a oil company.*

8.21 Item 2(Picture) Contact a oil company

8.21 Item 3(Picture) Contact a oil company

8.21 Item 4(Picture) Contact a oil company

8.21 Item 5(Picture) Contact a oil company

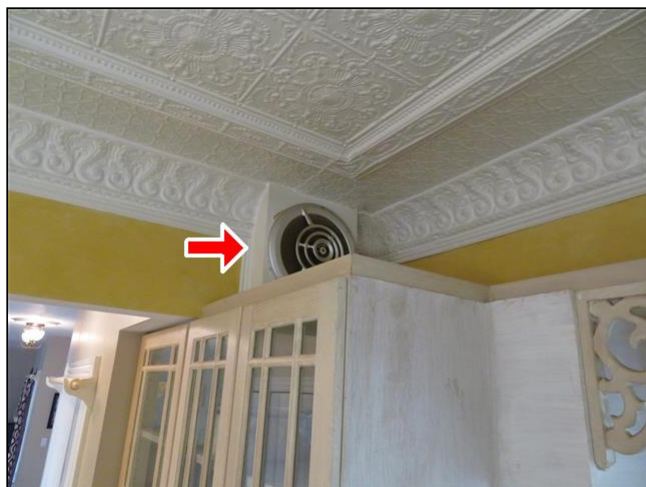
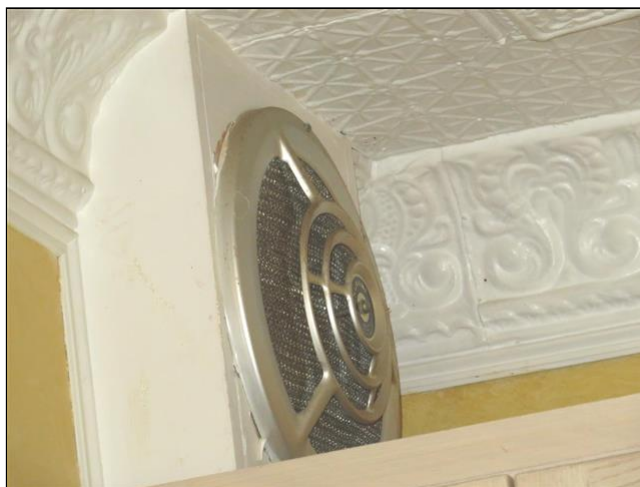
(4) The inspector could **NOT** determine the location of termination of the vent of the kitchen wall mounted exhaust fan. *The exhaust fan appears outdated.*

9.3 Item 4(Picture) The exhaust fan appears outdated

9.3 Item 5(Picture) The exhaust fan appears outdated

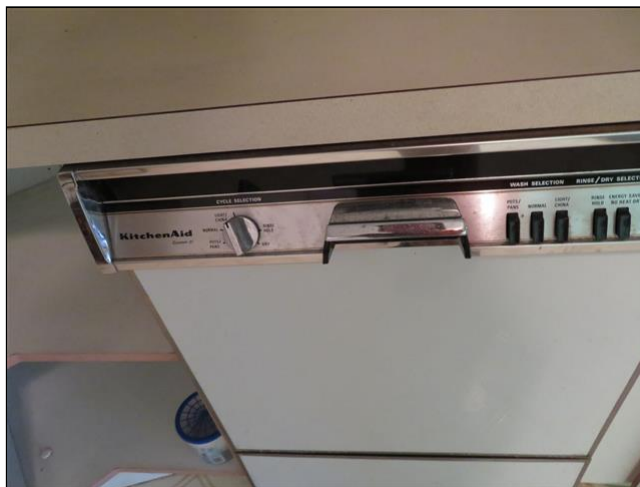
10.0 Item 2(Picture) Lower level dishwasher is not operational

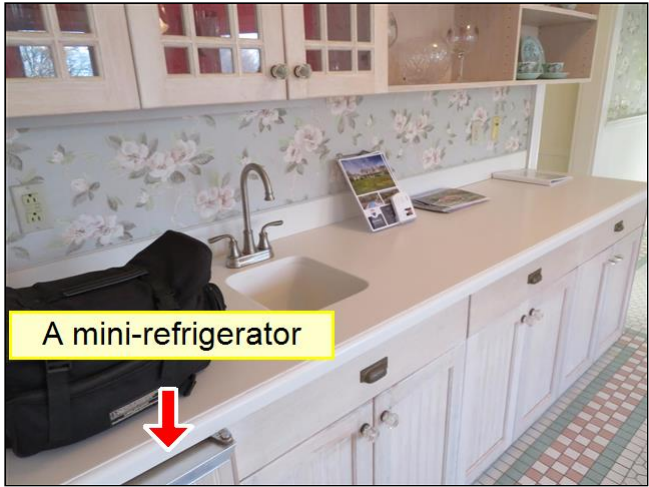
A mini-refrigerator is located in the dining room.

10.5 Item 1(Picture) Mini-refrigerator

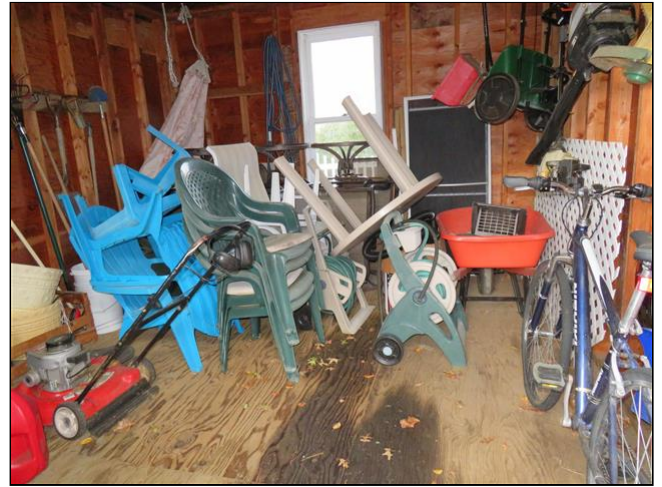
Personal items were observed in the shed. *Remove personal items prior to closing.*

12.12.A Item 2(Picture) Remove personal items prior to closing

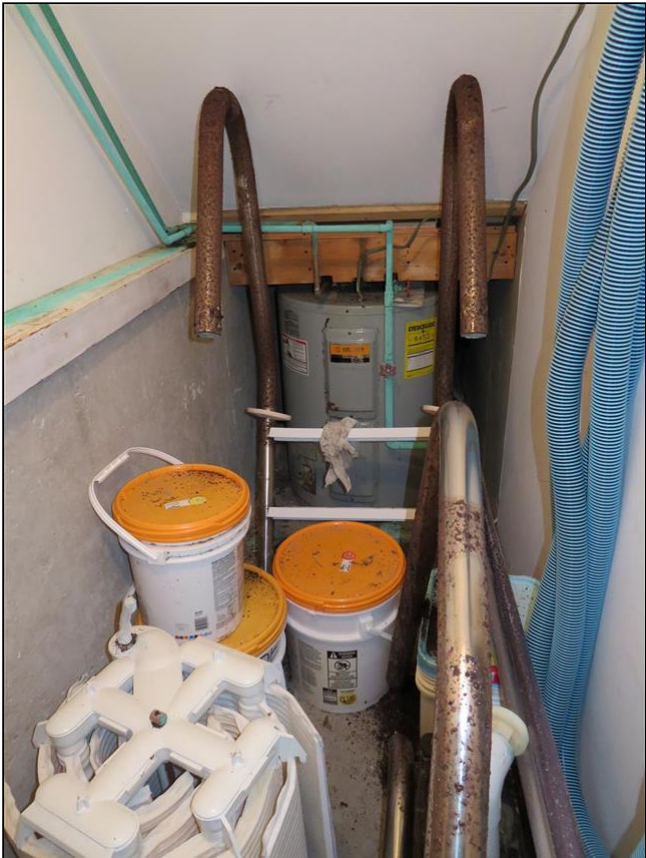
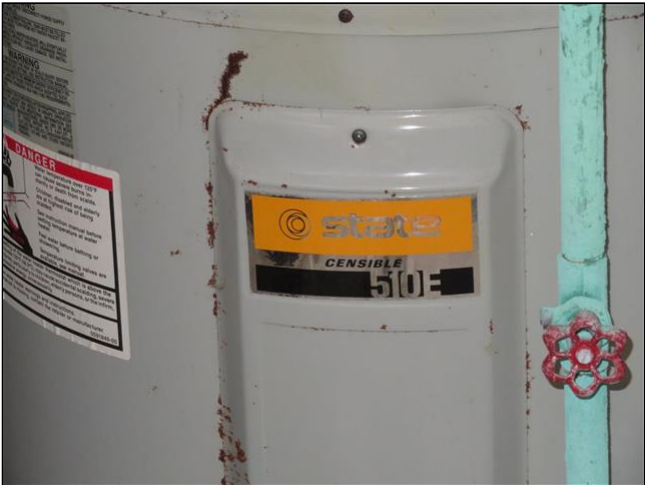
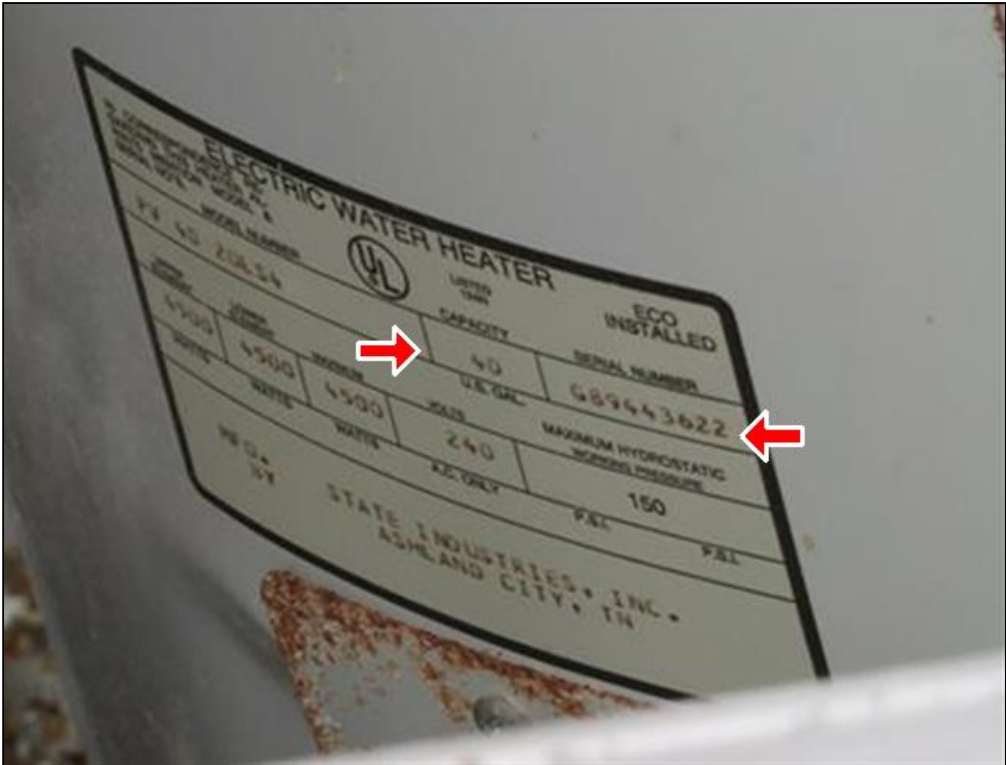
The 40-gallon, State brand electric water heater was manufactured in 1989. The water heater is 29 years old. The functional design life of water heaters is approximately eight (8) to twelve (12) years. *The water heater was operational at the time of the inspection.*

12.7.B Item 1(Picture) 29-year old, State brand, 40-gallon water heater

12.7.B Item 2(Picture) 29-year old, State brand, 40-gallon water heater

12.7.B Item 3(Picture) 29-year old, State brand, 40-gallon water heater label

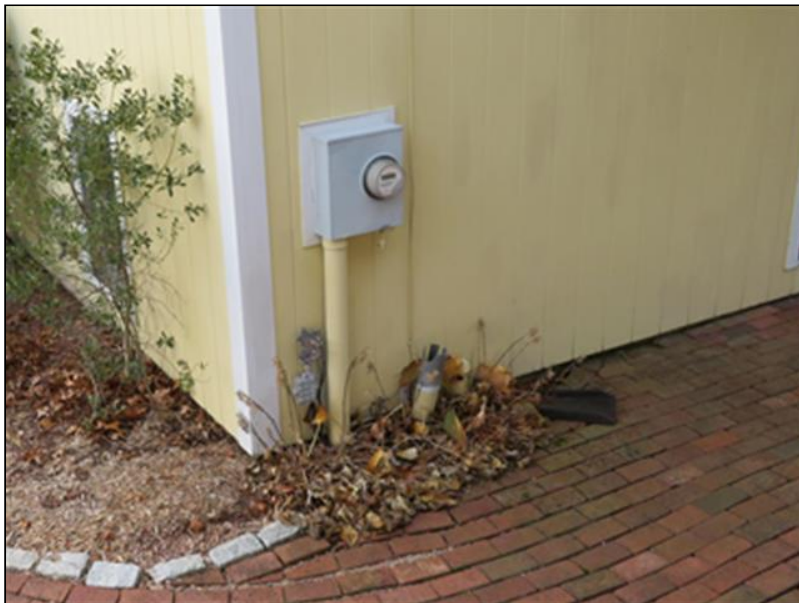
(3) Electric meter is located at the rear of the garage, and provides metering for the main panel and two sub panels. *This is for information purposes only.*

12.8.B Item 2(Picture) Electric meter for main and sub panels

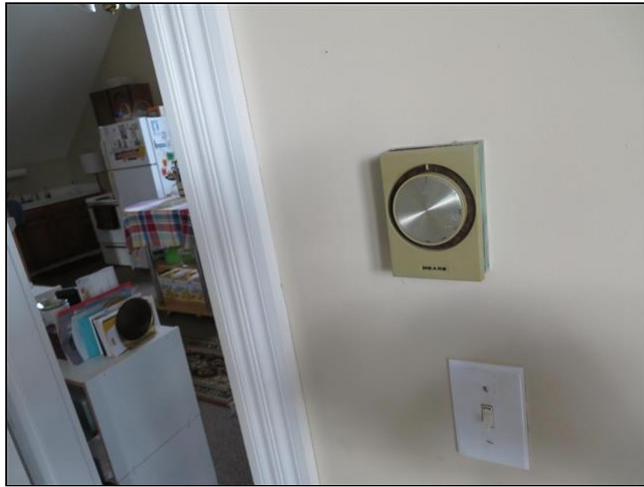
(4) Each room in the mother-in-law apartment has a thermostat control for the electric heat.

12.8.B Item 3(Picture) Thermostat in each room

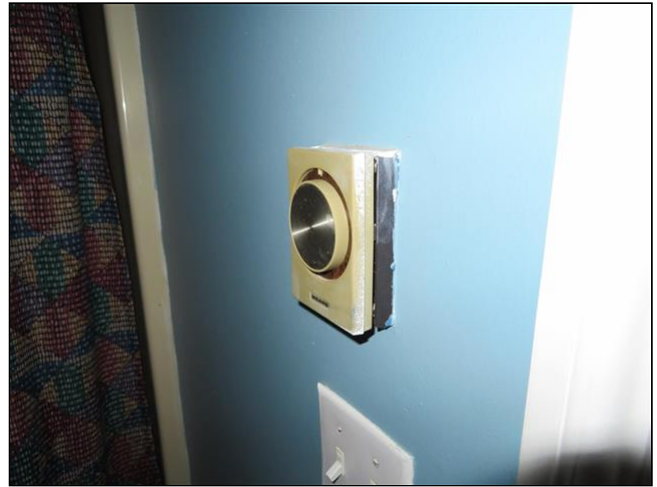
12.8.B Item 4(Picture) Bathroom thermostat

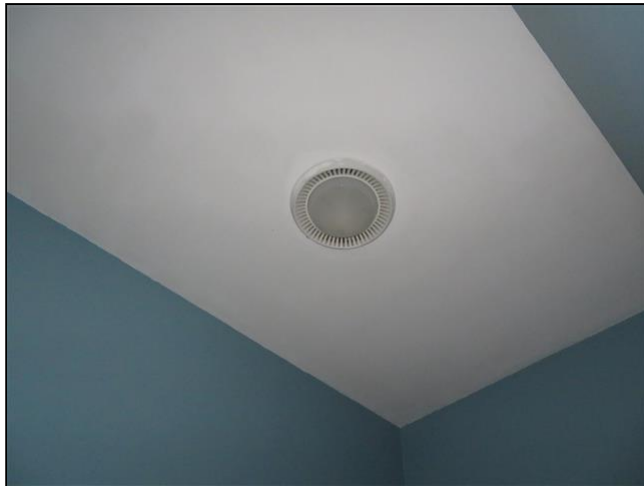
(5) The bathroom ceiling light was **NOT** operational.

12.8.B Item 5(Picture) NOT operational

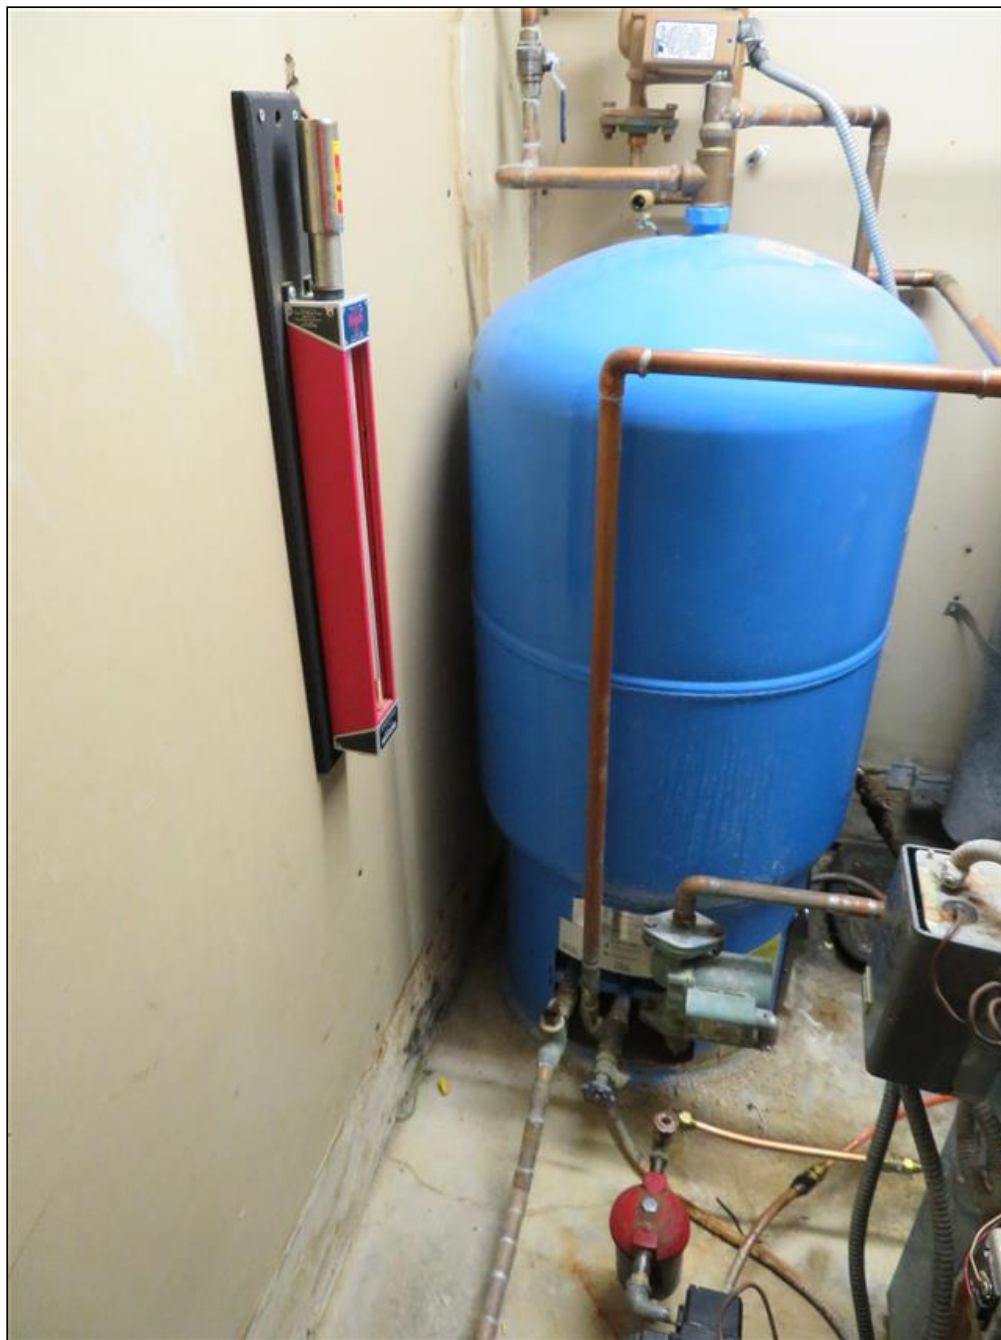
15.0 Item 1(Picture) Well holding tank

Sound Home Inspection, LLC. performed a well flow test. The submersible pump, and pressure switch operated correctly during the test. The installation is correctly installed with a well "T" pressure gauge, pressure relief valve and drain valve. The flow test confirmed that adequate water pressure and flow were observed.

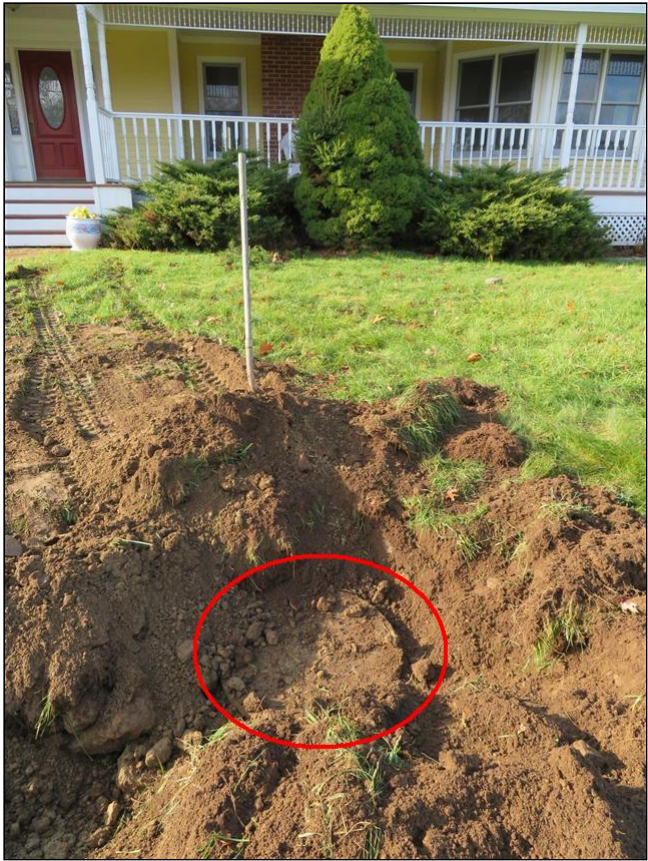
16.0 Item 1(Picture) Septic tank

Sound Home Inspection, LLC. completed on December 3, 2018 a functional flow test and inspection of the septic system. The center cover of the tank was removed prior to the commencement of the test. A mirror was placed in the tank to observe the inlet and exit baffles. The baffles and tank walls were in satisfactory condition. The relation of the scum layer to the solid layer was satisfactory. Thirty-five (35) gallons of water were introduced into the tank from the first floor bathroom. The operating level was monitored during the flow test. The operating level remained constant during the test. The system was operating satisfactorily. *The tank was pumped by Richard White & Sons on December 3, 2018 at 8:35 A. M.*
